## Investigation Update

March 2026

This document provides an update on the CSB's investigation of the October 10, 2025, incident at Accurate Energetic Systems, LLC.

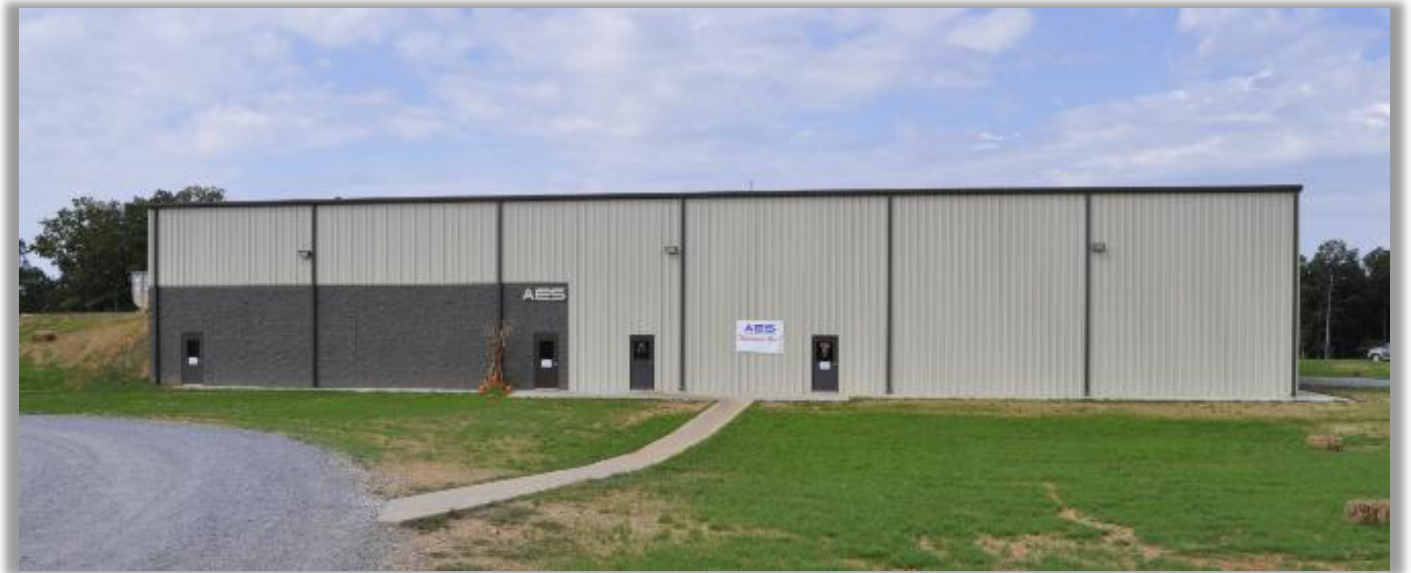
**Figure 2.** Pre-incident photo of Building 602. (Credit: AES)

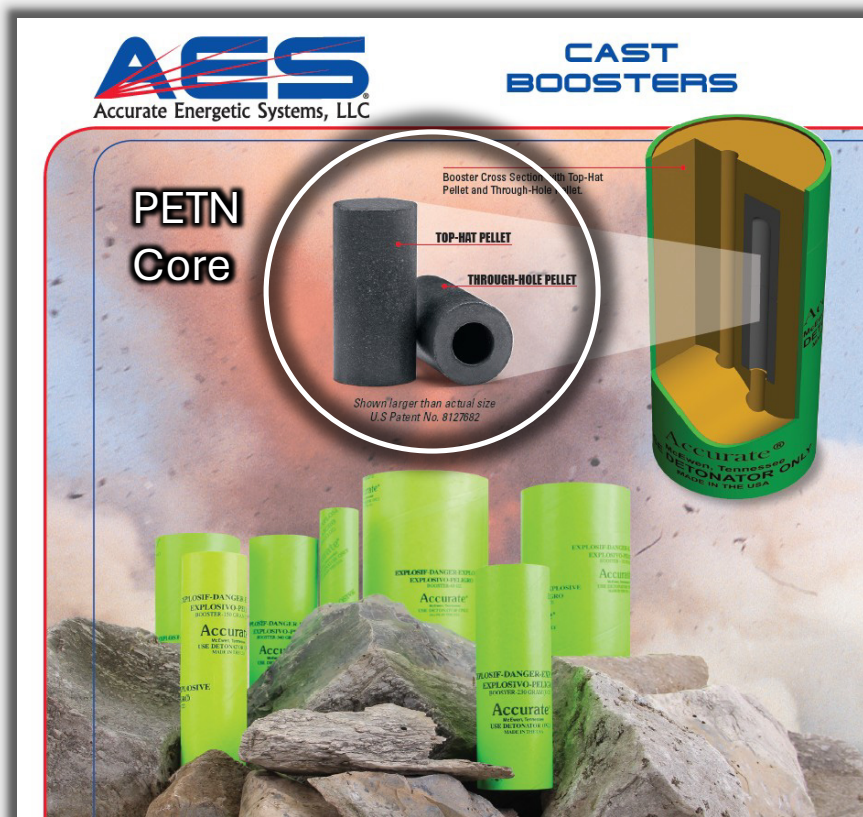
Figure 3. AES depiction of cast boosters (Credit: AES [11])

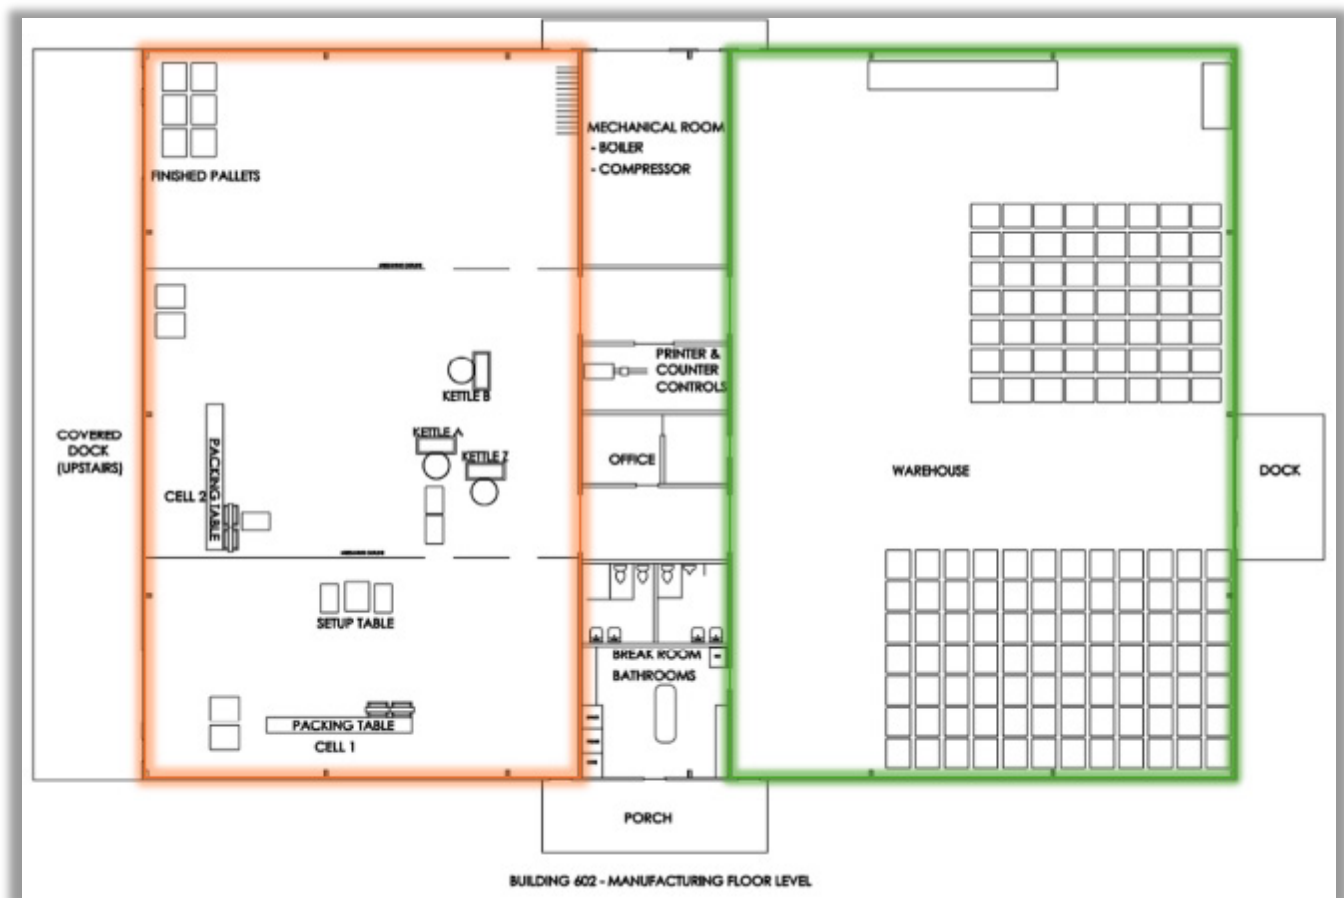
**Figure 4.** Layout of the ground level of Building 602. The explosive manufacturing area is outlined in orange, and the warehouse is outlined in green. (Credit: AES modified by CSB)

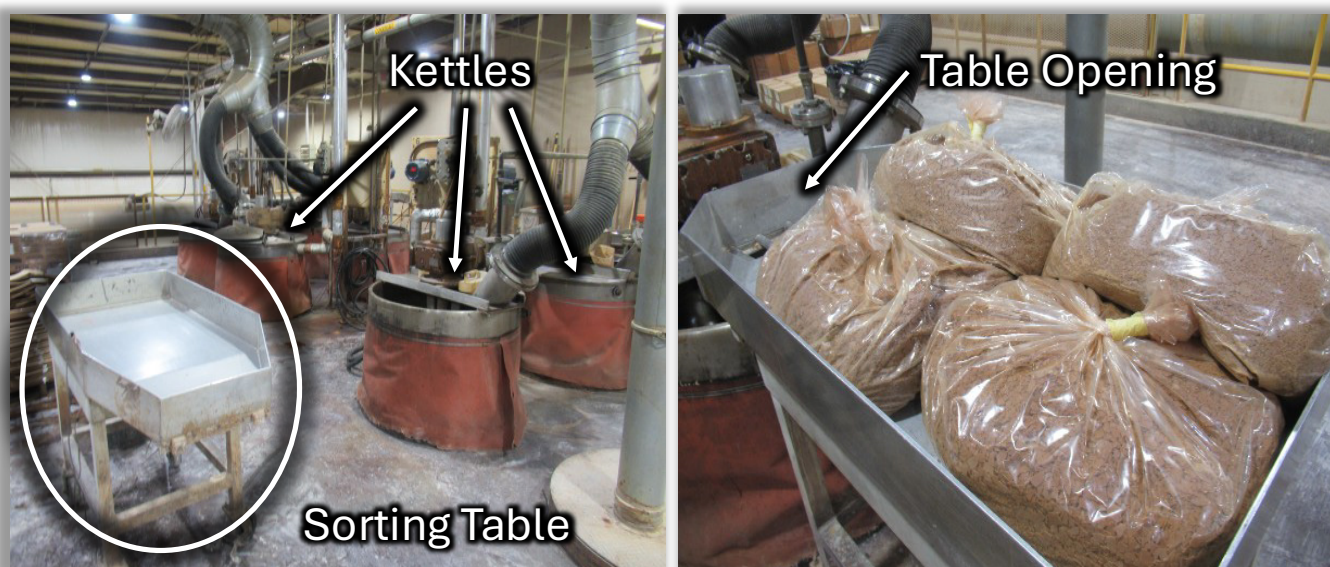
- To prepare for the melt/pour operation, AES workers would obtain solid, flaked TNT-based explosives from storage and deliver these materials to Building 602. A kettle operator would empty these explosive materials onto a wheeled, aluminum sorting table<sup>a</sup> on the mezzanine level and visually inspect for and remove identified debris. The table was equipped with magnets to capture and remove any ferrous metal debris. AES's sorting and inspection process equipment is shown in **Figure 5**.

**Figure 5.** Sorting table (circled on the left) next to the mezzanine-level kettles and TNT-based explosives in bags on sorting table before inspection (right). (Credit: AES, modified by CSB)

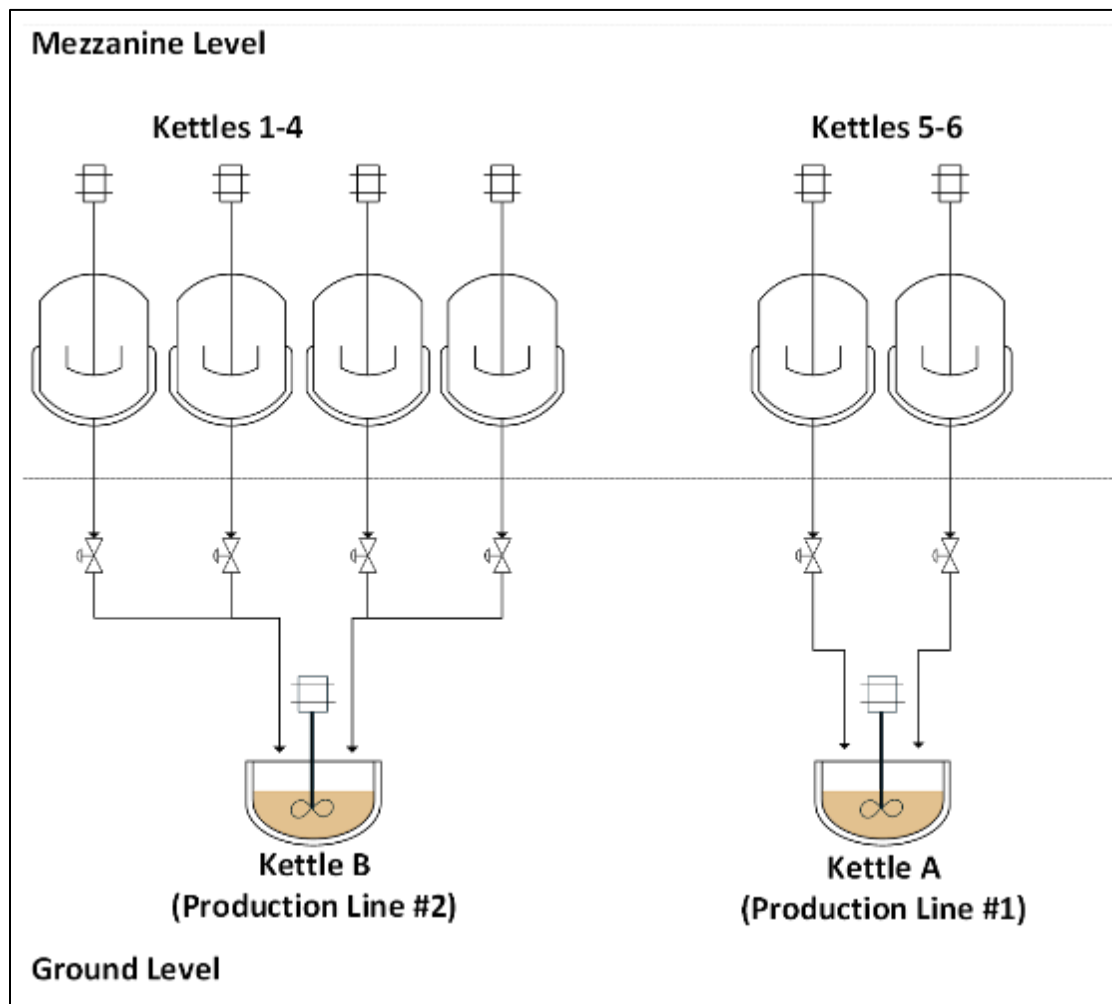
**Figure 6.** Simplified diagram of the melt/pour process (Credit: CSB)

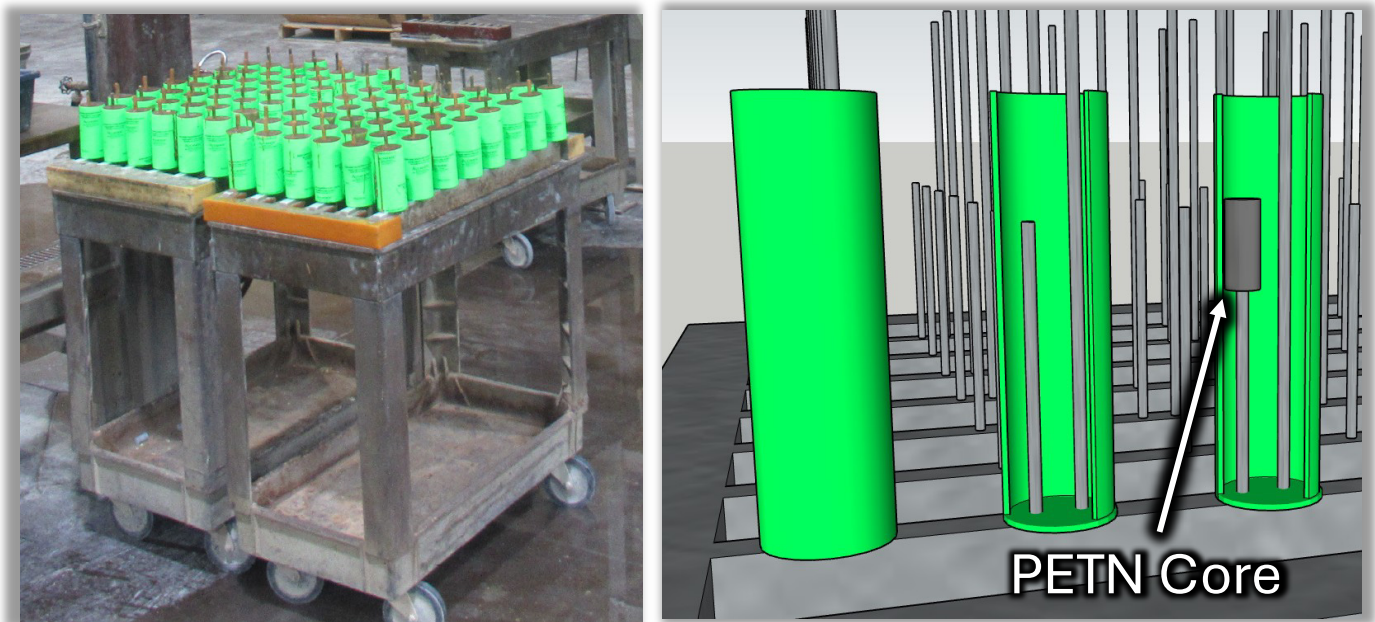
- On the ground floor, operators prepared the booster tubes to receive the molten explosives. Wheeled carts were staged, and metal fixtures, called “pin bars,” were inserted into the carts’ frames. Operators would put the empty tubes onto the pin bars and place a PETN core on one of the pins inside each tube. **Figure 7** shows a photo and depiction of the tubes situated on the pin bars.

**Figure 7.** Carts with staged booster tubes on pin bars (left) and depiction of how a booster tube was oriented on pin bars (right). (Credit: AES (left) and schematic by CSB (right))

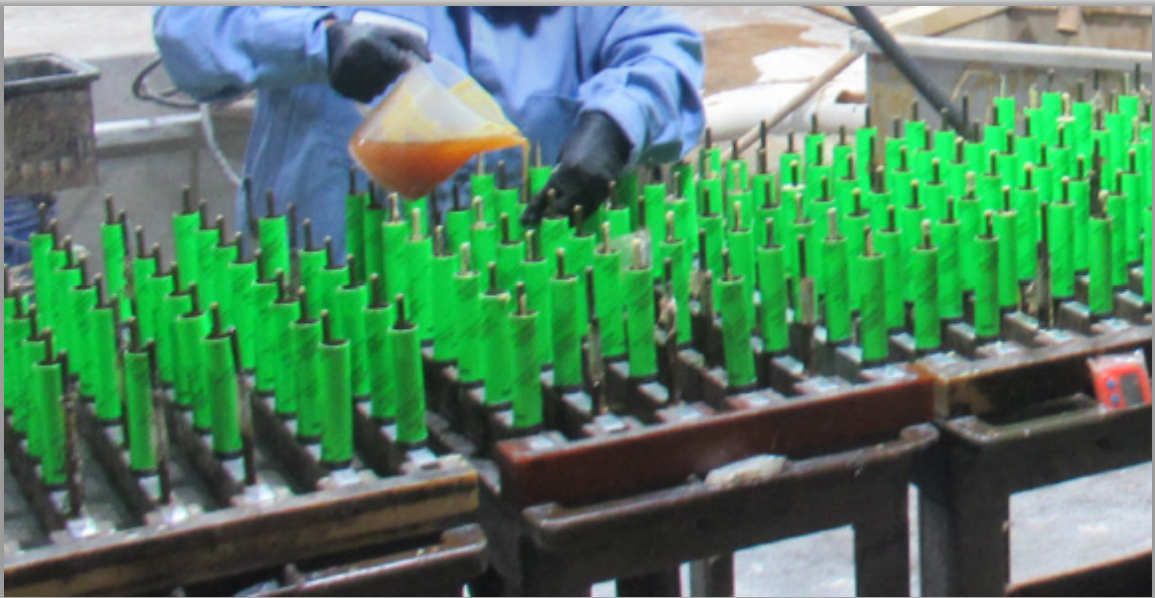
- After installing the PETN core, the tubes were ready to be filled with molten explosives. The prepared booster tube assemblies were moved to the pouring area, where the operators would pour the molten explosive into the tubes. Operators dipped a plastic pitcher into the kettle and then hand-poured the liquid into the prepared tubes, as shown in **Figure 8**.

**Figure 8.** AES operator pouring TNT mixture into tubes. (Credit: AES, Redaction by CSB)
