U.S. Chemical Safety and  
Hazard Investigation Board

# Chemical Decomposition, Fires, and Toxic Gas Release at KIK Consumer Products / Bio-Lab Conyers Facility

Conyers, Georgia | Incident Date: September 29, 2024 | No. 2024-04-I-GA

## Investigation Report

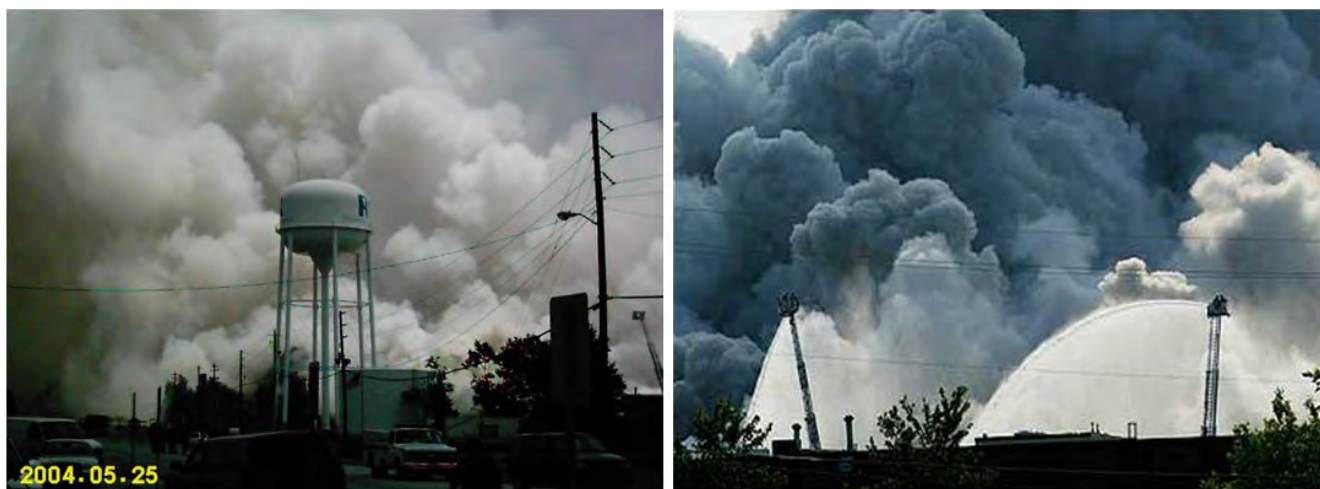
KIK. The 2004 incident involved approximately 12.5 million lbs. of pool-treatment chemicals and oxidizers, a release of HCl gas/vapor,<sup>a</sup> and a fire. The effect “of the plume was felt more than 50 miles away” [29]. Published news media reported that “the three main chemicals stored in the warehouse were trichloroisocyanuric acid, dichloroisocyanuric acid, and calcium hypochlorite” and that 28 people were admitted to hospitals, “but none was injured seriously” [30]. The community was impacted by road closures, including U.S. Interstate 20 (“I-20”), and a mandatory evacuation. Large plumes of smoke from the incident were visible in the surrounding area, as shown in **Figure 11**.

**Figure 11.** Chemical release and fire at Bio-Lab Conyers on May 25, 2004. (Credit: U.S. Environmental Protection Agency [29])

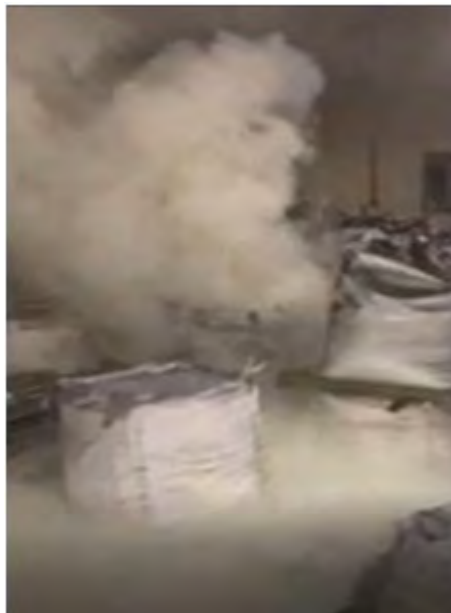
2. On September 14, 2020, Bio-Lab Conyers experienced a chemical reaction and decomposition involving TCCA-based formulations stored in Plant 6, a different building from the one where the 2024 incident occurred.<sup>b</sup> Much of the material in Plant 6 was stored in lined super sacks that sat on top of wood or plastic pallets on the floor. A 3/8-inch polyethylene water line connected to the water heater developed a leak, causing flooding in the building. The floodwater came into contact with TCCA-based formulation material on the floor, causing a decomposition event (**Figure 12**), which released a plume of hazardous chemicals. As a result, KIK employees assigned to Bio-Lab Conyers and nine firefighters were exposed to dangerous fumes, and the interstate highway near the facility was closed for approximately 6 hours. Following the incident, the TCCA-based formulation inventory was relocated from Plant 6 into trailers. The relocated inventory was exposed to moisture during the September 14, 2020, incident. Four days later, on September 18, 2020, a second decomposition occurred in one of the trailers involving the inventory that had been relocated from Plant 6.<sup>c</sup>

**Figure 12.** TCCA material decomposition reaction at Bio-Lab Conyers in 2020. (Credit: KIK)

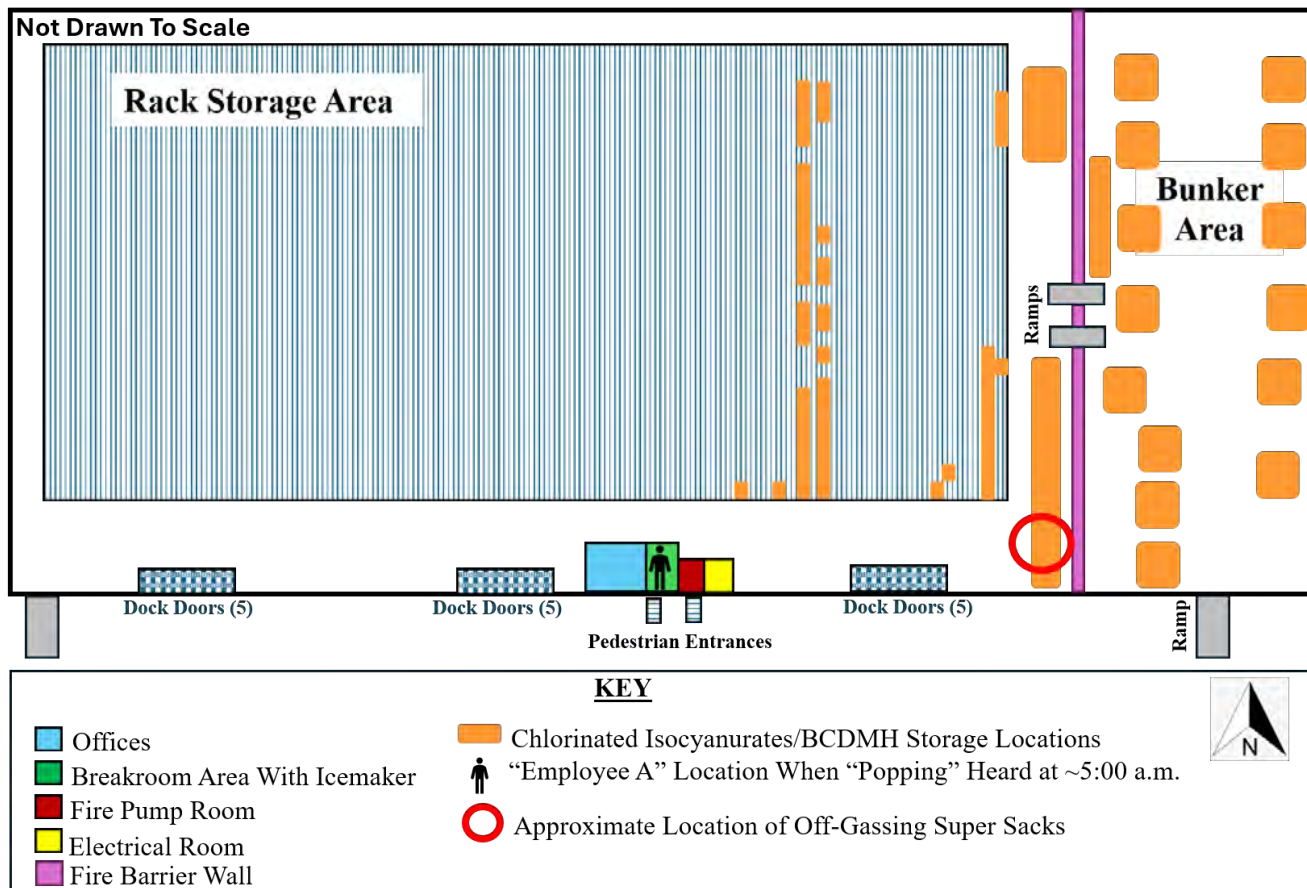
**Figure 15.** Depiction of the Plant 12 Storage Warehouse floor plan showing Employee A's location when they heard "popping." (Credit: CSB)

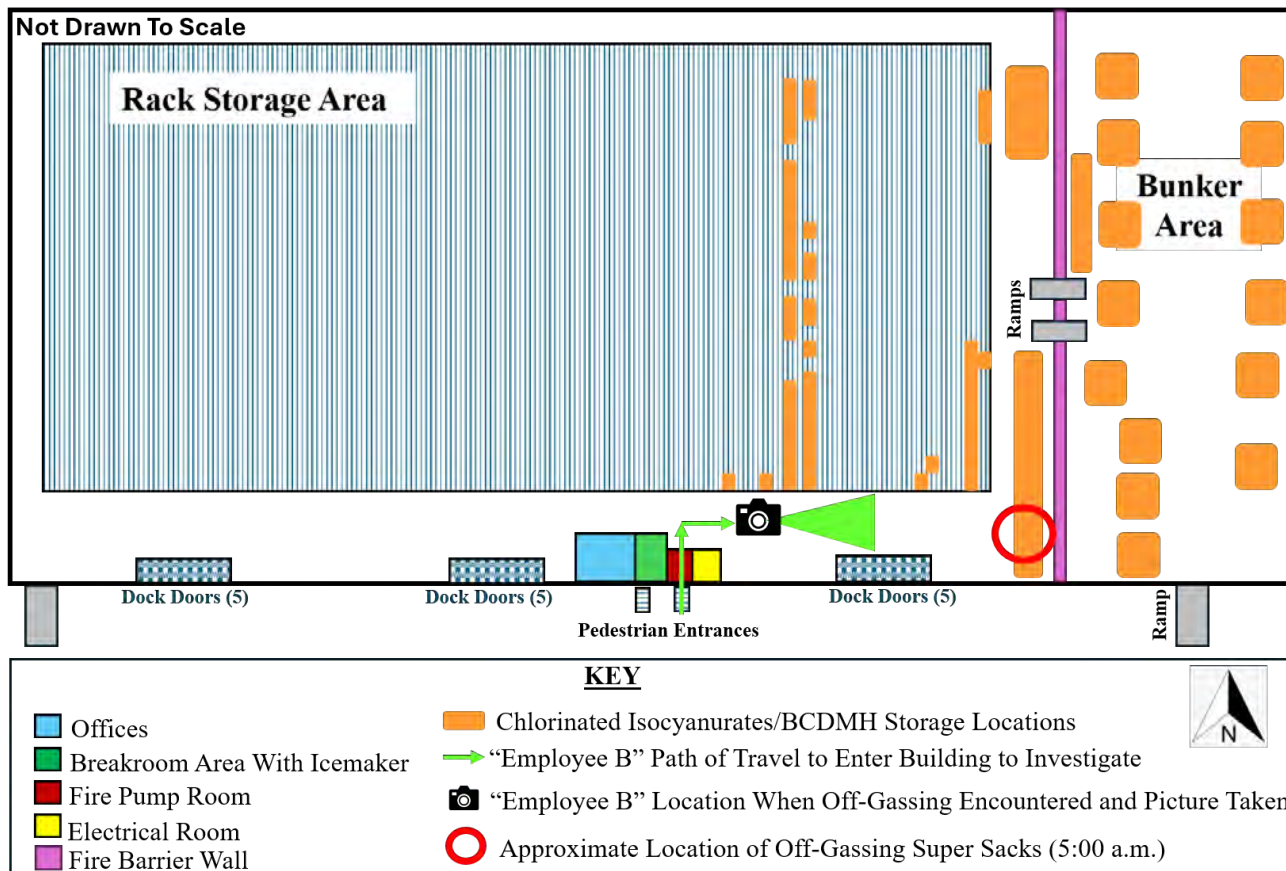
Employee B was able to remove only four super sacks of material from the area in front of the off-gassing super sacks before both employees had to leave the building due to the increasing fume density affecting visibility. Employee B also encountered difficulty moving the super sacks because there was "[n]o visibility and floors [were] too slick for forklift" due to the water from the sprinkler flow. Employee B took a picture and video of the dense white fumes before leaving the building (**Figure 17**).<sup>a</sup> **Figure 16** depicts the path of travel that Employee B took when entering the building to shut off the fire pump, the general location of the off-gassing material, and where Employee B was standing when they took the picture (**Figure 17**).

**Figure 16.** Depiction of the Plant 12 Storage Warehouse floor plan showing Employee B's path of travel into the warehouse and the location where the off-gassing picture was taken. (Credit: CSB)

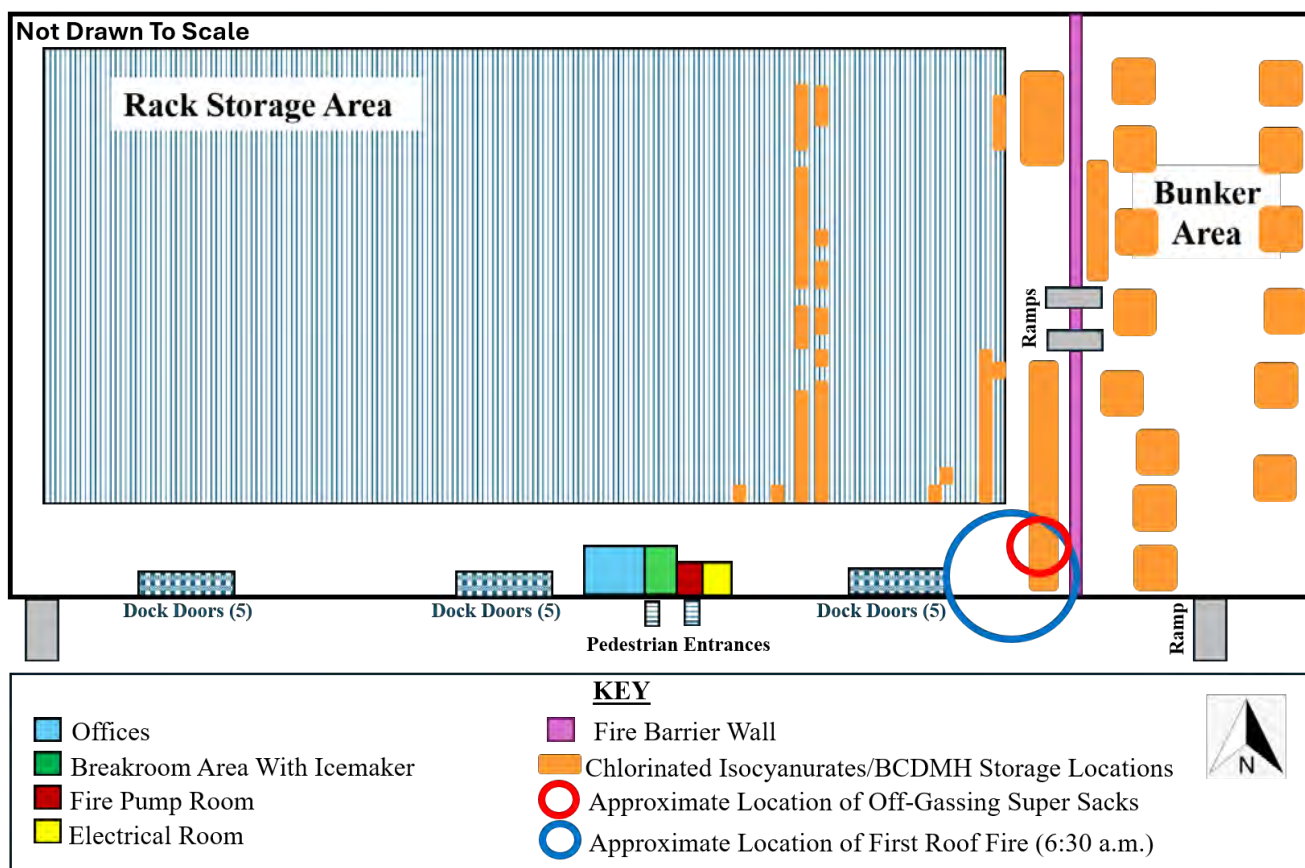
**Figure 20.** Approximate location of first roof fire relative to building interior layout. (Credit: CSB)

Although the flames on the roof were first observed at 6:30 a.m., it was not until approximately 8:10 a.m. that the responders extinguished the roof membrane fire by applying a relatively small stream of water, estimated by fire rescue personnel as only a “couple gallons.” RCFR personnel told the CSB they wanted to use the minimum amount of water necessary and not wet additional material based on their experience with previous TCCA (TCCA-based formulation) incidents at Bio-Lab Conyers, such as the 2020 Plant 6 decompositions.<sup>a</sup> The RCFR responders performing external reconnaissance also looked into the bunker through the open dock door and reported minimal fumes and no signs of sprinkler activation within the bunker area.

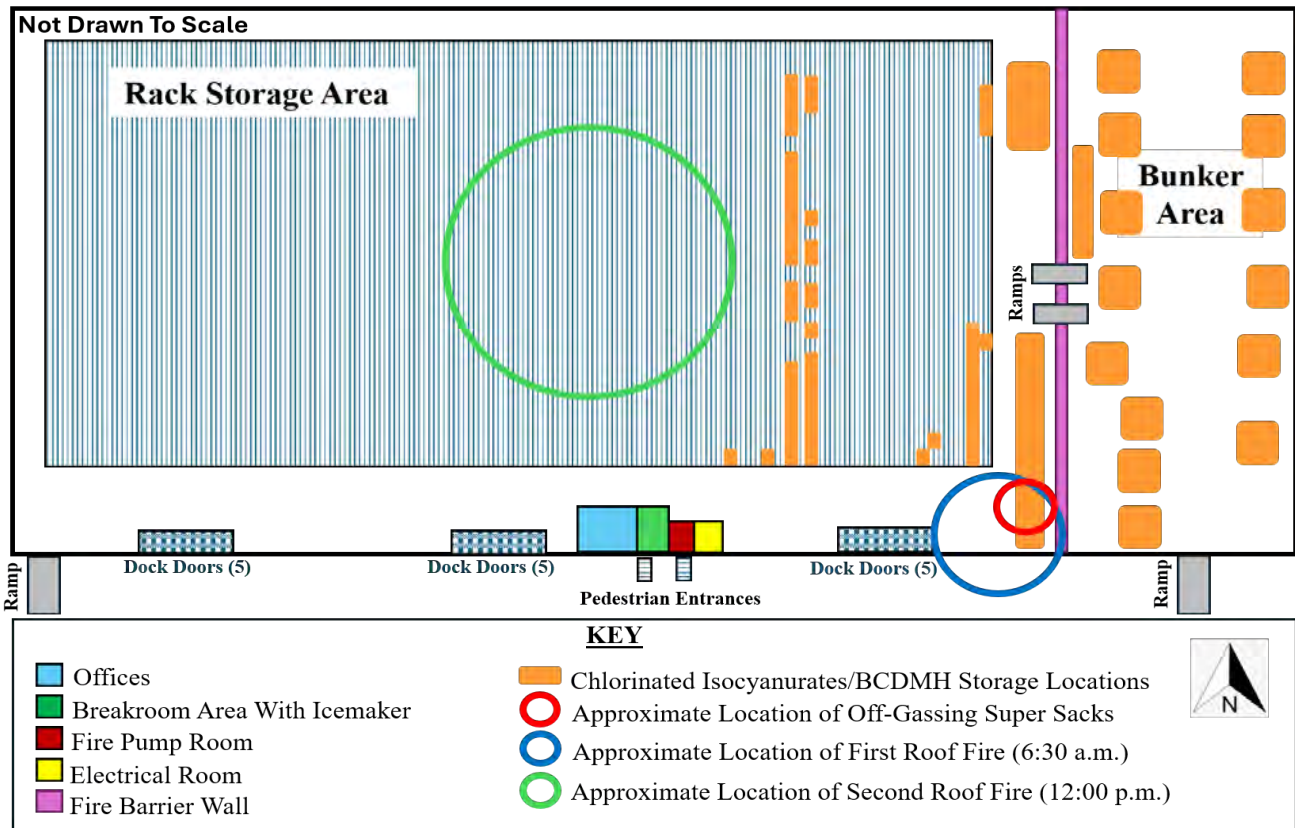
**Figure 22.** Location of second roof fire relative to first fire and building interior layout. (Credit: CSB)

RCFR personnel described that the second fire as initially consisting of a large plume of black smoke, thick white fumes and large flames, before changing over to multicolored plumes of smoke, as shown in **Figure 23**.

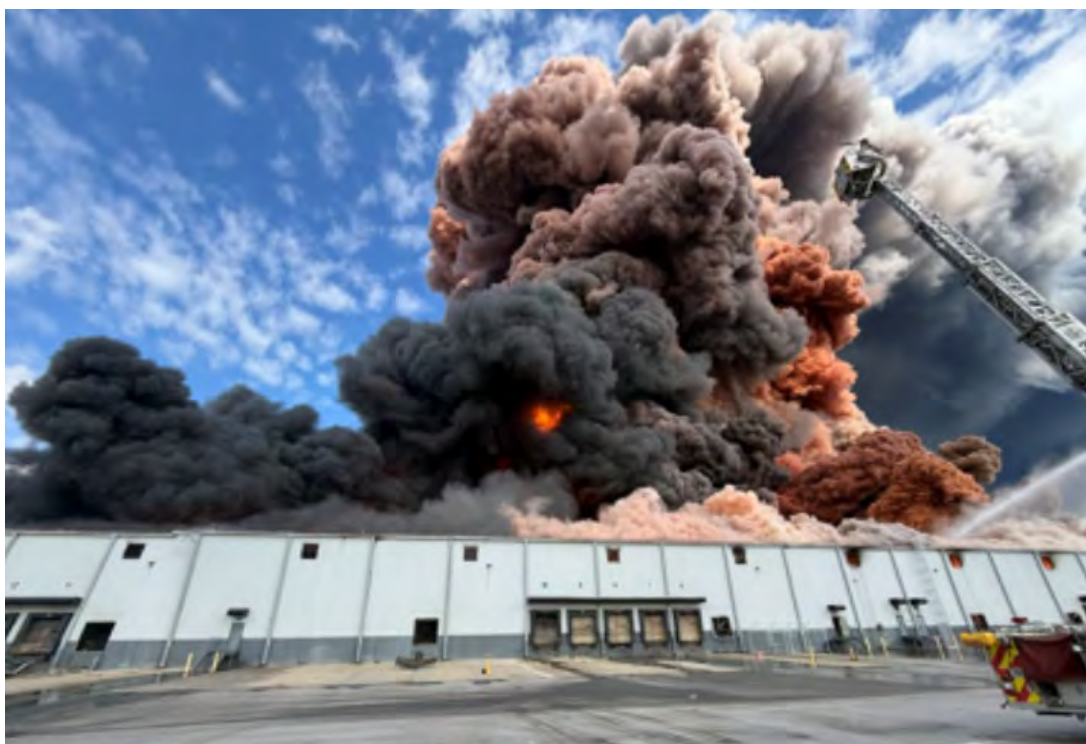
**Figure 23.** Multicolor plumes of smoke observed during the second fire at Bio-Lab Conyers on September 29, 2024. (Credit: Ross/11Alive)

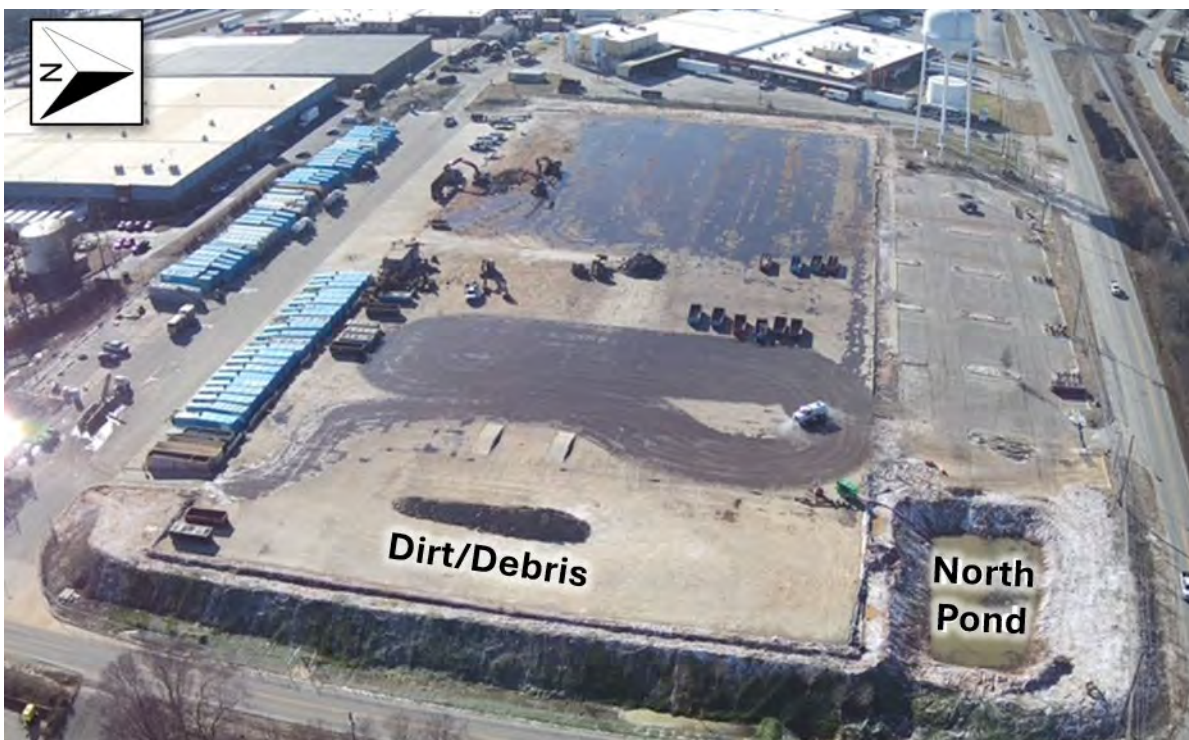
**Figure 29.** Concrete slab where the Plant 12 Storage Warehouse was located before the 2024 Bio-Lab Conyers incident. (Credit: KIK, annotated by CSB)

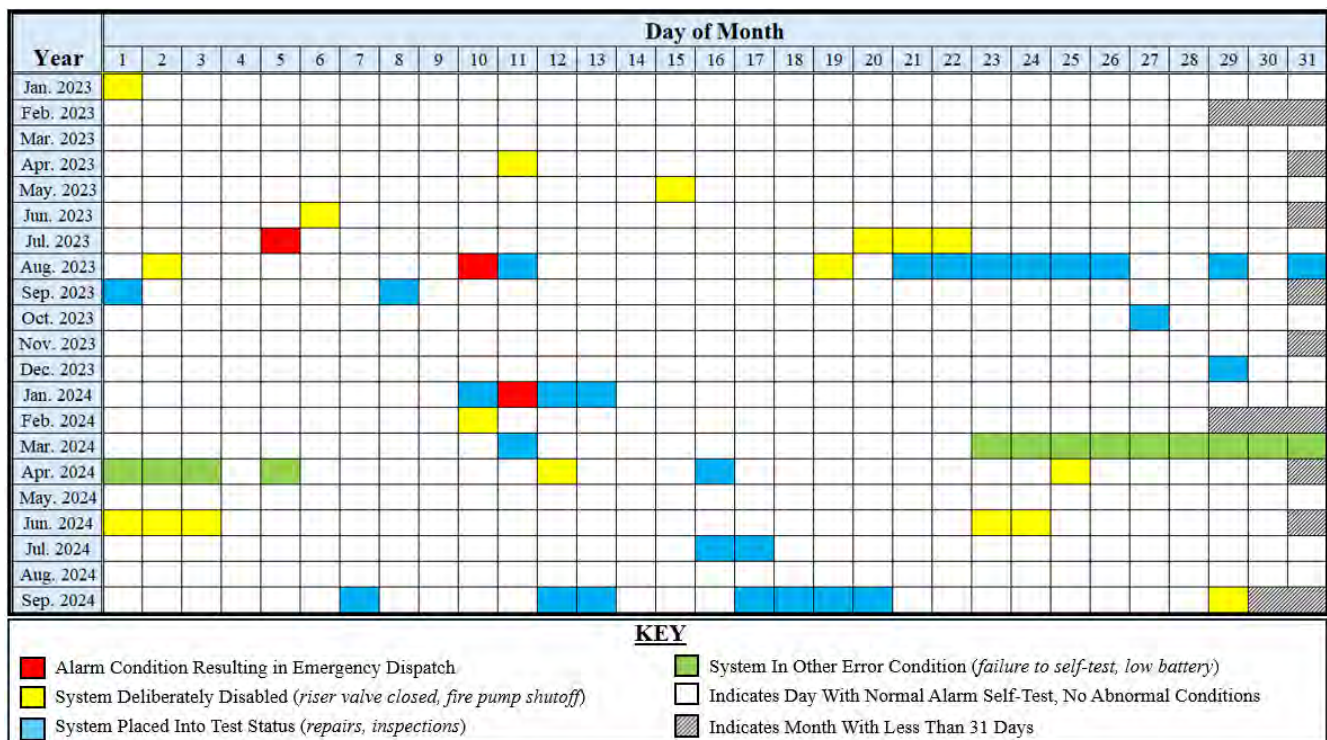
**Figure 38.** Daily fire alarm monitoring system status from January 1, 2023, through September 29, 2024. (Credit: CSB)

For 17 days, including the day of the September 29, 2024, incident, the fire protection system was deliberately disabled by an employee, either manually shutting off power to the fire pump or closing the riser valves. Risers are the above-ground horizontal or vertical pipes between the water supply and the fire piping and sprinkler zone it supplies with water [49, pp. 25-12]. The location of the risers relative to the seven sprinkler system zones is shown in **Figure 37**. KIK employees explained to the CSB that their standard practice for responding to a sprinkler system leak at the facility was to manually shut the riser valve to the sprinkler zone containing the leak, which was unsuccessful when the ERT personnel attempted to do so on September 29, 2024, as they were unable to access the riser. This approach was known to and approved of by Bio-Lab Conyers management and environmental and safety personnel, as indicated in the ERT’s Telegram app chat logs.<sup>a</sup>

Not all sprinkler system leaks resulted in Bio-Lab employees turning off the fire pump or closing the riser valves, and this information would not have been captured in the fire alarm system monitoring logs and included in the analysis presented in **Figure 38**. For example, internal communications document that Bio-Lab employees and supervision decided not to disable the fire protection system during the sprinkler leak discovered the evening of September 17, 2024, at 5:57 p.m., and instead controlled the leaking water with a bucket. The test status shown in **Figure 38** for September 17, 2024, was associated with sprinkler repair work conducted during the workday hours, and the new failure was discovered after sprinkler technicians had departed the facility. Based on these observations, the frequency of fire protection system failures may have been higher than what is indicated by the sprinkler system alarm monitoring history.

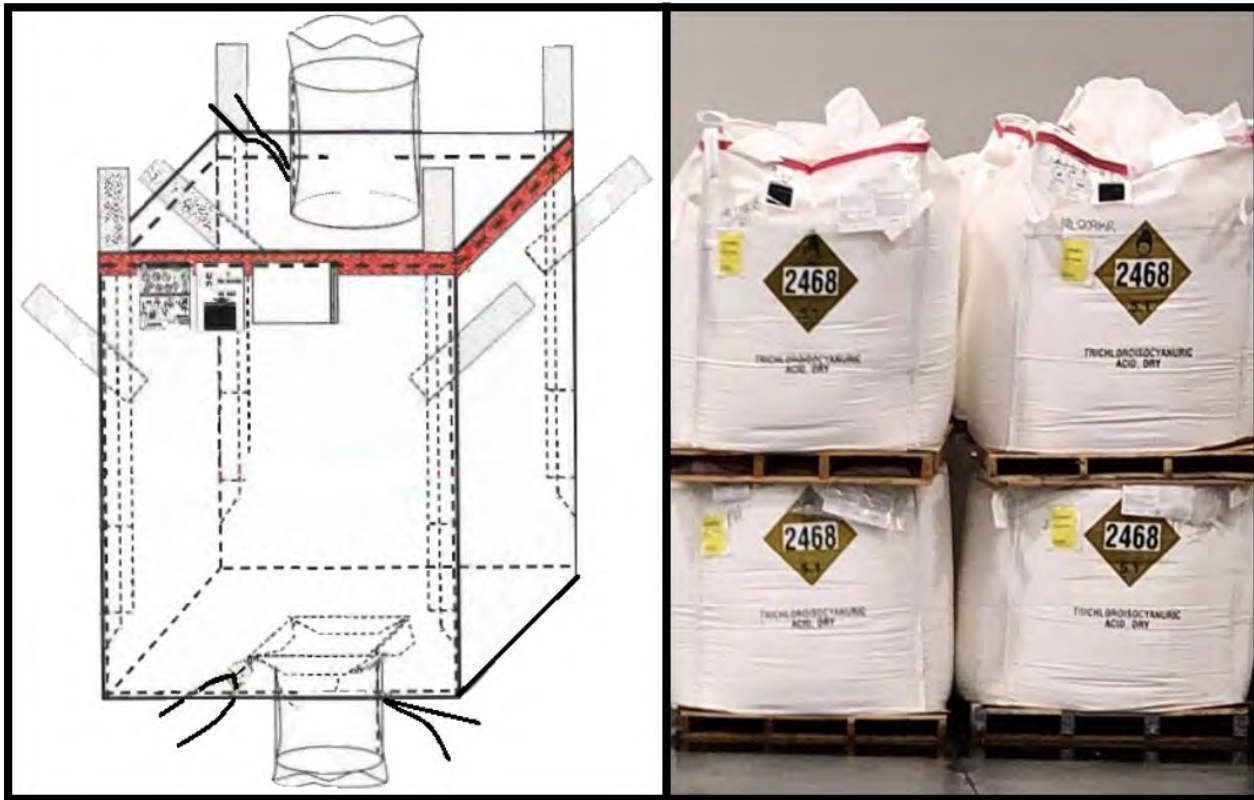
**Figure 40.** Design of the super sacks used in Plant 12 Storage Warehouse (left), and exemplar super sack used at Plant 12 Storage Warehouse (right). (Credit: Bio-Lab and ARCO, modified by CSB)

However, the outer super sack fabric (woven polypropylene) is not waterproof. Because the bags are not sealed, there's an opportunity for moisture in the air to enter the bags, contact the chlorinated isocyanurates, and cause them to release corrosive vapors, such as HCl, as stated in **Section 1.2.3**. These corrosive vapors create a corrosive atmosphere that can corrode metals in the area, such as the sprinkler system. Corrosion of a sprinkler system can cause failures, resulting in water leaking onto bags stored below it. Once wetted, the material in the super sacks underwent a decomposition reaction, producing toxic vapors described by employees as “dense white clouds” coming from the “off-gassing bags” (see **Section 2.2**).

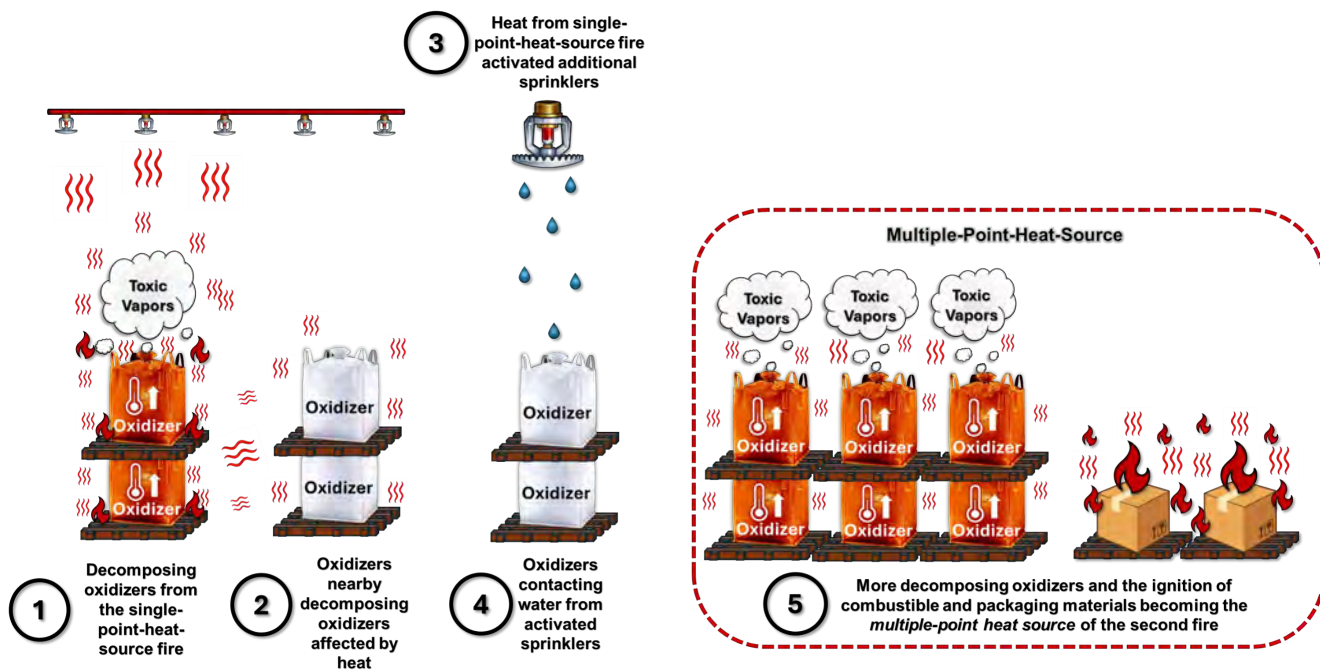
Although the first building fire was extinguished at approximately 8:10 a.m., the elevated temperatures inside the building from additional decomposing super sacks of materials continued to affect other areas of the warehouse. As shown in steps 1 through 3 of **Figure 42**, the heat emitted by decomposing oxidizers also activated the sprinklers in additional zones of the warehouse (see **Section 2.2**).

**Figure 42.** Depiction of the progression of the second fire in Plant 12 Storage Warehouse caused by a multiple-point heat source. (Credit: CSB)

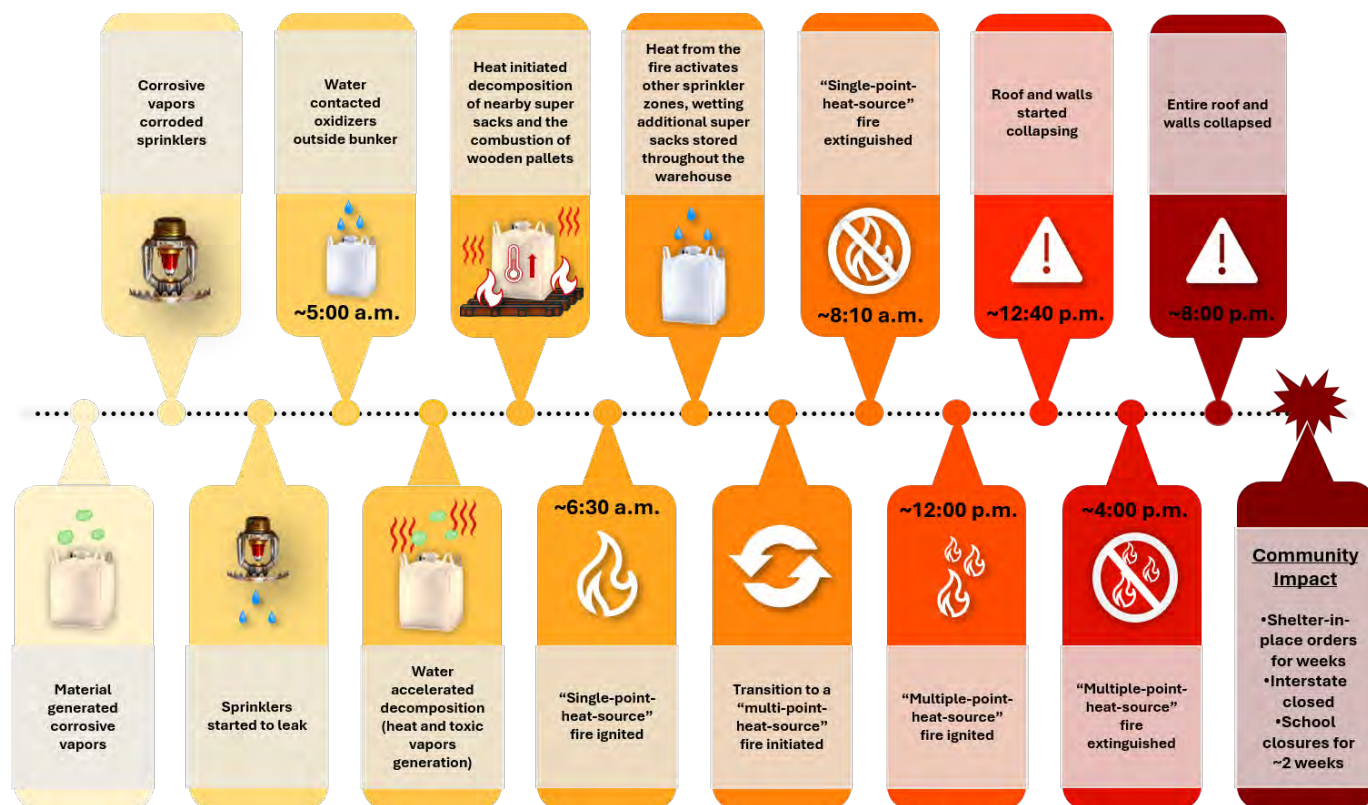
**Figure 44** presents a timeline of the incident that outlines the chronological sequence of events from the initial fire started by a “single-point-heat-source” on the morning of September 29, 2024, through the transition to a “multiple-point-heat-source” fire [65, pp. 13-367], the subsequent roof collapse, and its impact on the community.

**Figure 44.** Timeline of the incident at Bio-Lab Conyers on September 29, 2024. (Credit: CSB)

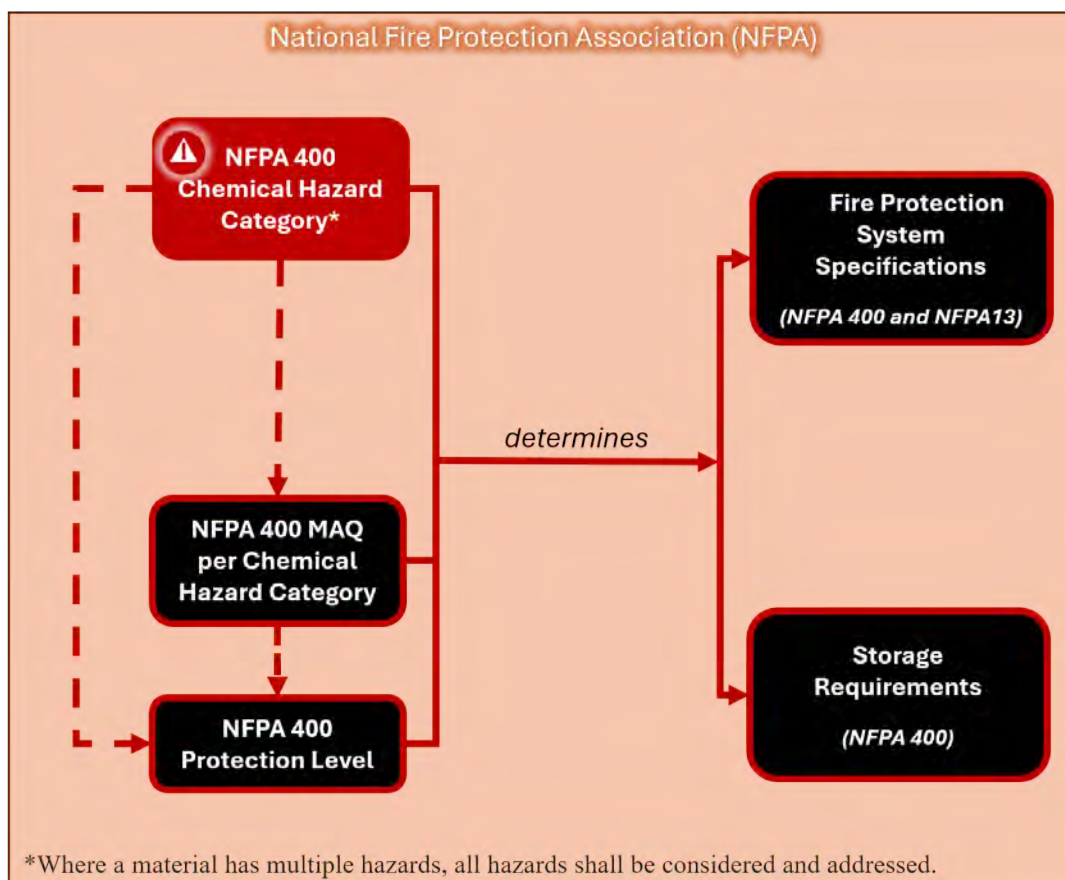
Primarily focusing on the oxidizing properties of these pool-treatment chemicals in NFPA 400 Annex G, without specifically noting their additional hazardous categories, could possibly lead a user to overlook their corrosivity and water reactivity. As illustrated in **Figure 50**, misclassification of the chemical hazard category or failure to properly assess each hazard category and appropriately address the most restrictive requirements directly affects MAQ determinations and Protection Level requirements, which, in turn, impact storage requirements and fire protection system design (black round rectangles).

**Figure 50.** Impact of incomplete hazard classification on NFPA 400 and NFPA 13 requirements. (Credit: CSB)

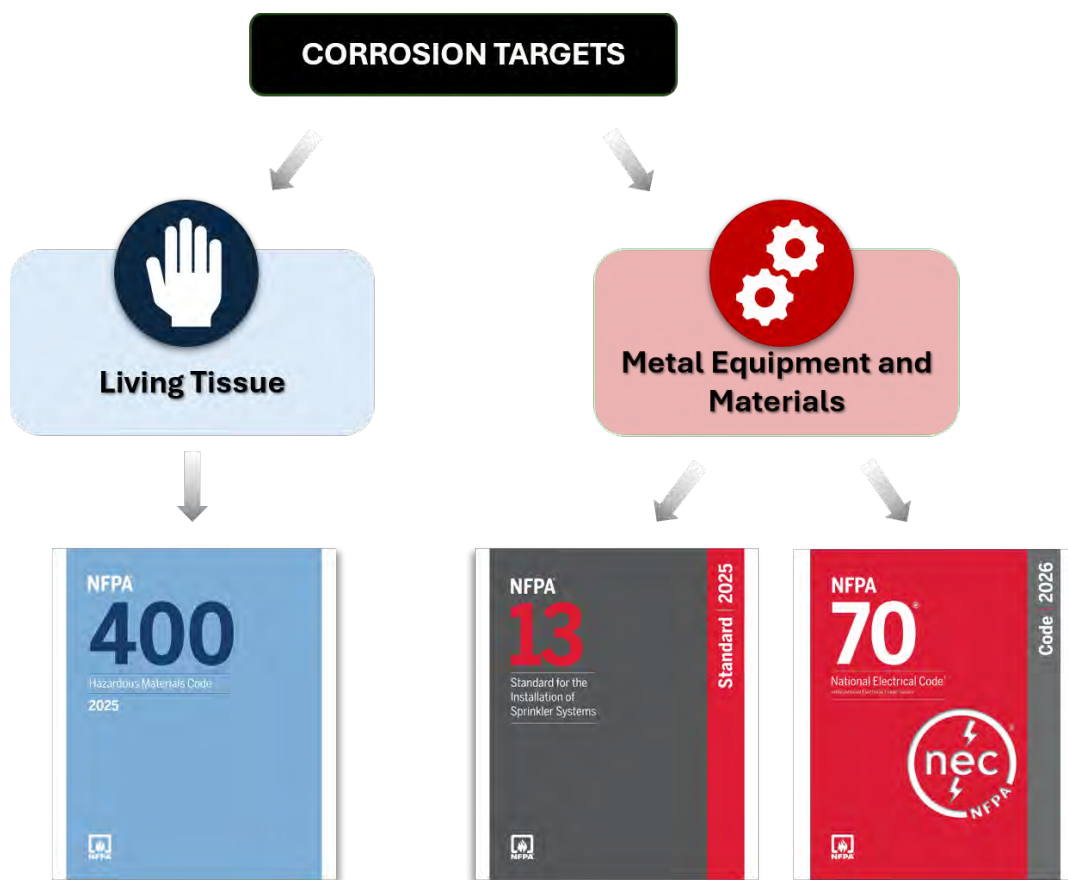
The resulting safety requirements are not harmonized across the standards, leading to differing interpretations of how corrosion should be addressed. **Figure 51** illustrates how each NFPA standard targets a distinct aspect of corrosion within its respective scope.

**Figure 51.** Corrosion targets for NFPA 400, NFPA 13, and NFPA 70 [94]. (Credit: CSB)

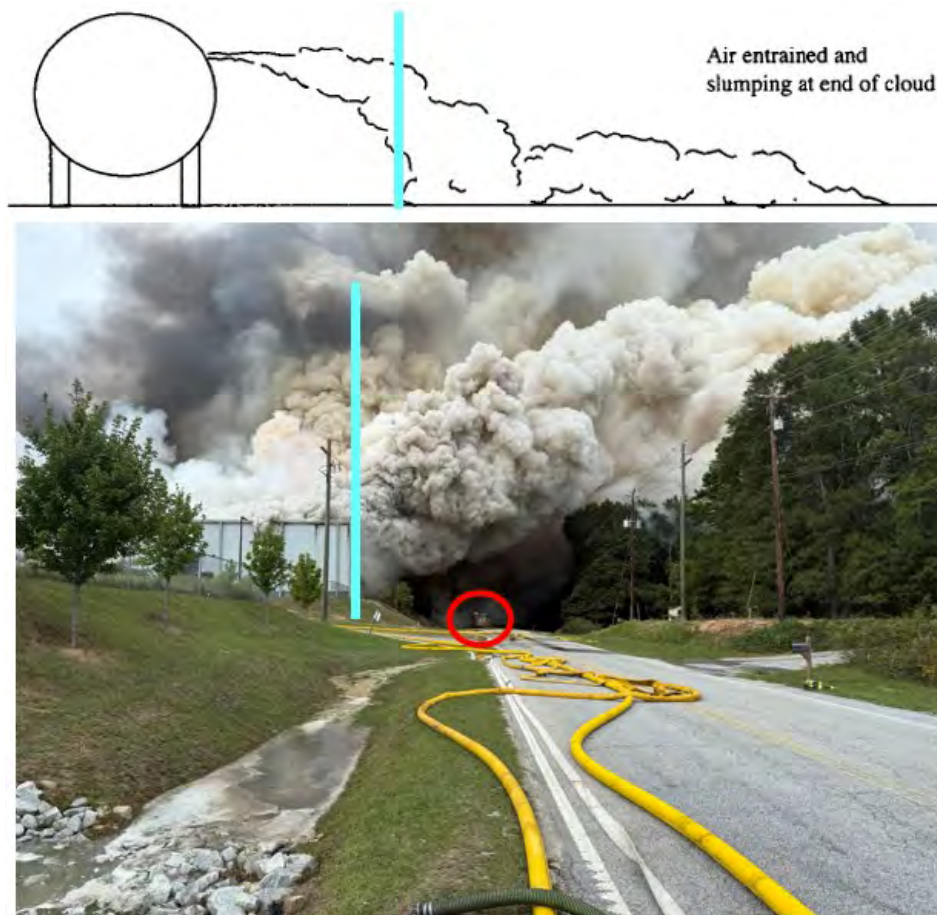
Air monitoring by EPA following the September 2024 Conyers incident indicated that the observed plume from the site contained bromine, chlorine, and hydrogen chloride.<sup>b</sup> Per EPA’s *Risk Management Program Guidance for Offsite Consequences Analysis*, bromine, chlorine, and hydrogen chloride are all classified as dense gases for EPA RMP off-site consequences modeling [100, pp. B-2 and B-4]. **Figure 52** shows the dense gas behavior of the plume during the incident, where a significant portion of the gas plume remained close to the ground, where it would have a greater impact at the ground level compared with a lighter buoyant plume. The light blue line in **Figure 52** shows the point at which the dense plume slumps to the ground, and the red circle shows the RCFR fire truck inundated by the thick ground-level plume.

**Figure 52.** Comparison of expected dense gas behavior to plume behavior observed during the Bio-Lab Conyers 2024 incident. (Credit: Wells [98, p. 40], at top; RCFR at bottom; annotated by CSB)

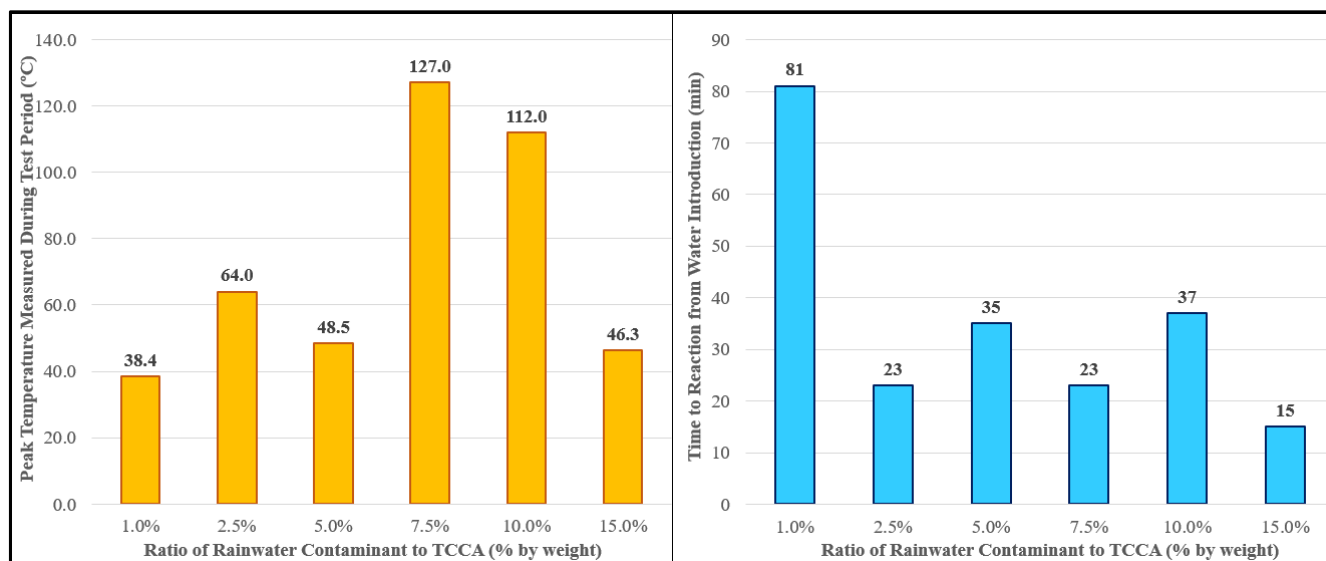
**Figure 54.** Summary of peak temperature (left) and time to reaction results (right) from TCCA and rainwater test series (2021). (Credit: Raw data from Bio-Lab, summary graphics developed by CSB)

Although all samples exhibited a temperature increase relative to ambient conditions (29°C), the highest peak temperatures measured were for the tests performed at concentrations of 7.5 percent and 10 percent water. For the samples in the concentration range of 2.5 percent to 10 percent water, the time between water exposure and onset of temperature rise was approximately 30 minutes. Upon initiation of reaction, active TCCA decomposition and elevated temperatures persisted for several hours for the samples tested at water concentrations of 2.5 percent, 5 percent, 7.5 percent, and 10 percent. For example, during the test for the 7.5 percent water concentration, although the time to reaction was 23 minutes, the peak temperature was not achieved until approximately 400 minutes, declining to approximately 40°C at 700 minutes. The 2021 testing results demonstrated that TCCA exhibits the strongest reaction concentration of approximately 7.5% to 10 percent water to total material.
