SAFETY DIGEST:

PREPARING EQUIPMENT AND INSTRUMENTATION FOR COLD WEATHER OPERATIONS

Preparing for Cold Weather at Chemical and Other Process Facilities

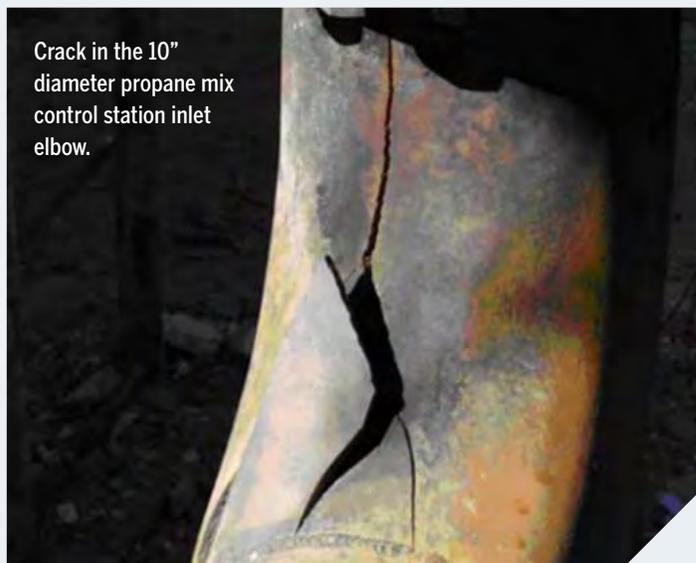
Crack in the 10" diameter propane mix control station inlet elbow.

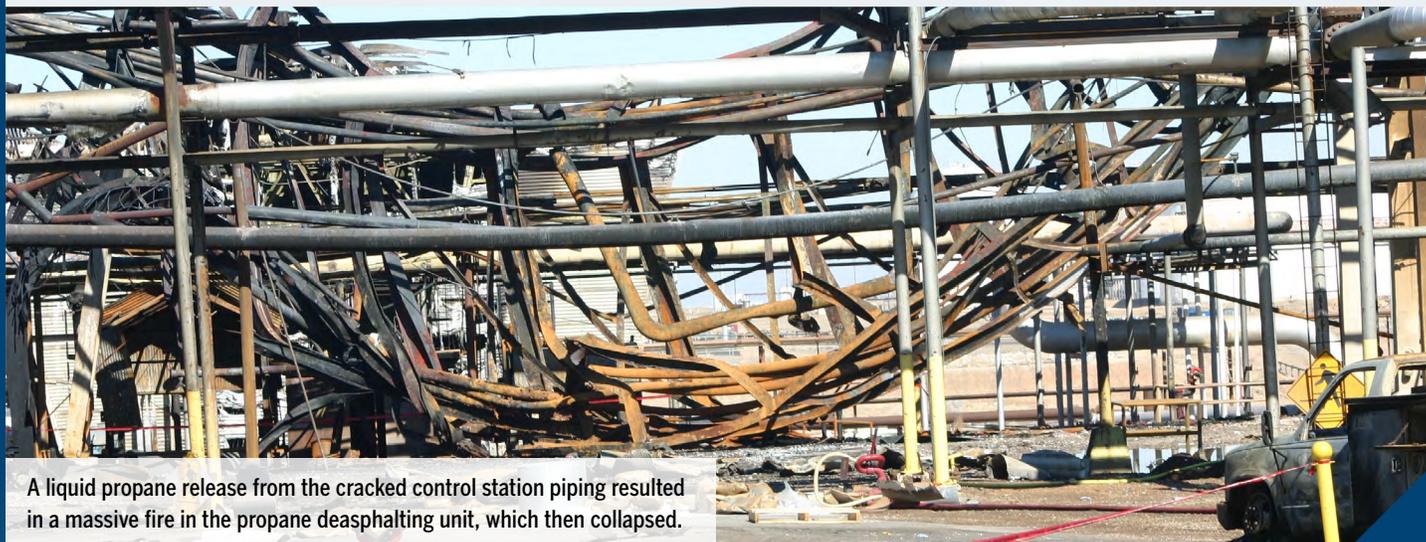
A liquid propane release from the cracked control station piping resulted in a massive fire in the propane deasphalting unit, which then collapsed.
