**Testimony of John S. Bresland  
Chairman and Chief Executive Officer  
U.S. Chemical Safety Board  
Before the U.S. House of Representatives  
Committee on Energy and Commerce  
Subcommittee on Oversight and Investigations  
April 21, 2009**

### **Preliminary Findings of the CSB Investigation**

## **Explosion Occurred During Methomyl Unit Startup**

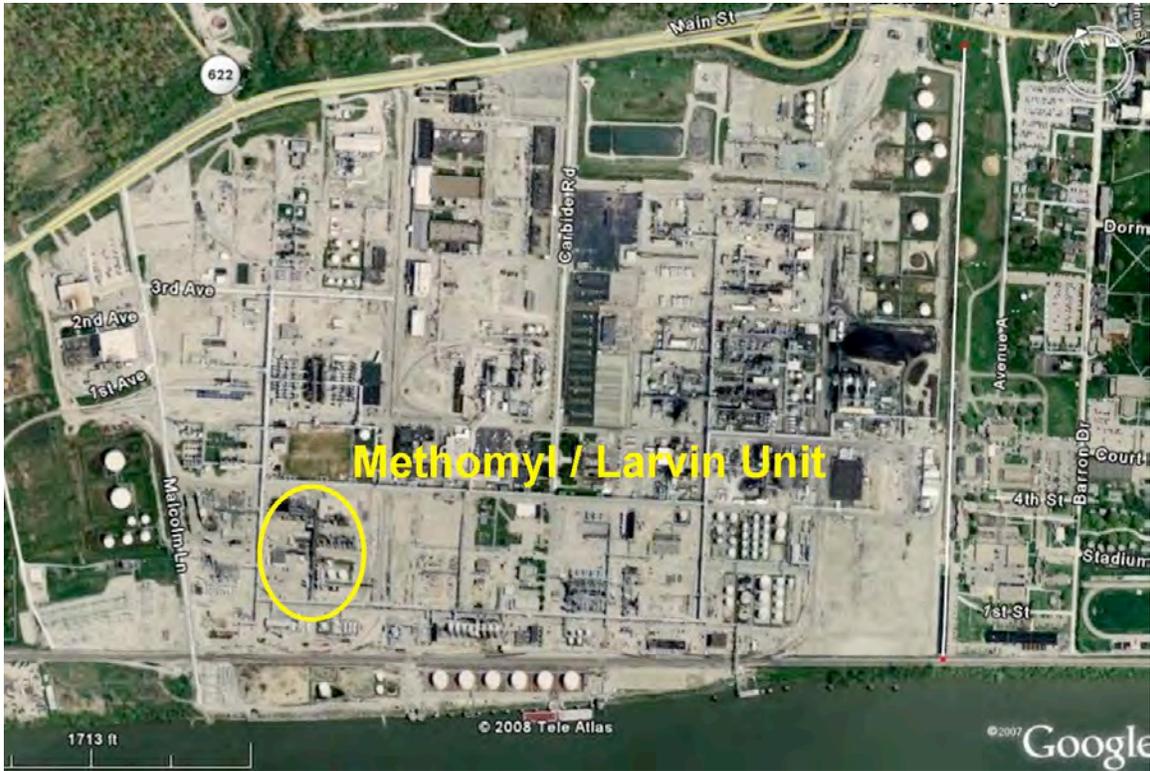
**Figure 1:** The Bayer chemical manufacturing complex in Institute, West Virginia, indicating the location of the Methomyl/Larvin unit, site of the explosion.

The facility stands in a populated area along the Kanawha River, about 10 miles to the west of Charleston (see Figure 1). Chemical safety has been a major issue in the Kanawha Valley for decades, fueled in part by concerns about the number of major chemical plants, the density of settlement, the local geography, and the potential difficulty of evacuating the area in case of a chemical emergency.

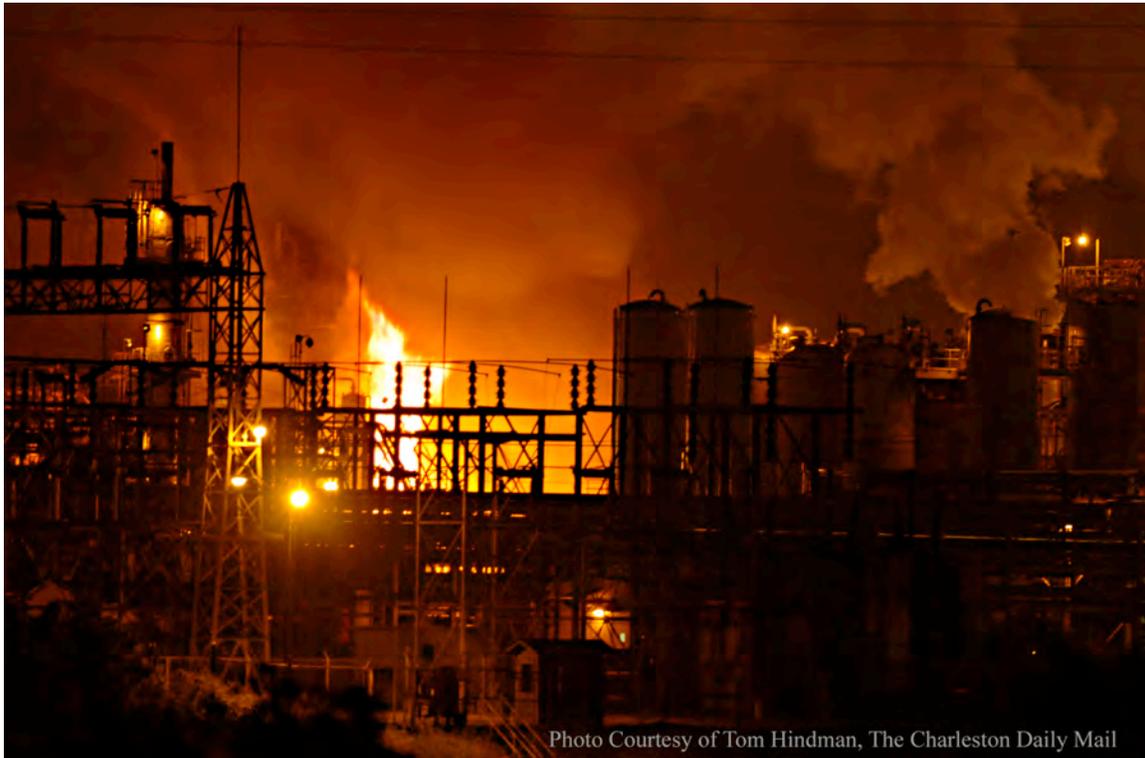
**Figure 2:** Fire in the Methomyl/Larvin unit following the explosion of the Methomyl residue treater on the night of August 28, 2008 (photo courtesy of Tom Hindman, The Charleston Daily Mail).

When the explosion occurred at 10:35 p.m. on the night of August 28, the flammable and toxic contents of the residue treater, amounting to about 2,500 gallons, were suddenly ejected and a major fire erupted in the unit (see Figure 2). Chemical pipes and venting systems were broken open and their contents released to the atmosphere. Projectiles were hurled in all directions.

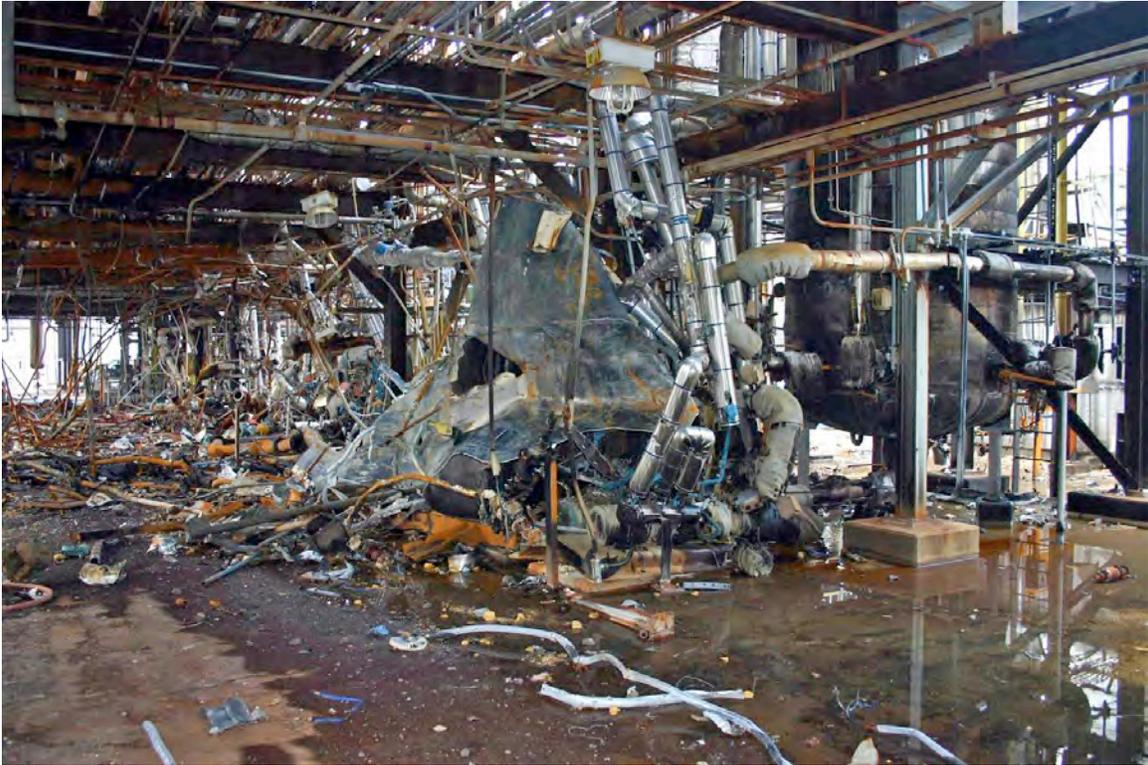
**Figure 3:** Equipment destruction along the trajectory of the residue treater vessel; the deformed shell of the vessel is visible at the center of the photograph.

However, the pressure relief system was not sized or designed for a runaway reaction involving large amounts of Methomyl, and pressure continued to build inside the vessel. Moments later, the vessel suddenly ruptured. The entire vessel was violently propelled in a northeasterly direction into the production unit – demolishing process equipment, twisting steel beams, and breaking pipes and conduits. The vessel finally came to rest about 50 feet away, grossly deformed and flattened. In its wake, it left a continuous swath of destruction.

As I have described, when the residue treater ruptured it was hurled with tremendous force in a northeasterly direction. This trajectory took the vessel through a highly congested section of process equipment, where it left a wide, long swath of destruction (see Figure 3).

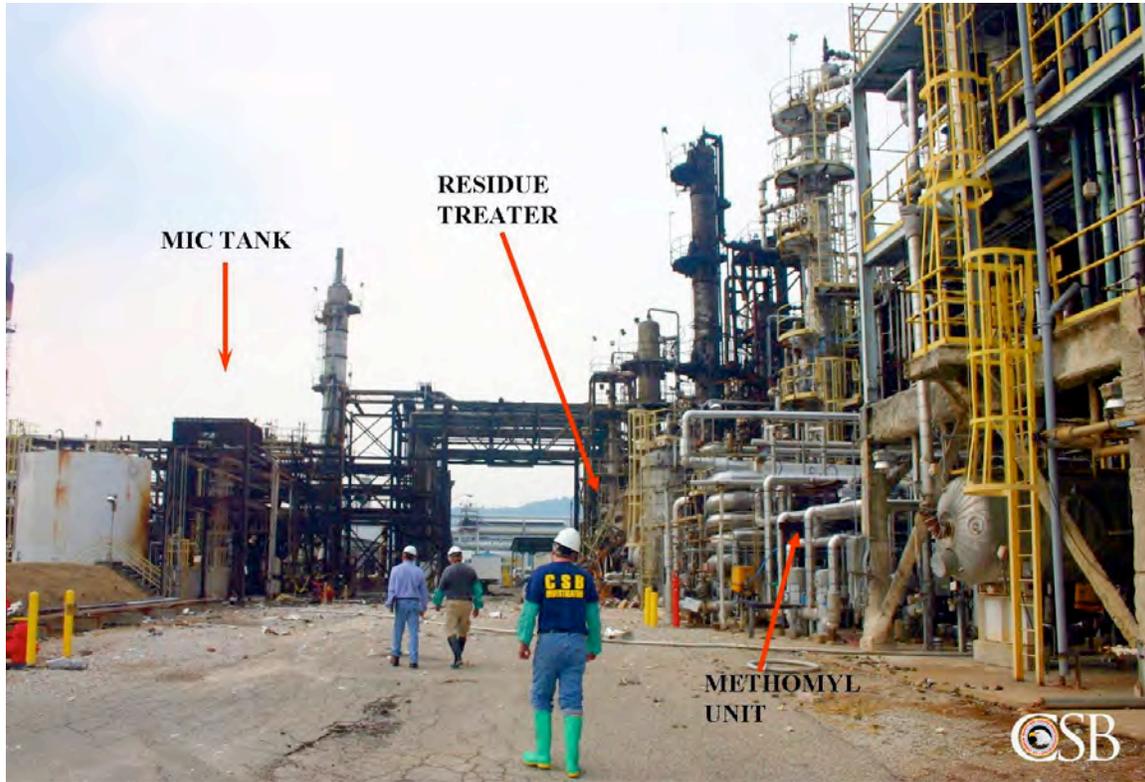
**Figure 5:** Ground-level view showing the proximity of the residue treater to the MIC storage tank, approximately 80 feet away across a roadway.

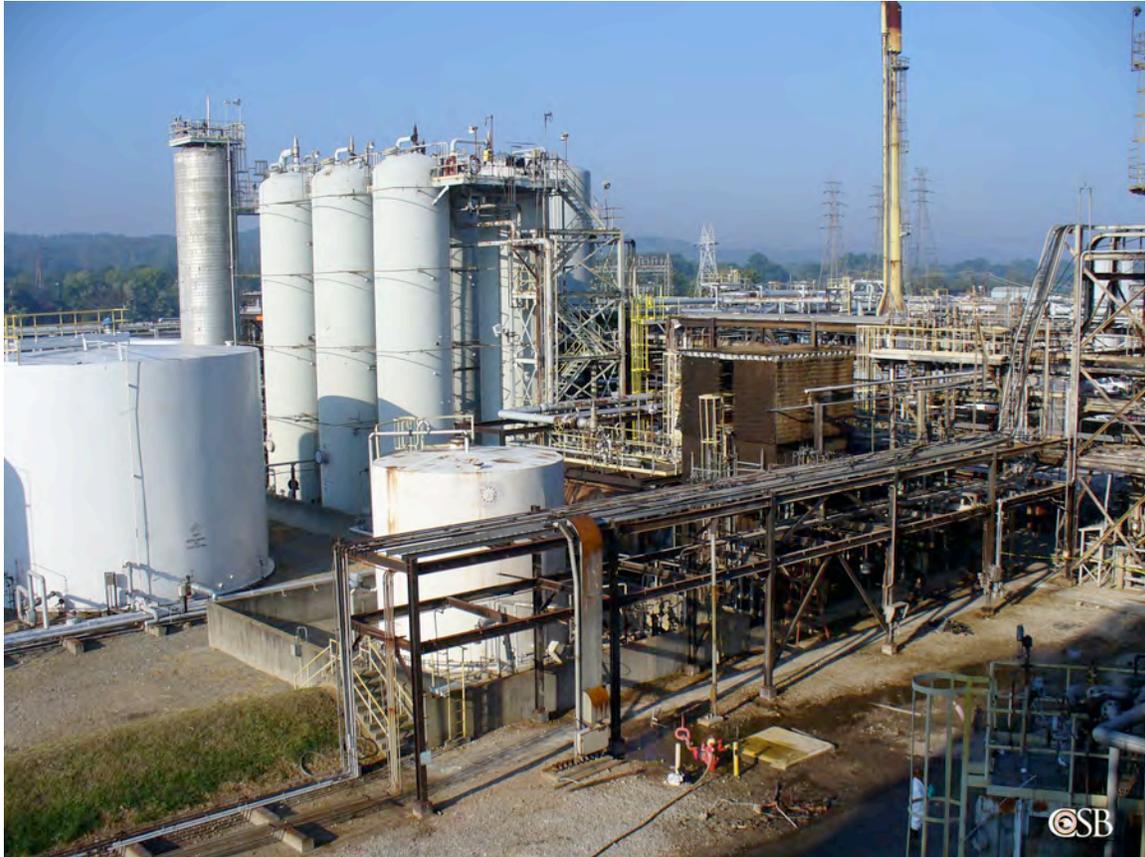
**Figure 6:** View of the MIC storage tank in the Methomyl/Larvin unit showing the blast blanket first installed in 1982 and then extended upward in 1994.

Although the MIC tank and the blast mat escaped serious damage on August 28, there is reason for concern. This was potentially a serious near miss, the results of which might have been catastrophic for workers, responders, and the public.

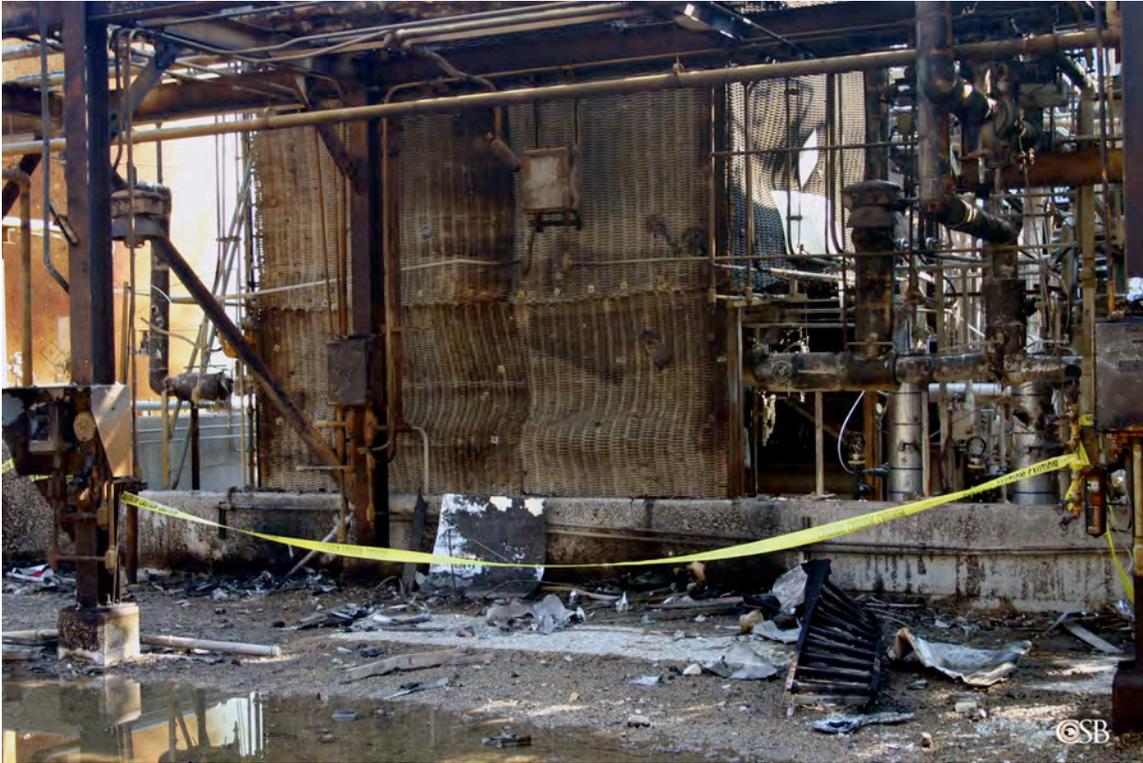
**Figure 7:** Explosion debris observed by CSB investigators at the base of the blast blanket surrounding the MIC tank.

On the night of August 28, 2008, the rupture of the residue treater sent metal projectiles in all directions. Some of these projectiles weighed up to a hundred pounds. When our investigators arrived at the site, they observed explosion debris near the base of the MIC blast blanket (see Figure 7).
