Investigation Report

Published: June 2019

- Emergency Planning and Response (Preparedness)
- Implementation of Process Safety Management Systems
- Assessment of Process Safety Culture

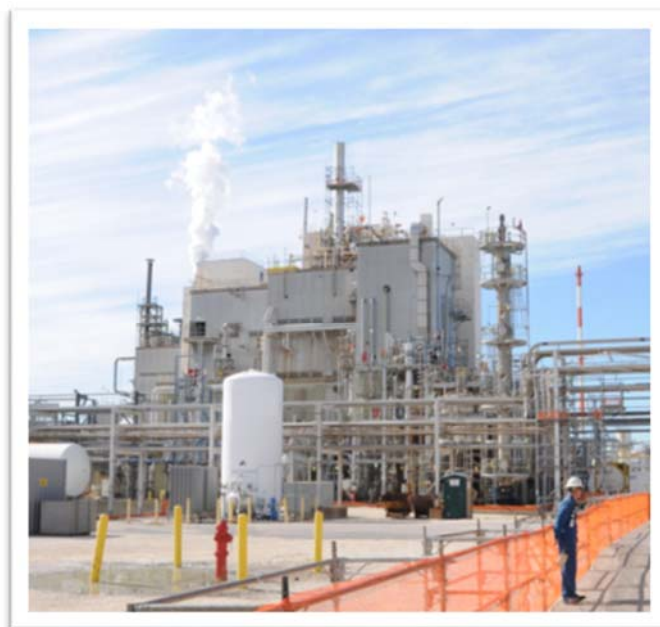
Figure 1. The Lannate[®] Manufacturing Building. The methyl mercaptan release occurred in the manufacturing building. Source: CSB.

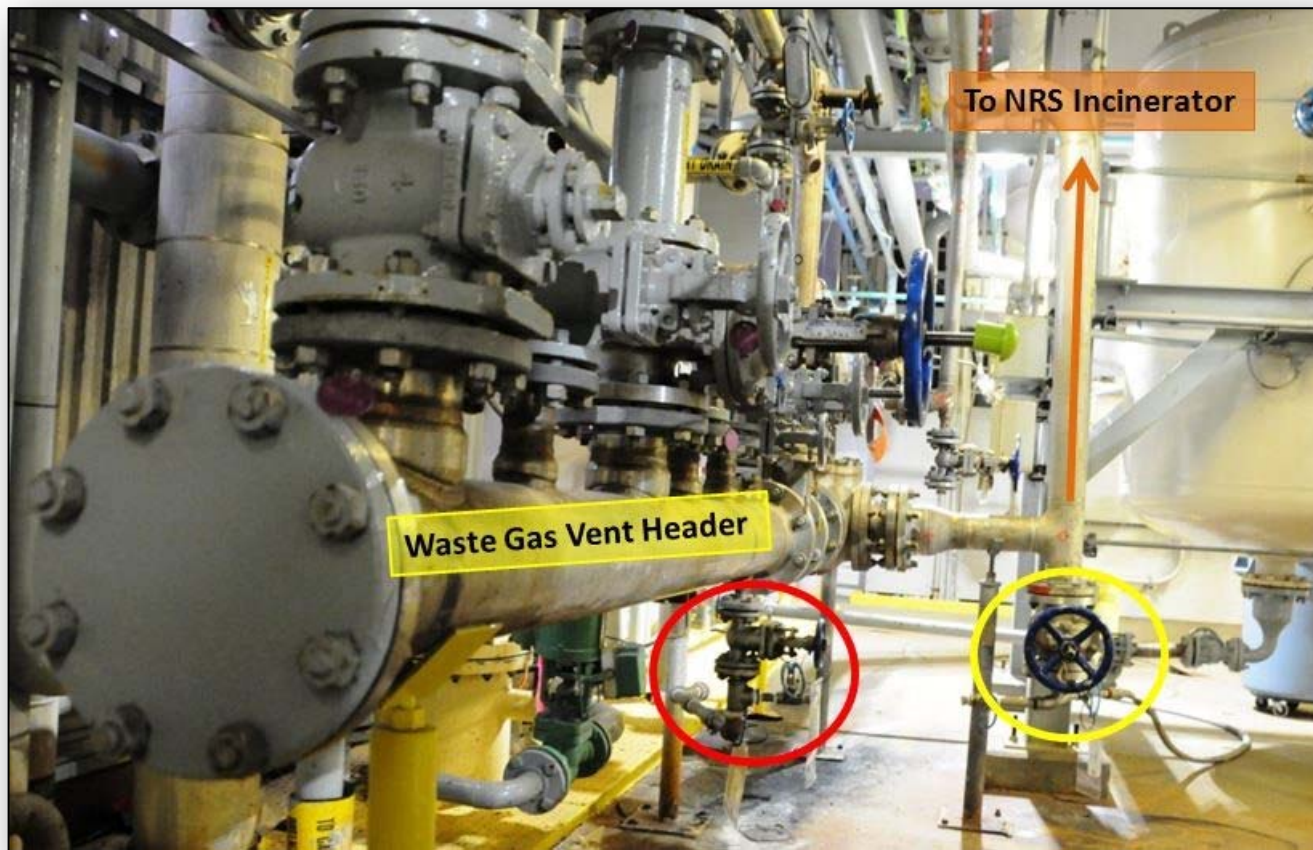
Figure 2. Waste Gas Vent Header Piping on the Third Floor of the Manufacturing Building. This portion, where several waste gas sources come together, is referred to as the *waste gas vent header*. Waste gas from this portion of the vent header traveled up to reach the NRS incinerator, a piping configuration that created a low spot where liquid accumulated. To remove the liquid during waste gas vent header piping high-pressure events, operators were instructed to open valves (yellow circle) and drain the system through a hose routed to a floor drain located near a safety shower. The floor drain is connected an open trench-type sump on the first floor. At the time of the incident, a second set of drain valves (red circle) were also opened directly to the floor inside the manufacturing building. Source: CSB.

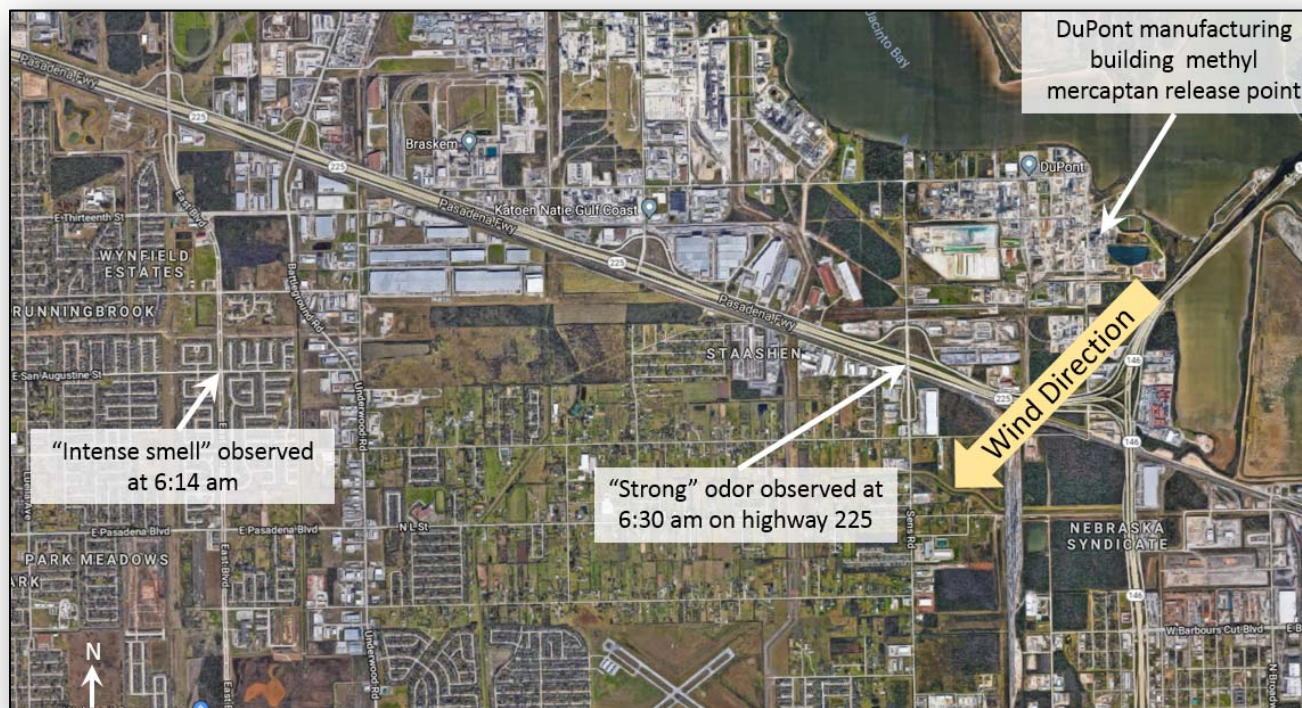
Figure 8. Locations Where a Sheriff’s Sergeant Reported Strong Methyl Mercaptan Odor During the Incident. Source: Google Earth, with annotations by CSB.

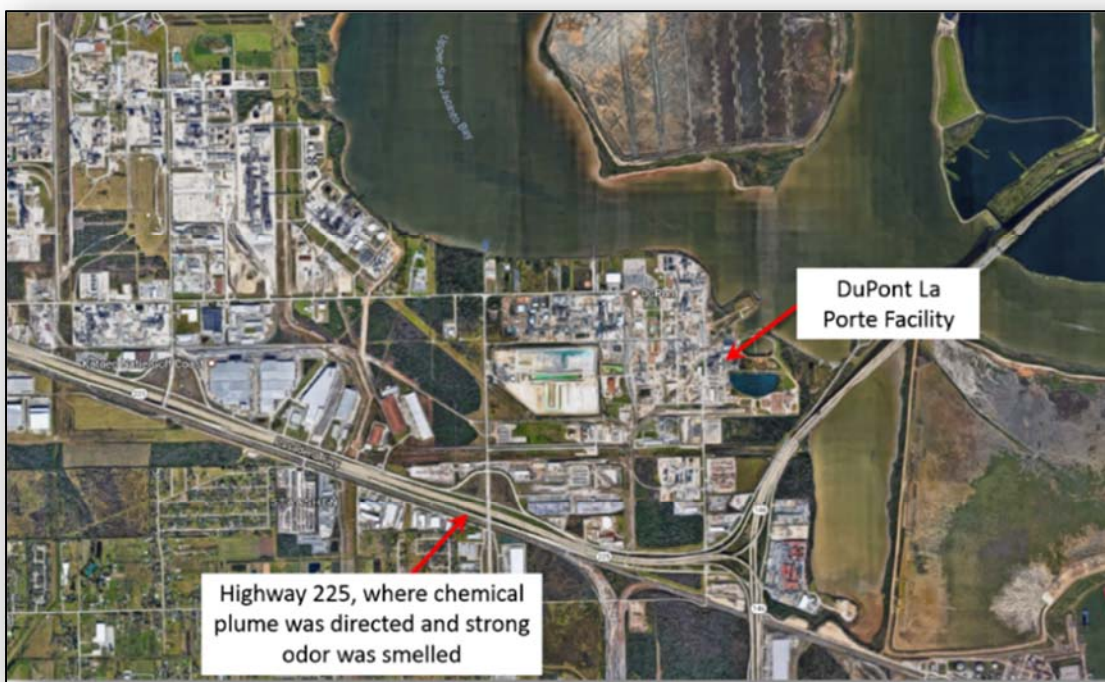
Figure 16. Overhead Image of DuPont La Porte Facility. A plume of methyl mercaptan left the DuPont property in a southeasterly direction toward a major highway and residential area. Source: Google Earth, with annotations by CSB.

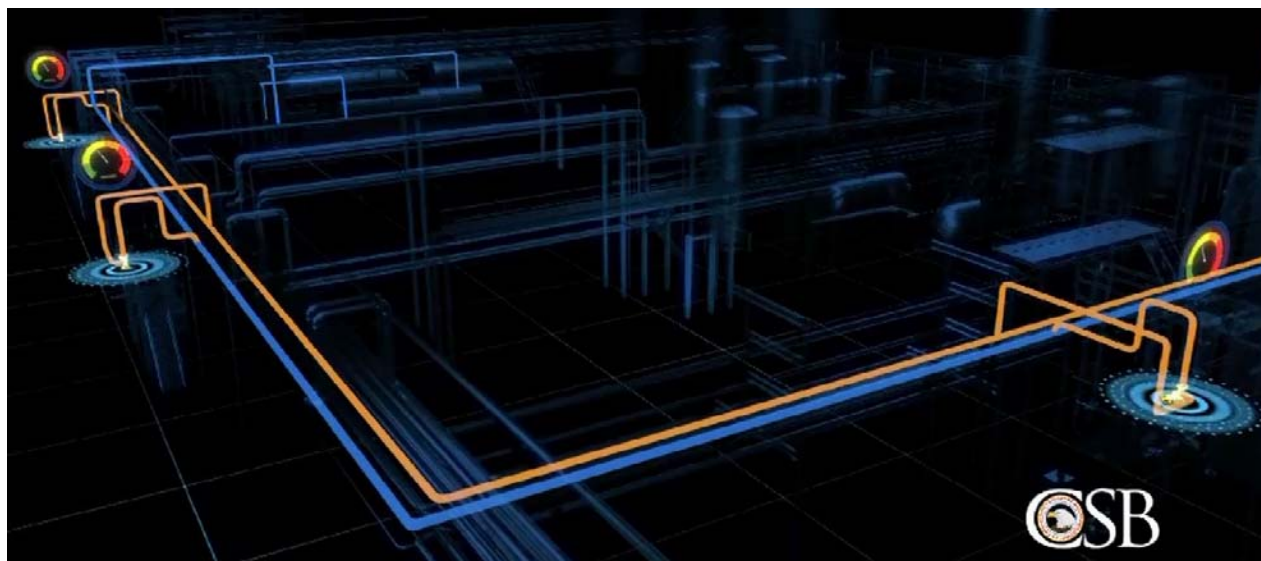
Figure 31. Excerpt from CSB Animation. It depicts the three locations where valves connected the methyl mercaptan feed piping (blue) to the waste gas vent header piping (orange). Workers used the pressure gauges shown at these locations to monitor the progress of clearing the hydrate blockage inside the methyl mercaptan feed piping. Source: CSB.

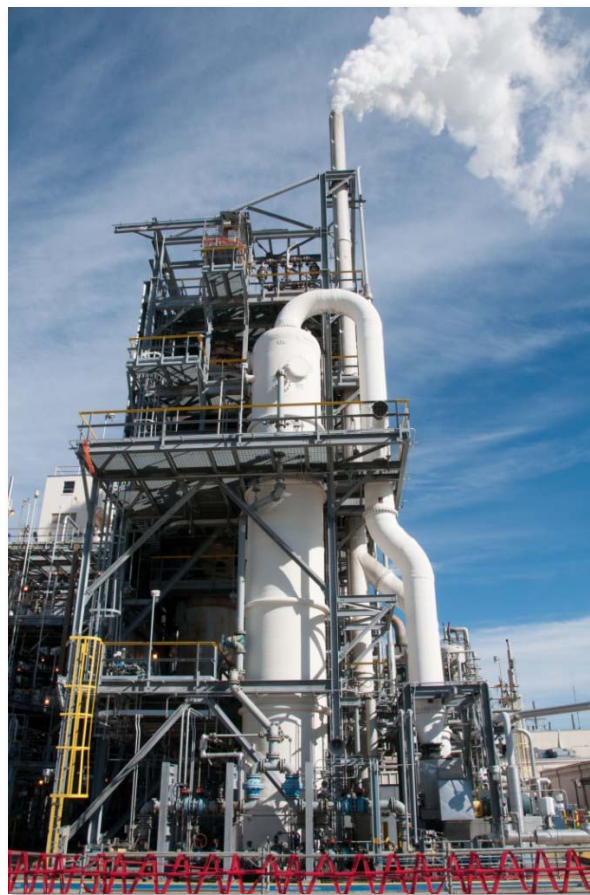
Figure 34. NRS Incinerator. NRS was installed in 2011 to reduce emissions and allow increased production at the DuPont La Porte facility. Source: CSB.

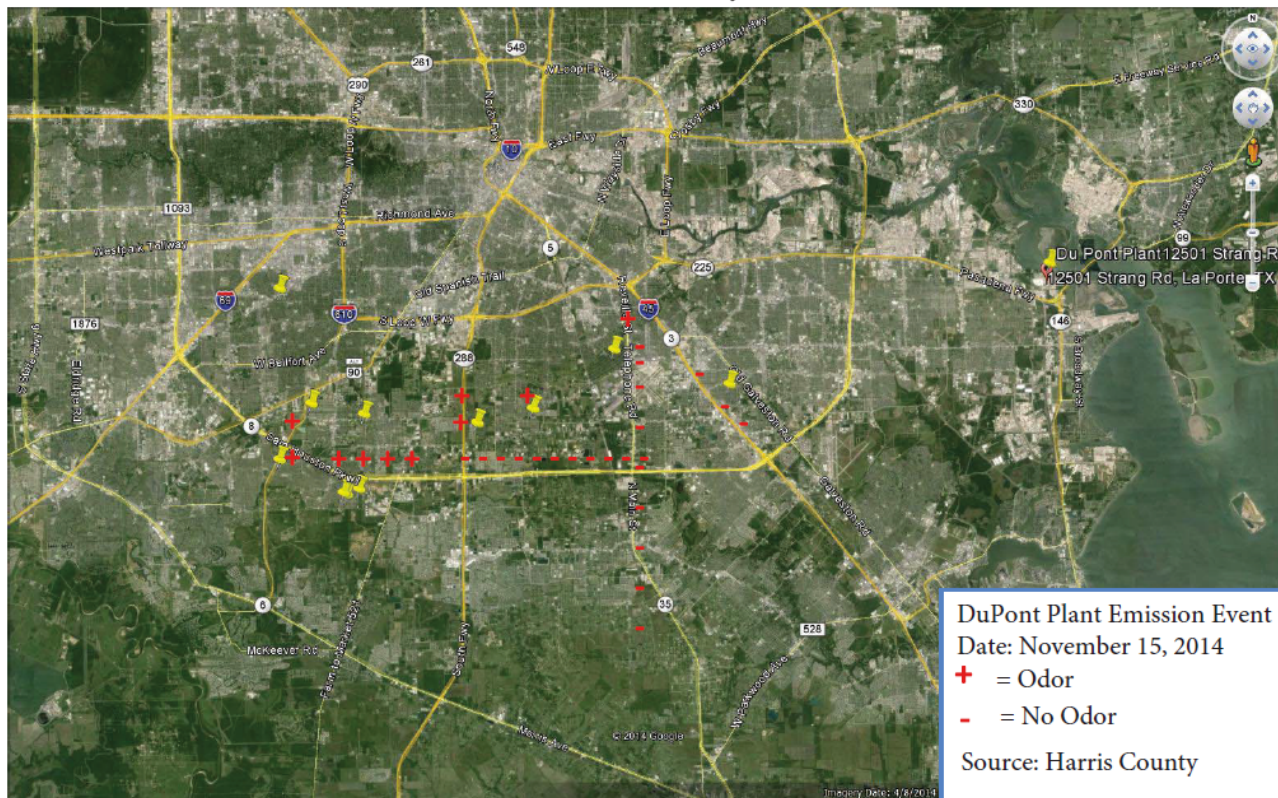
Figure 40. Map of the Odor Complaints (Yellow Pins) from the November 15, 2014 Incident. Source: Harris County, Texas.
