## Investigation Report

Published: June 2019

- Emergency Planning and Response (Preparedness)
- Implementation of Process Safety Management Systems
- Assessment of Process Safety Culture

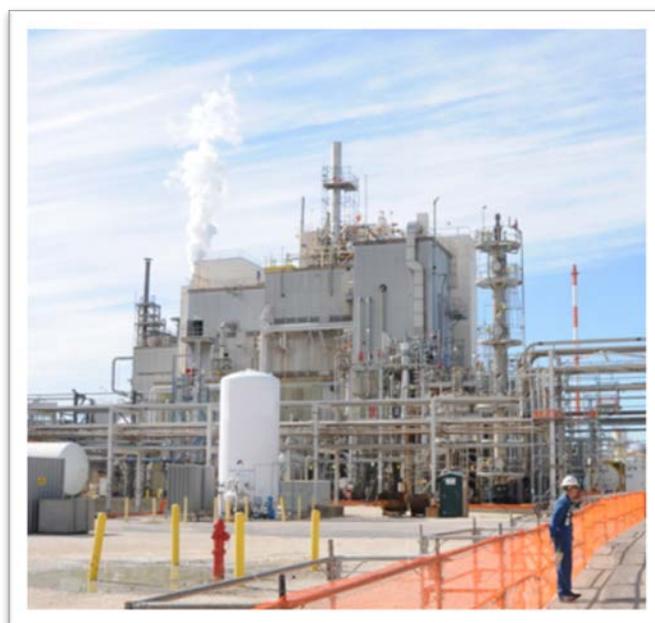
**Figure 1.** The Lannate<sup>®</sup> Manufacturing Building. The methyl mercaptan release occurred in the manufacturing building. Source: CSB.

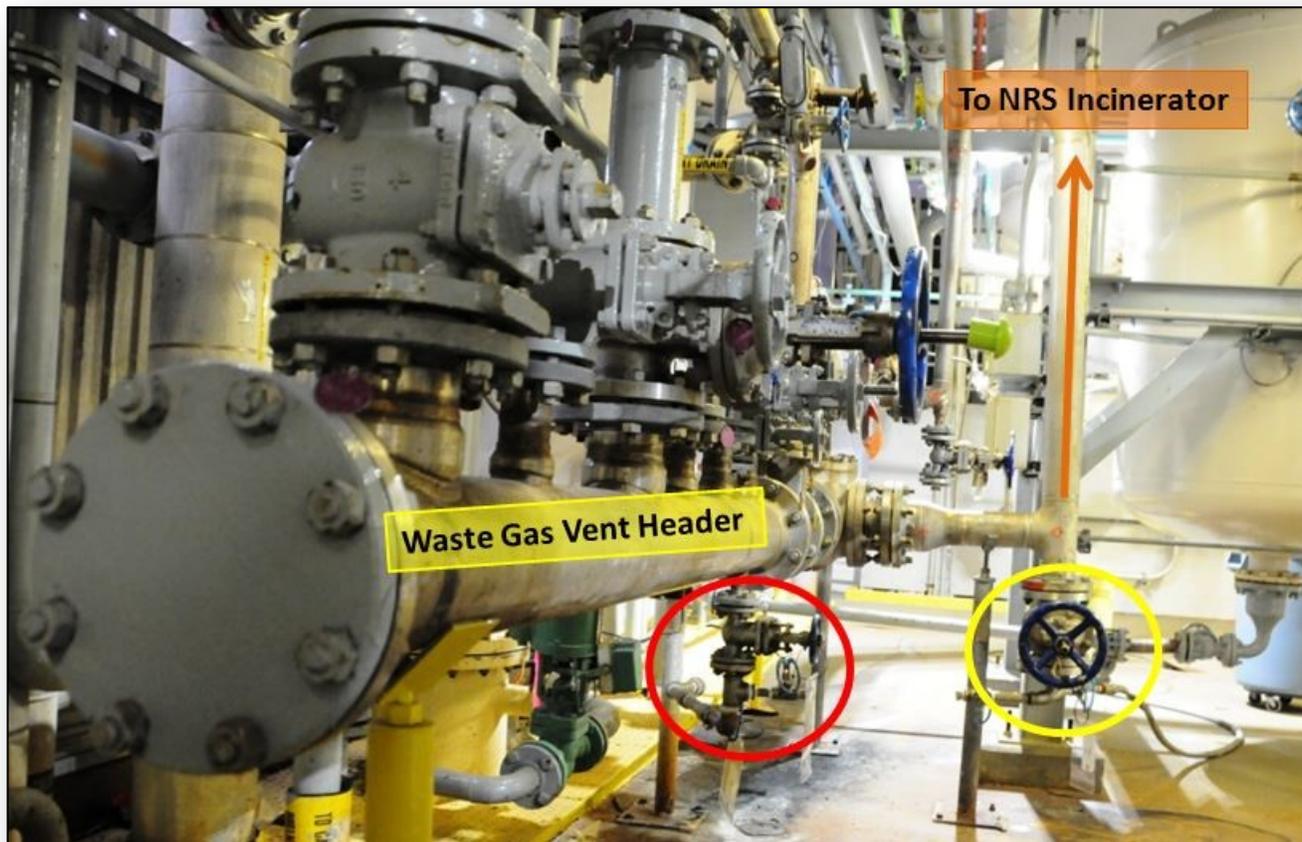
**Figure 2.** Waste Gas Vent Header Piping on the Third Floor of the Manufacturing Building. This portion, where several waste gas sources come together, is referred to as the *waste gas vent header*. Waste gas from this portion of the vent header traveled up to reach the NRS incinerator, a piping configuration that created a low spot where liquid accumulated. To remove the liquid during waste gas vent header piping high-pressure events, operators were instructed to open valves (yellow circle) and drain the system through a hose routed to a floor drain located near a safety shower. The floor drain is connected an open trench-type sump on the first floor. At the time of the incident, a second set of drain valves (red circle) were also opened directly to the floor inside the manufacturing building. Source: CSB.

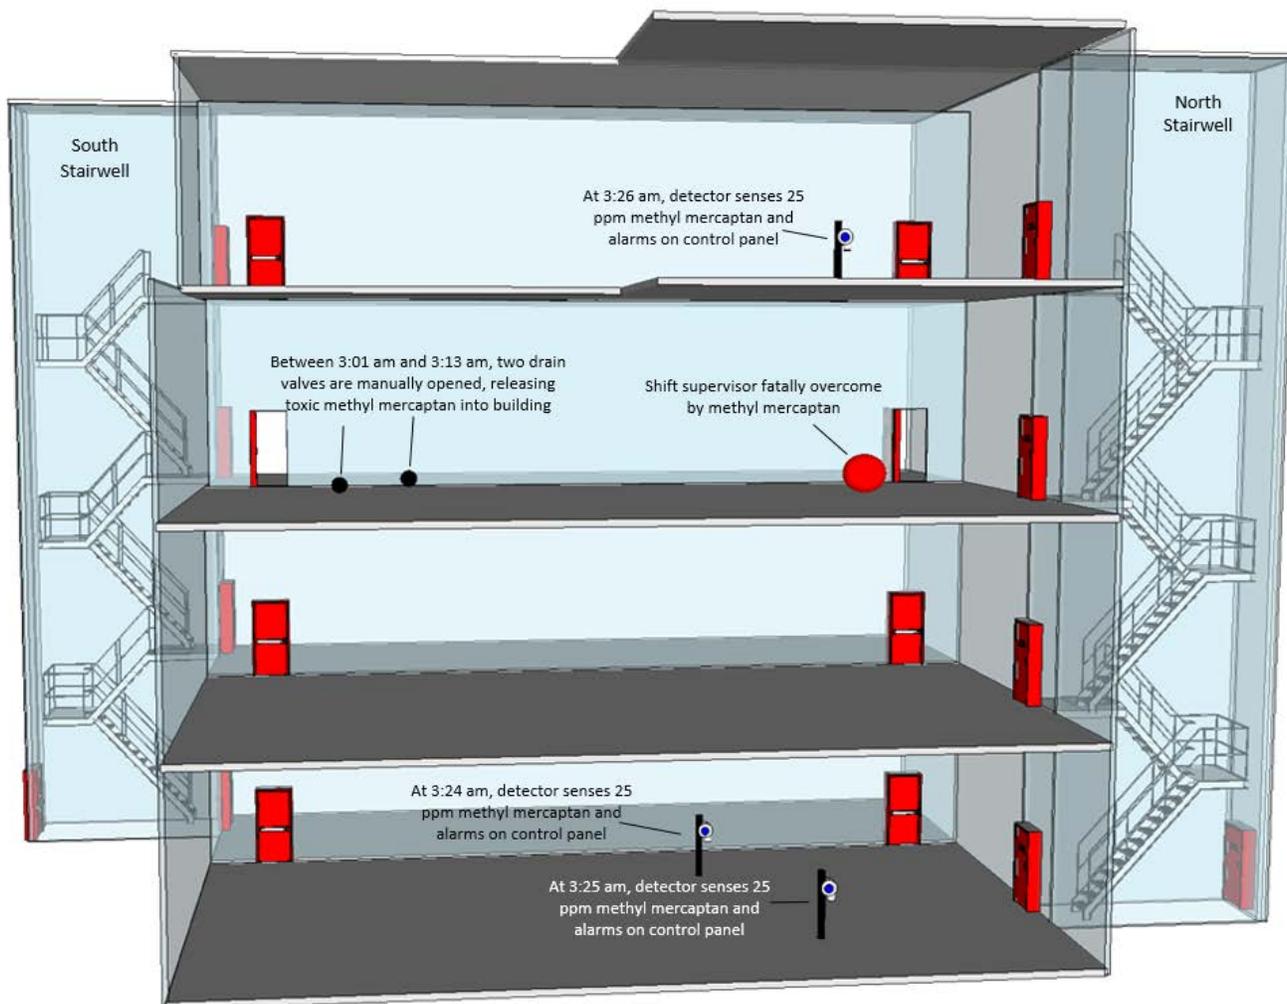
**Figure 3.** Depiction Showing Where Drain Valves Were Opened. These drain valves released toxic methyl mercaptan into the manufacturing building. Methyl mercaptan detectors on the first and fourth floors detected high concentrations of methyl mercaptan shortly after the release began. This depiction is a simplified graphic of the manufacturing building (see Section 4.5) and does not show the location of Operator 1. Source: CSB.

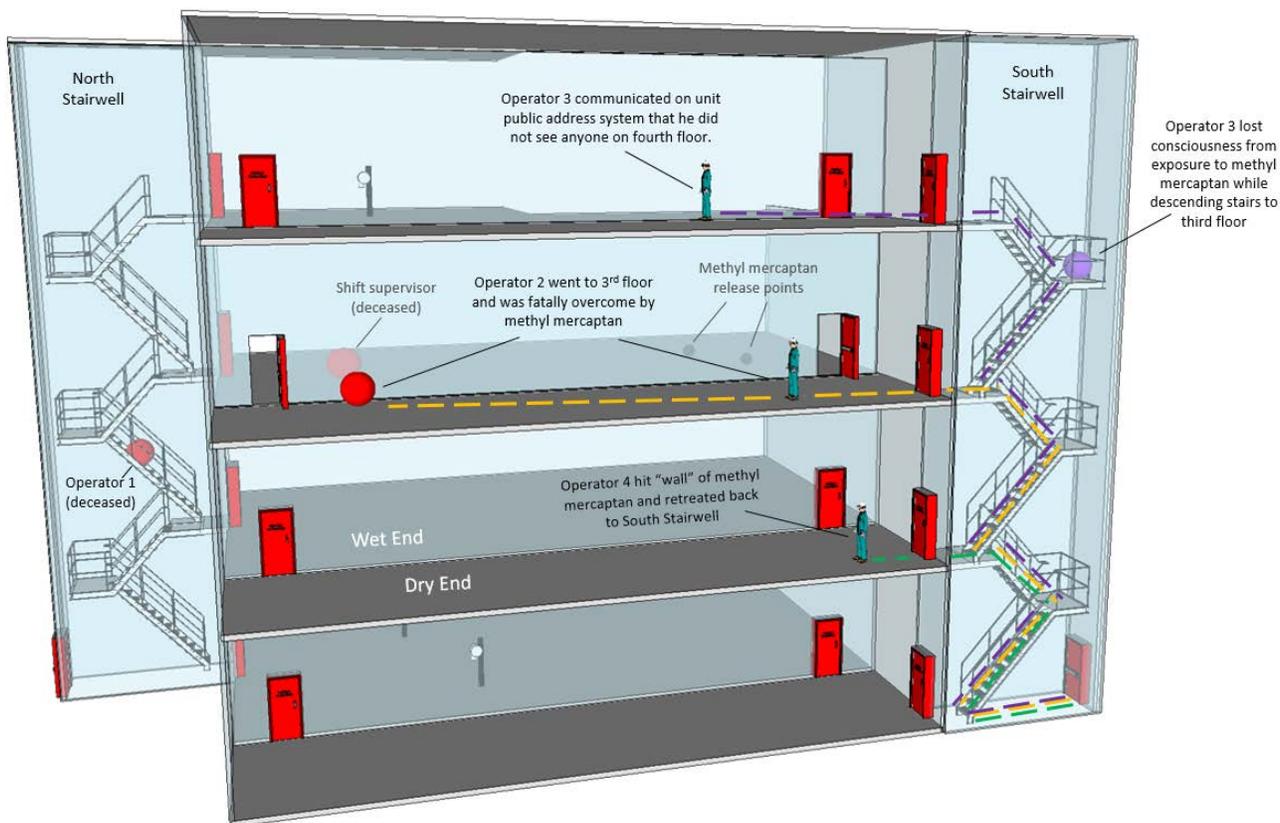
Operator 2, Operator 3, and Operator 4 each entered the south stairway and took different a route inside the manufacturing building to try to find Operator 1 (Figure 4). Operator 2 went to the third floor, where he was fatally overcome by methyl mercaptan [1, p. 29]. Operator 4 went to the second floor. He walked about 10 feet and hit what he later described as a "wall" of methyl mercaptan, but he managed to retreat to the stairwell [1, p. 29]. Operator 3 went to the fourth floor but did not find anyone. He then announced on the Lannate<sup>®</sup> Unit's public-address system that he did not see anyone on the fourth floor. The Board Operator responded that the Shift Supervisor and Operator 1 may be on the third floor [1, p. 29]. Operator 3 then began to feel light-headed. He made his way to the stairwell and lost consciousness while descending from the fourth floor [1, p. 29].

**Figure 4.** Depiction of Paths Taken by Operator 2, Operator 3, and Operator 4 When They Responded to Operator 1’s Distress Call. Locations of the deceased Shift Supervisor and Operator 1 are also shown. Operator 2 was killed by methyl mercaptan exposure, and Operator 3 and Operator 4 were exposed to high concentrations of methyl mercaptan. This figure shows the opposite side of the manufacturing building from the view in Figure 3. Source: CSB.

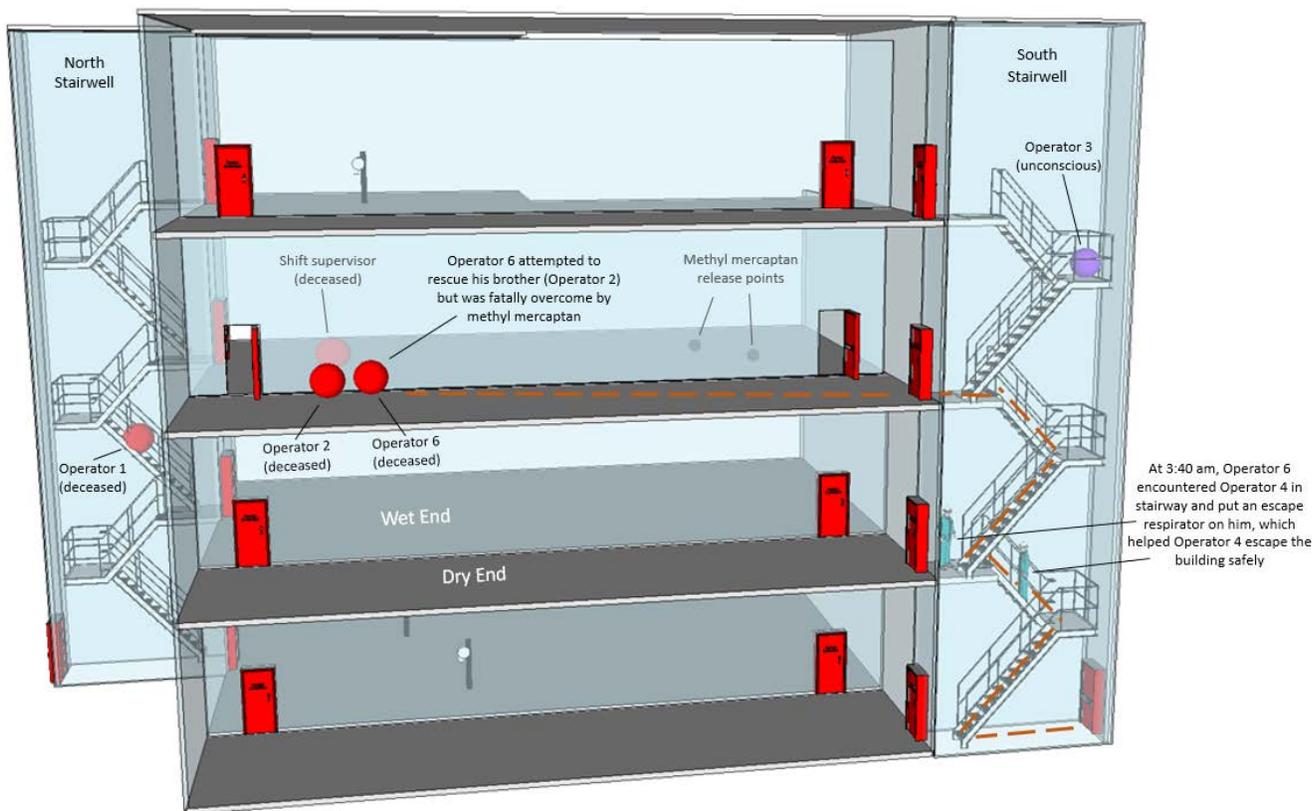
**Figure 5.** Depiction of the Path Taken by Operator 6 Inside the Manufacturing Building. Operator 6 helped Operator 4 escape by providing him with a respirator. Operator 6 was fatally overcome by methyl mercaptan when trying to rescue his brother, Operator 2, on the third floor. Source: CSB.

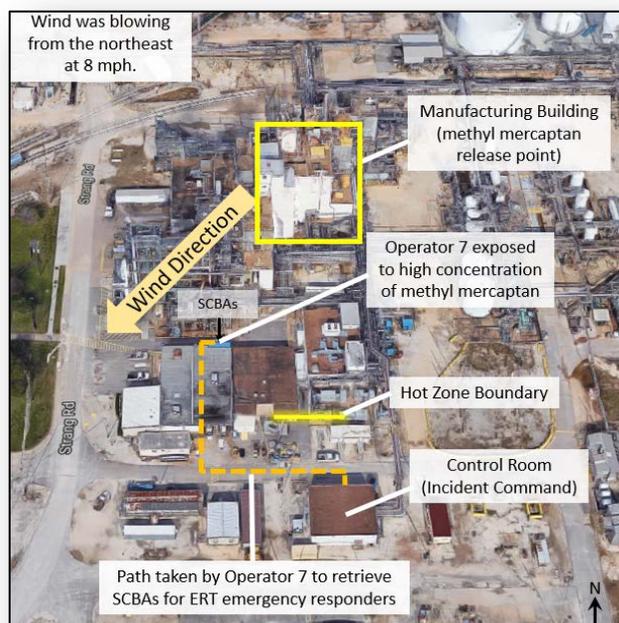
**Figure 6.** Depiction of Path Taken by Operator 7 to Retrieve SCBAs for ERT When the Mini Pumper Truck Would Not Start. The hot zone was not controlled adequately to ensure that personnel did not enter a hazardous area. Source: Google Earth, with annotations by CSB.

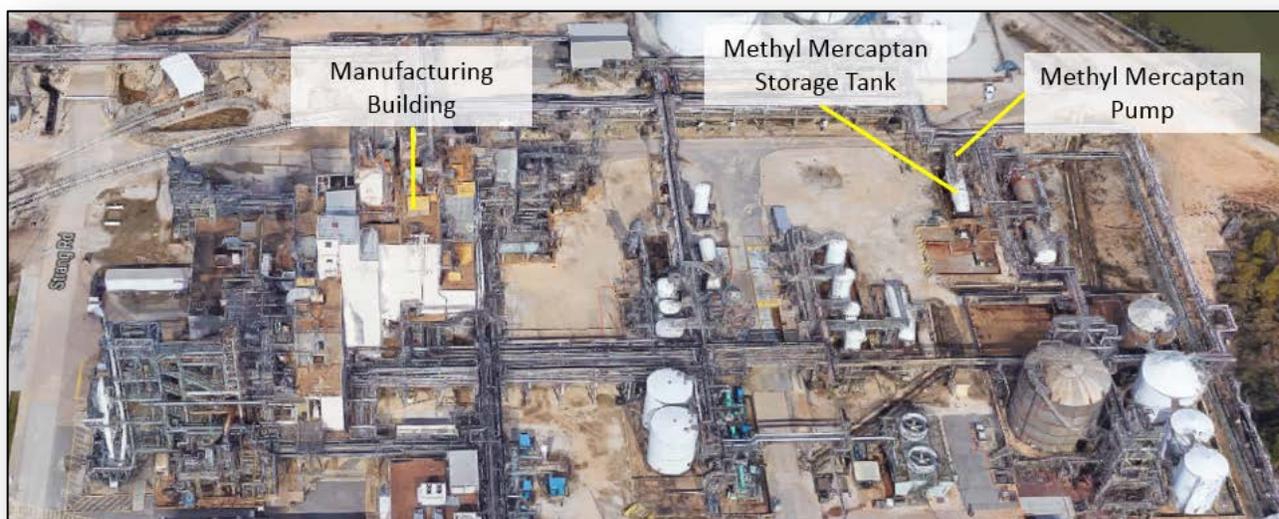
At 6:02 am, approximately three hours after the release started, DuPont La Porte personnel turned off the methyl mercaptan storage tank pump, which had been operating since the last startup attempt, before the release began (Figure 7). Shutting off this pump significantly slowed the methyl mercaptan release rate (Section 4.6).<sup>a</sup>

**Figure 7.** Location of Methyl Mercaptan Pump. The pump was turned off nearly three hours after the release began. Source: Google Earth, with annotations by CSB.

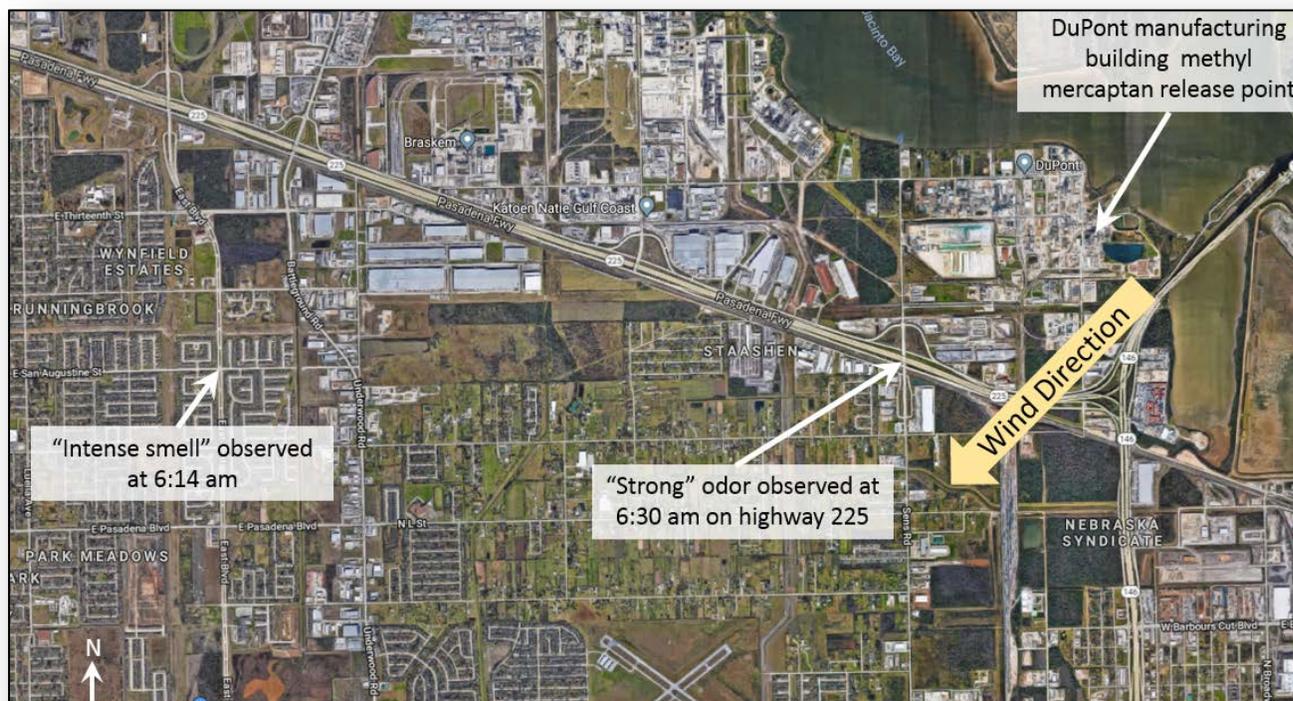
**Figure 8.** Locations Where a Sheriff’s Sergeant Reported Strong Methyl Mercaptan Odor During the Incident. Source: Google Earth, with annotations by CSB.

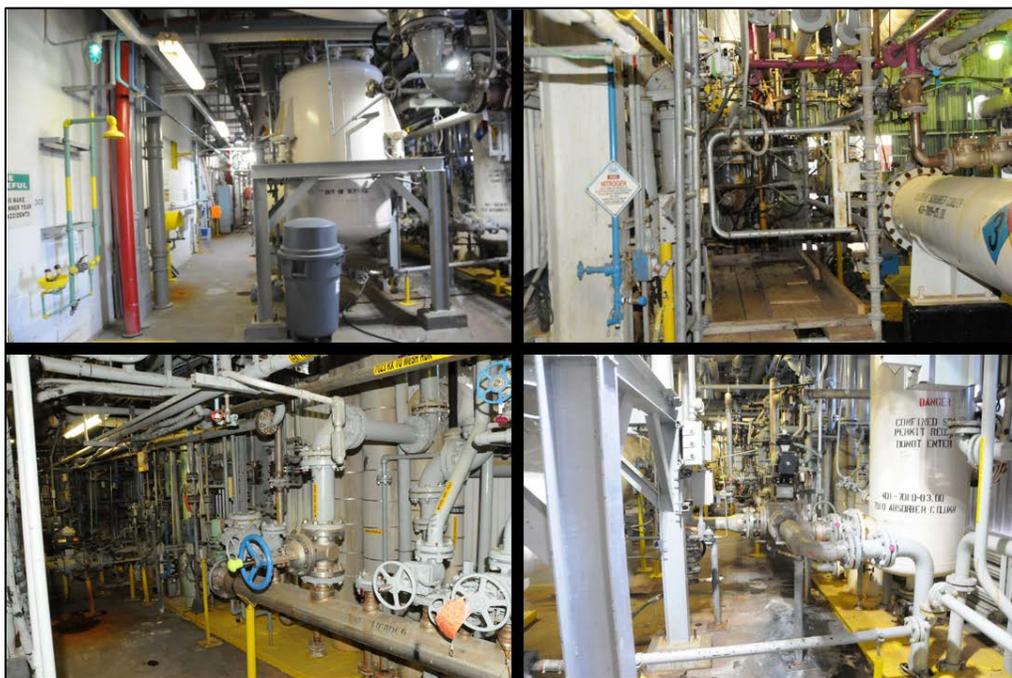
Many of the emergency responders searching the manufacturing building worked at the La Porte site as operators in other units or for other companies located there. Some of these responders, therefore, were unfamiliar with the manufacturing building—a four-story building containing a large amount of piping and process equipment, dividing walls, multiple stairwells, and an elevator. Figure 11 shows photos taken inside the manufacturing building, illustrating the complexity of the layout inside the building.

Figure 11. Photos of the Interior of the Lannate® Manufacturing Building. Source: CSB.

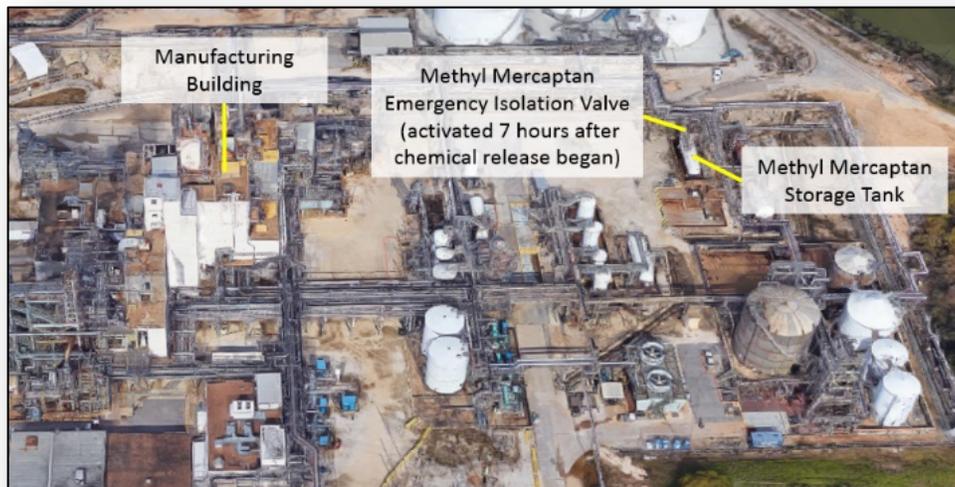
**Figure 13.** Location of Methyl Mercaptan Emergency Isolation Valve Relative to Manufacturing Building Where Leak Occurred. The emergency isolation valve was not activated until seven hours after the release began. Source: Google Earth, with annotations by CSB.

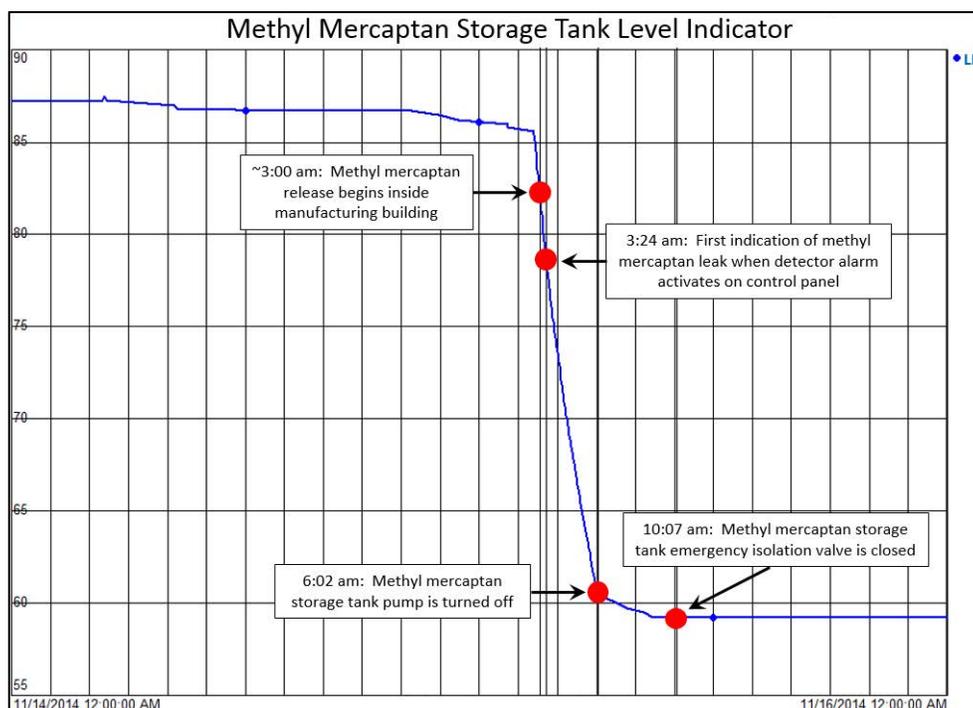
1. Personnel did not recognize the need to close the methyl mercaptan storage tank isolation valve when they determined that methyl mercaptan was the chemical being released inside the manufacturing building.
2. No one evaluated process data to determine what was causing the release until hours into the response efforts. Had personnel looked at the process data earlier during the release, it should have been clear that methyl mercaptan was flowing from the methyl mercaptan storage tank, requiring closure of the emergency isolation valve (Figure 14).

**Figure 14.** Process Data from November 15, 2014. Data shows that methyl mercaptan was abnormally flowing from the methyl mercaptan storage tank. No one analyzed these data during the first hours of the incident. Source: CSB graph based on DuPont data.

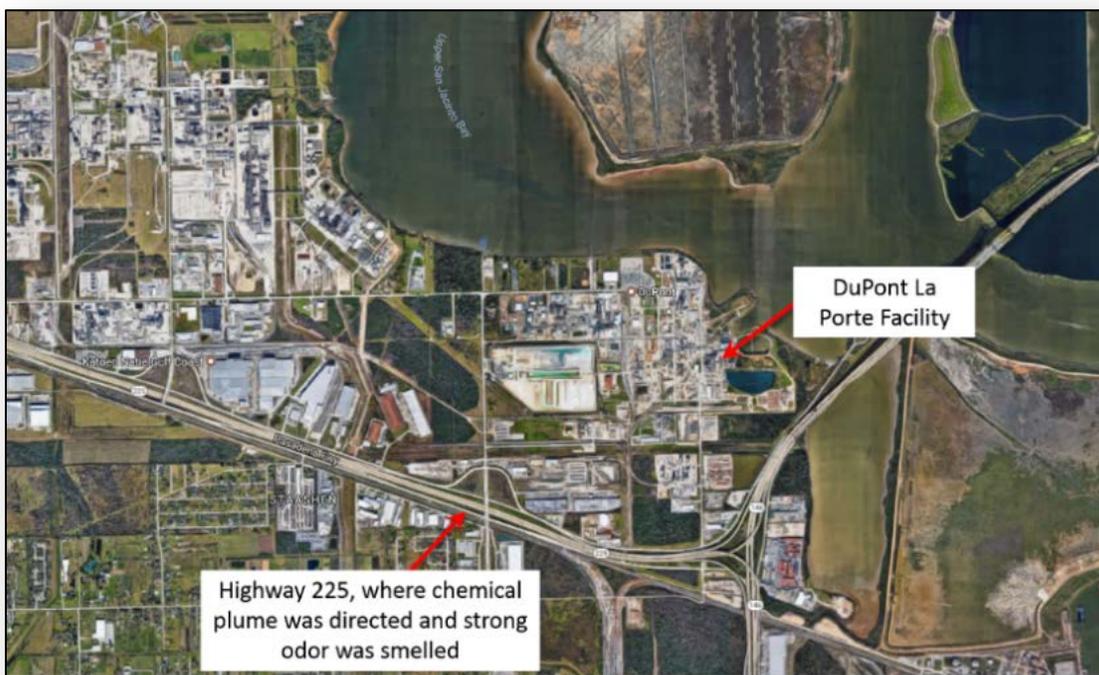
**Figure 16.** Overhead Image of DuPont La Porte Facility. A plume of methyl mercaptan left the DuPont property in a southeasterly direction toward a major highway and residential area. Source: Google Earth, with annotations by CSB.

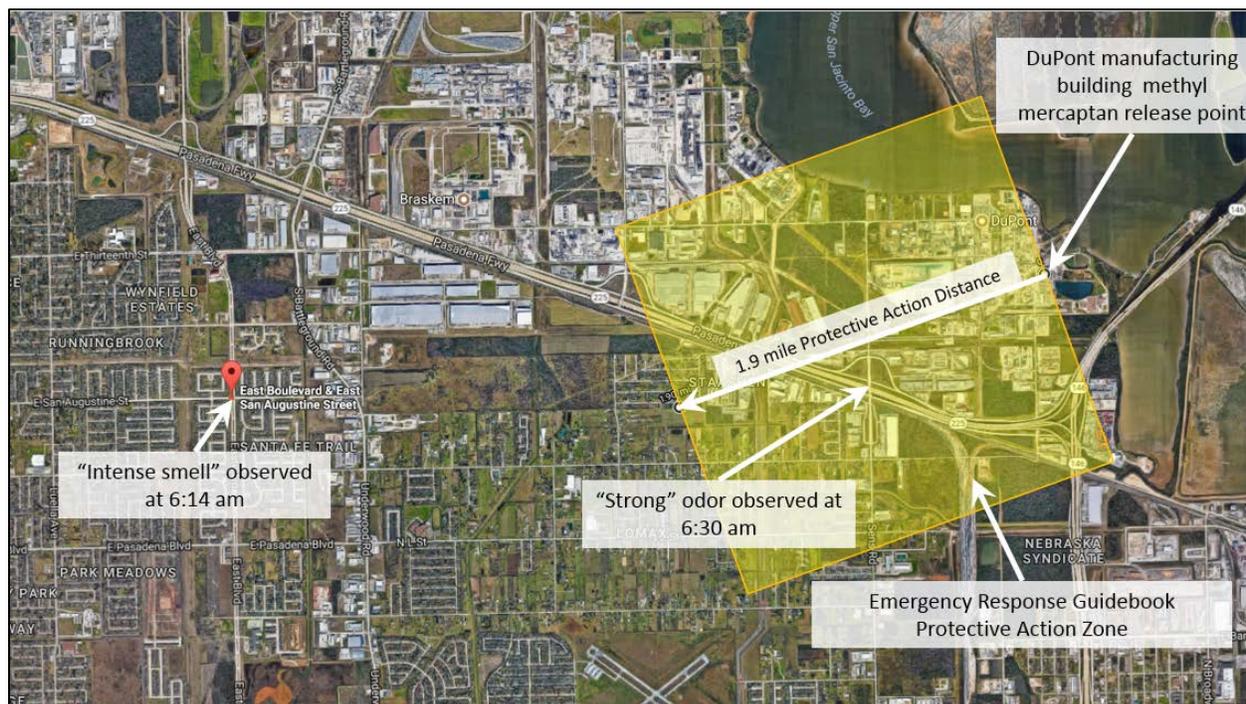
**Figure 17.** Overhead Image of DuPont La Porte Facility with Recommended Downwind Protection Zone (Shown in Yellow) Based on the 2016 *Emergency Response Guidebook* [12, p. 297]. Downwind sections of Highway 225 and residential areas were within the area recommended for public protection from a methyl mercaptan chemical leak. Source: Google Earth, with annotations by CSB.

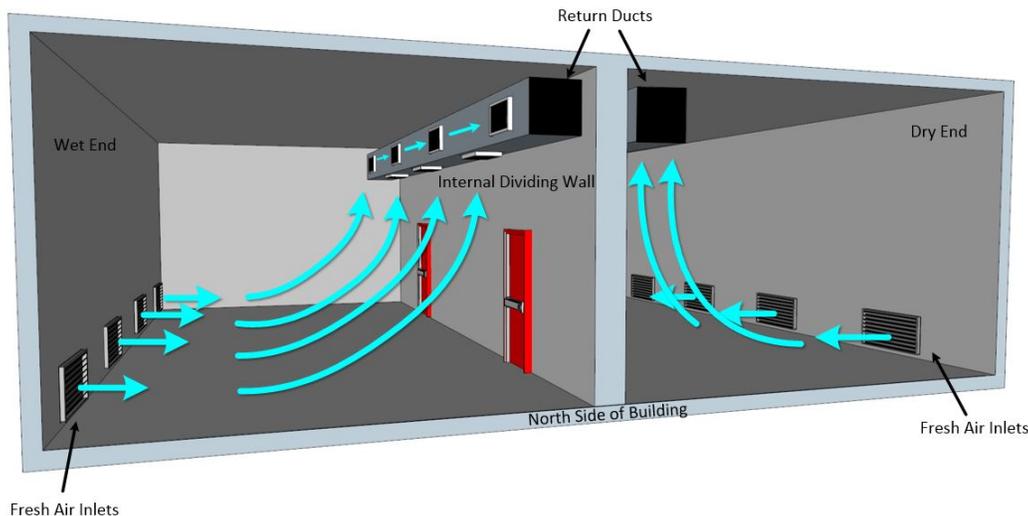
**Figure 27.** Simplified Graphical Representation of a Typical Floor of the Manufacturing Building. It shows how fresh air was pulled in from the outside walls, swept across the floor, and entered the exhaust return air ducts on each side. Source: CSB.

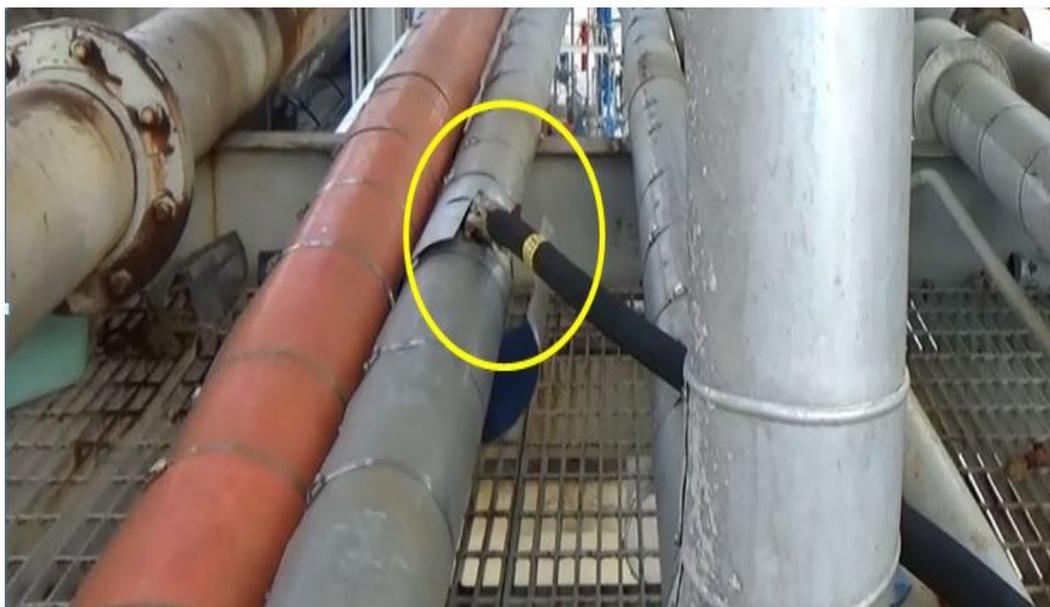
**Figure 30.** Hot Water Hose Positioned on the Liquid Methyl Mercaptan Feed Piping. Hot water flowed between the piping and the insulation to heat the piping and dissociate the solid hydrate that had formed after water inadvertently entered the methyl mercaptan storage tank. Source: CSB.

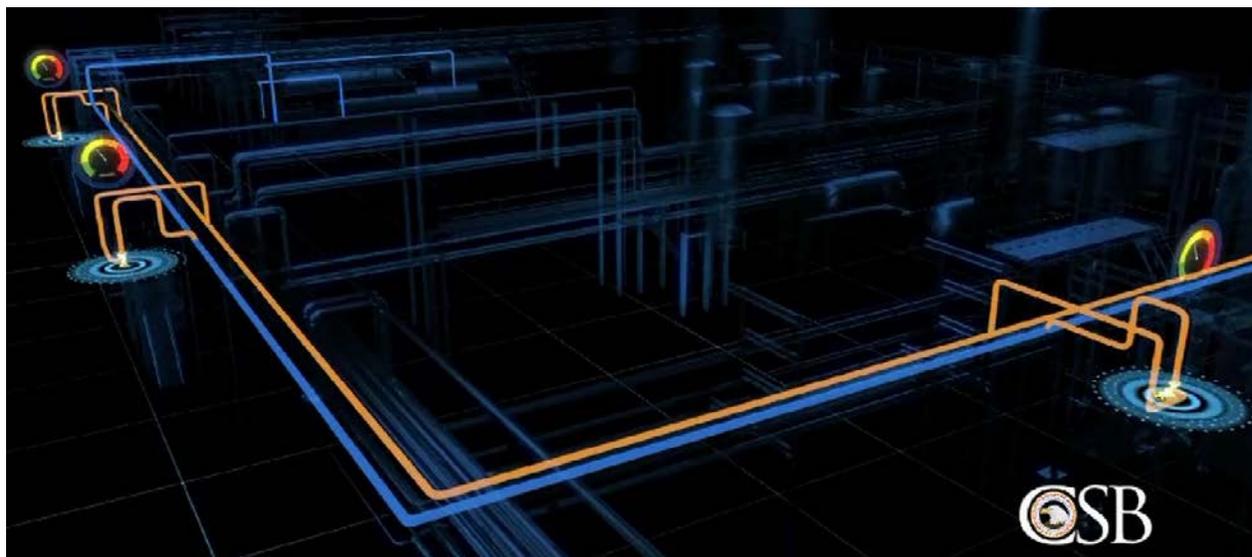
**Figure 31.** Excerpt from CSB Animation. It depicts the three locations where valves connected the methyl mercaptan feed piping (blue) to the waste gas vent header piping (orange). Workers used the pressure gauges shown at these locations to monitor the progress of clearing the hydrate blockage inside the methyl mercaptan feed piping. Source: CSB.

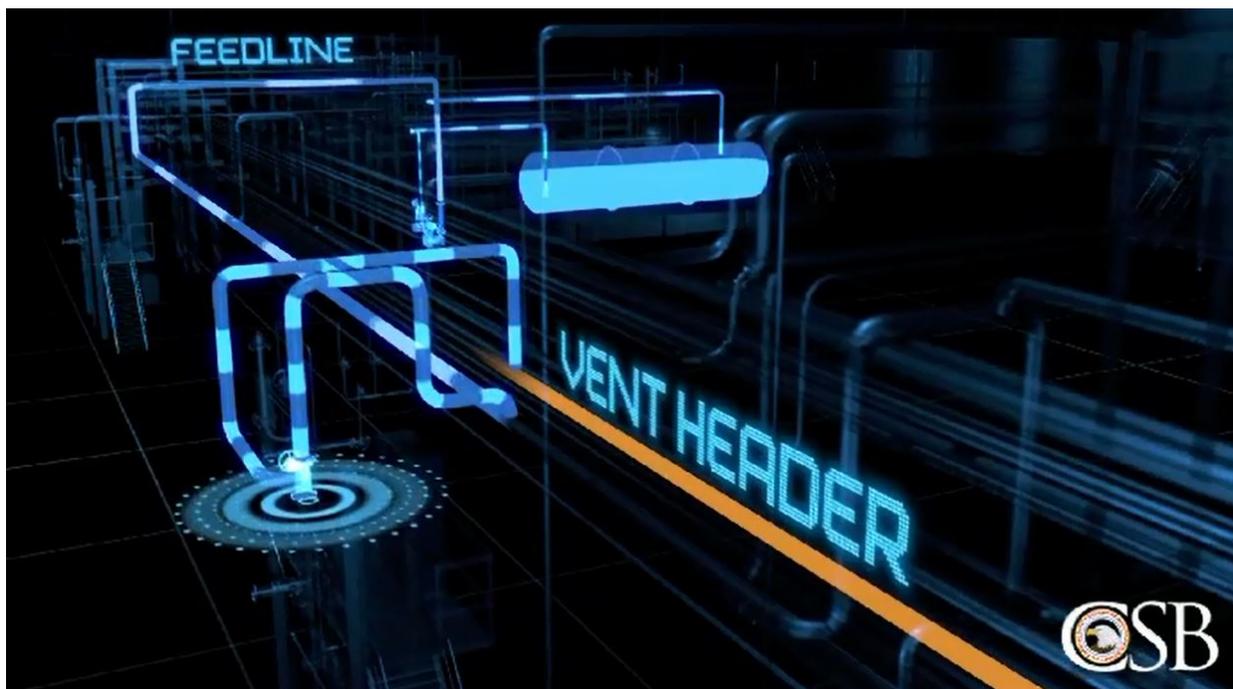
**Figure 32.** Excerpt from CSB Animation. It depicts the piping arrangement that allowed liquid methyl mercaptan from the feed line (blue) to flow into the waste gas vent header piping (orange). Source: CSB.

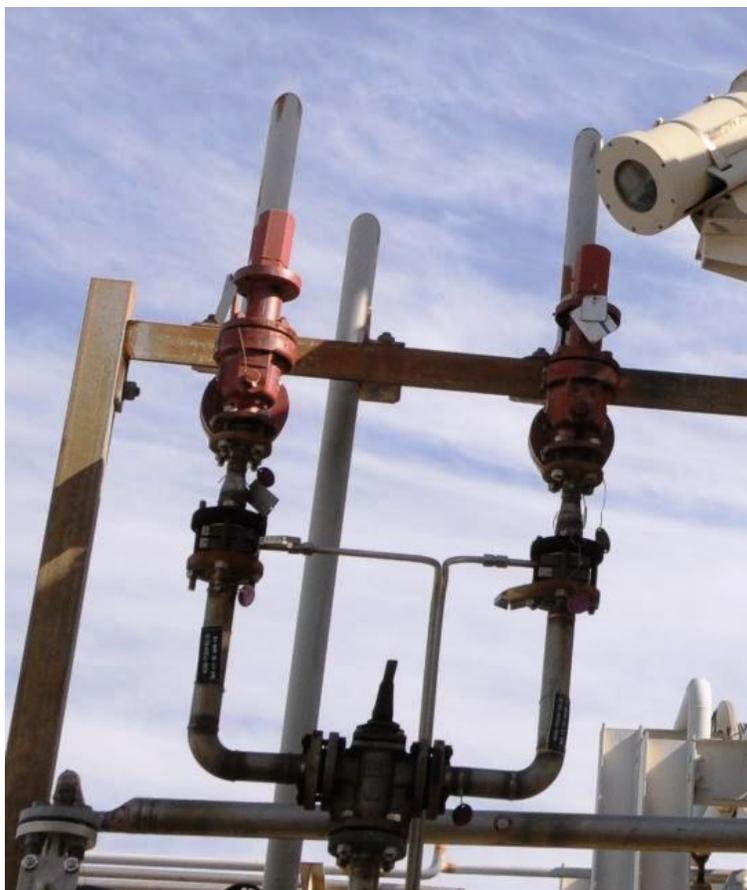
**Figure 33.** Nitrogen Relief Valves at One of the Two Methyl Mercaptan Railcar Unloading Stations. DuPont PHAs and relief valve design documents never considered the possibility of lining up the methyl mercaptan storage tank pumps to these relief valves—as they were at the time of the incident. As a result, liquid methyl mercaptan was discharged from a system designed for nitrogen vapor. Source: CSB.

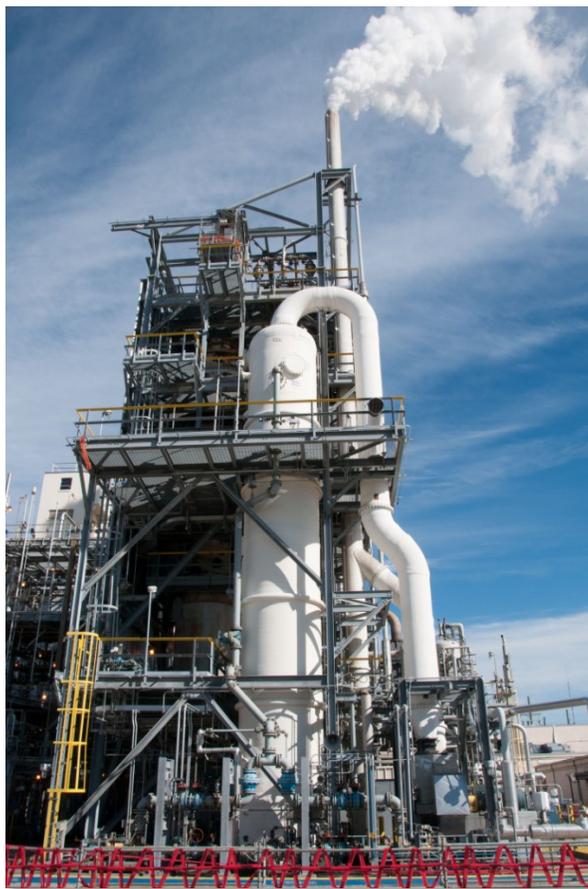
**Figure 34.** NRS Incinerator. NRS was installed in 2011 to reduce emissions and allow increased production at the DuPont La Porte facility. Source: CSB.

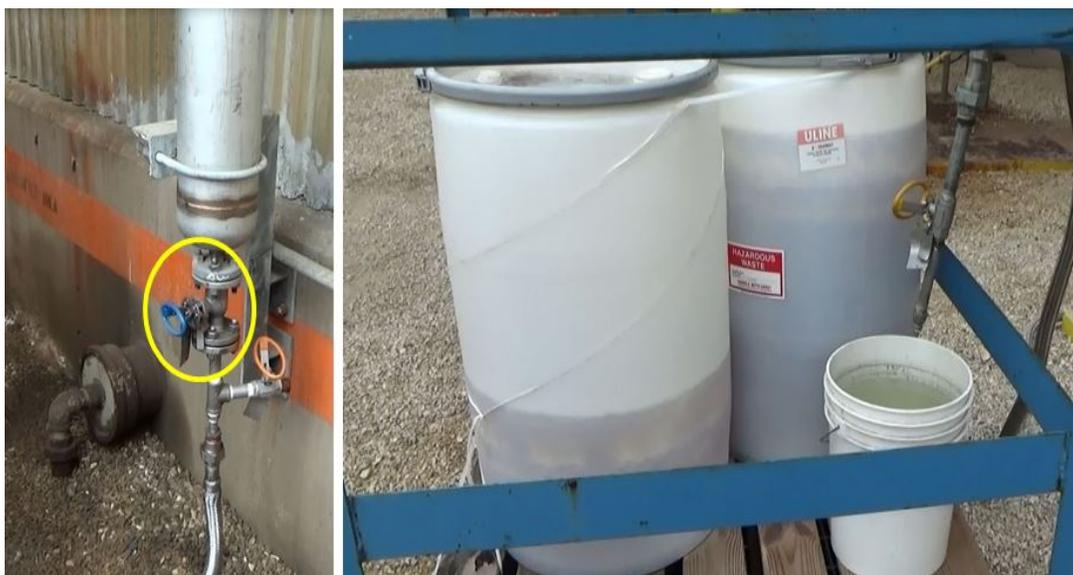
**Figure 37.** Photo Showing Another Line Break. Operators drained liquid accumulation in another vent header without using line-breaking procedures. Source: CSB.

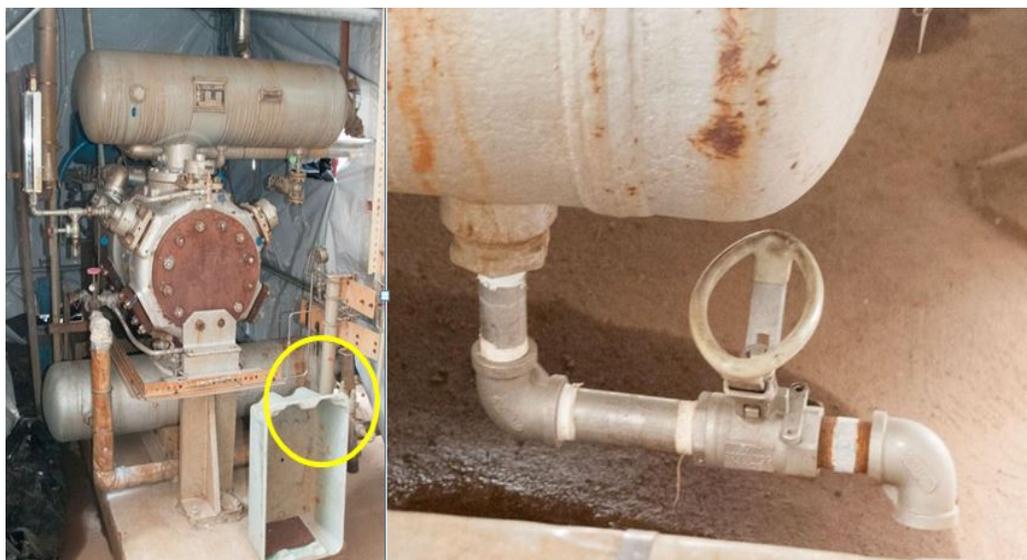
**Figure 38.** Methylene Chloride<sup>a</sup> Compressor. Photo shows where operators routinely drained liquid accumulation from a methylene chloride compressor without using line-breaking procedures. Source: CSB.
