Union Carbide Nitrogen Asphyxiation

Hahnville, Louisiana March 27, 1998

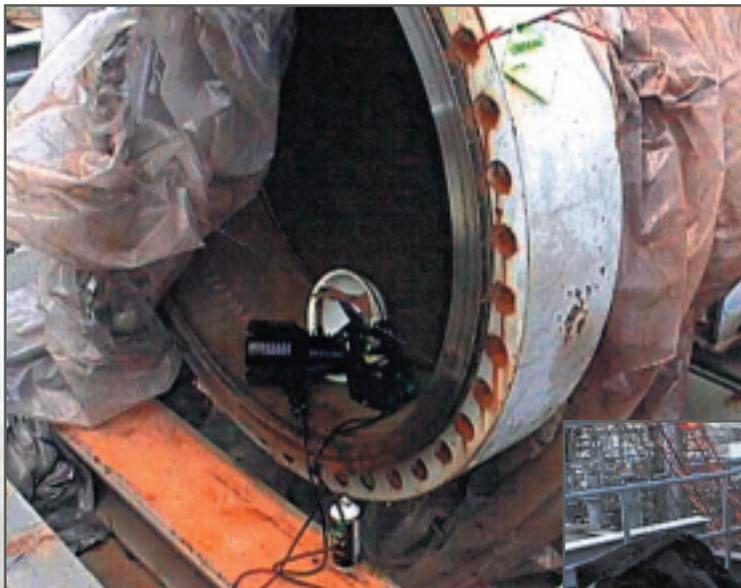
Large open pipe end where the two victims were working

tenance project, in which some process equipment had been temporarily removed. The equipment removal left the pipe connected into the process unit but open to the air at one end. The two victims, both skilled and experienced workers, were inspecting the inside of the 48-inch open pipe end to gauge the effectiveness of an earlier cleaning effort. While the men worked, nitrogen gas was being used to purge air and moisture from the unit, protecting the chemicals inside.

tractors to hold a black plastic sheet over the open pipe end while they crouched just inside. Unknown to any of the workers, the plastic sheet created a dangerous enclosure where nitrogen gas could accumulate, displacing oxygen and causing asphyxiation.

After the accident, managers said they did not know that the workers were going to perform a black light inspection of the pipe, which led to the creation of a temporary enclosure. However, the CSB found that the open pipe end itself presented a hazard, and any worker who simply leaned into the open pipe could have been overcome, depending upon the wind and other conditions.

The CSB recommended that the plant modify its safety program to better control the hazards associated with temporary enclosures. Whenever tanks, pipes or other pieces of equipment are opened, the plant should post warning signs stating "Danger, Confined Space: Do Not Enter without Authorization." In cases where nitrogen is added to a confined space, an additional warning sign should be used.
