U.S. Chemical Safety and Hazard Investigation Board

Investigation Report

Organic Peroxide Decomposition, Release, and Fire at Arkema Crosby Following Hurricane Harvey Flooding

Crosby, Texas

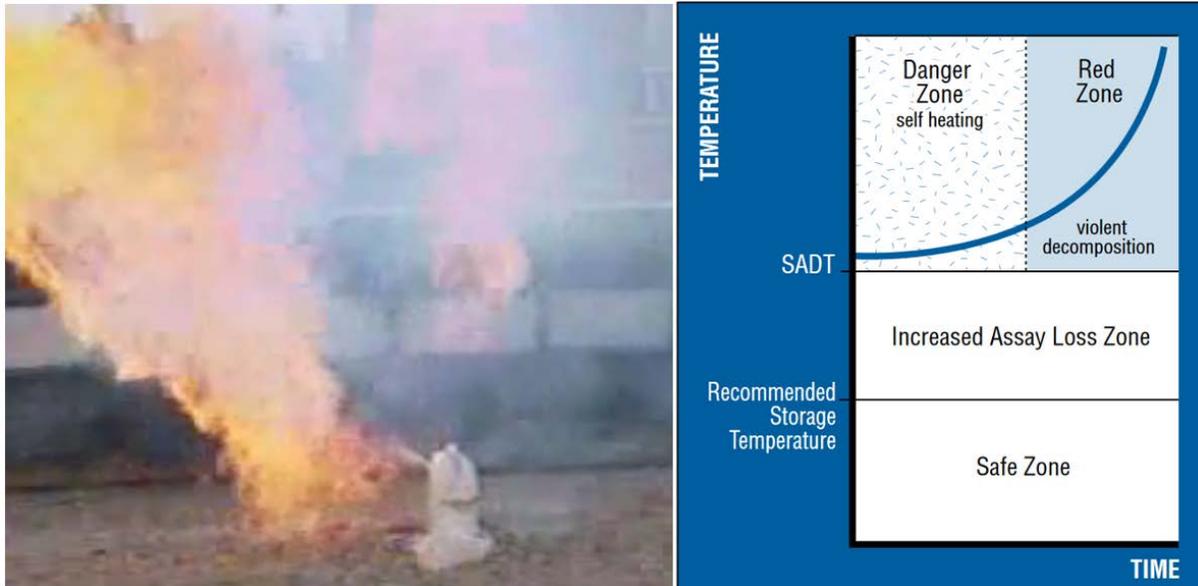
Figure 2. Organic Peroxide Decomposition. The image on the left is from a video showing an organic peroxide container under self-accelerating decomposition conditions [18]. The graphic on the right is an Arkema illustration showing that organic peroxide products are safe below the “Recommended Storage Temperature” and that the uncontrolled decomposition reaction that occurs above the SADT [11, p. 3].

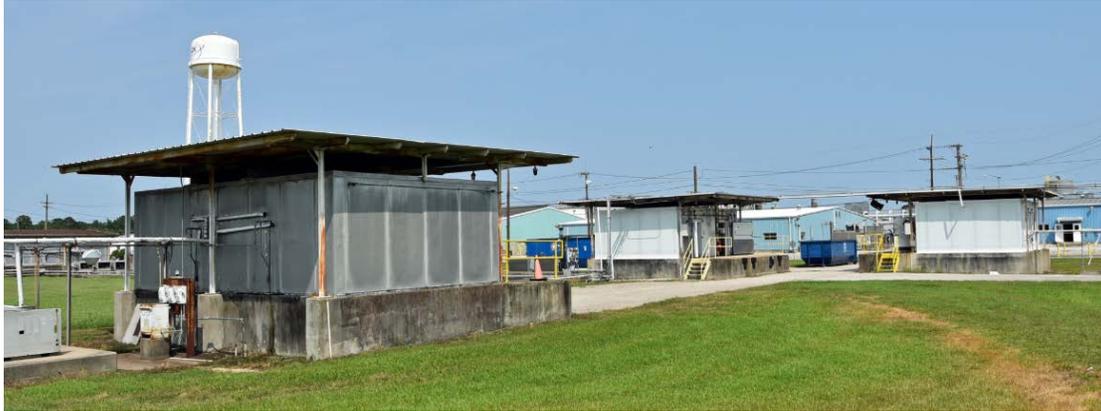
Figure 3. Crosby Low Temperature Warehouses. Three of the seven Low Temperature Warehouses at the Arkema Crosby facility are shown in this photograph. (Source: CSB Photo)

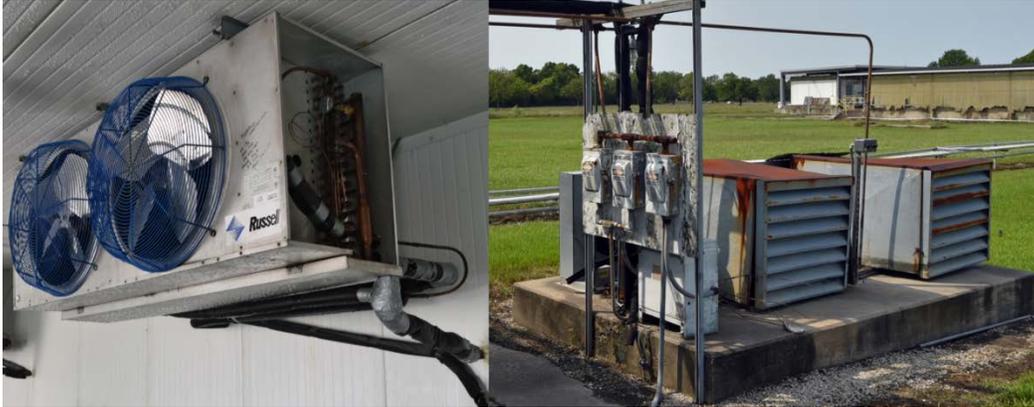
Figure 4. Typical Refrigeration Equipment Used to Keep the Low Temperature Warehouses Cold at the Arkema Crosby Facility. The photo on the left shows refrigeration evaporator equipment used to remove heat from the inside of a Low Temperature Warehouse. The photo on the right shows refrigeration condensing equipment, that removes heat from the refrigerant and also shows electrical equipment for the refrigeration system and other electrically powered equipment for the building, such as lighting.^a (Source: CSB Photo)

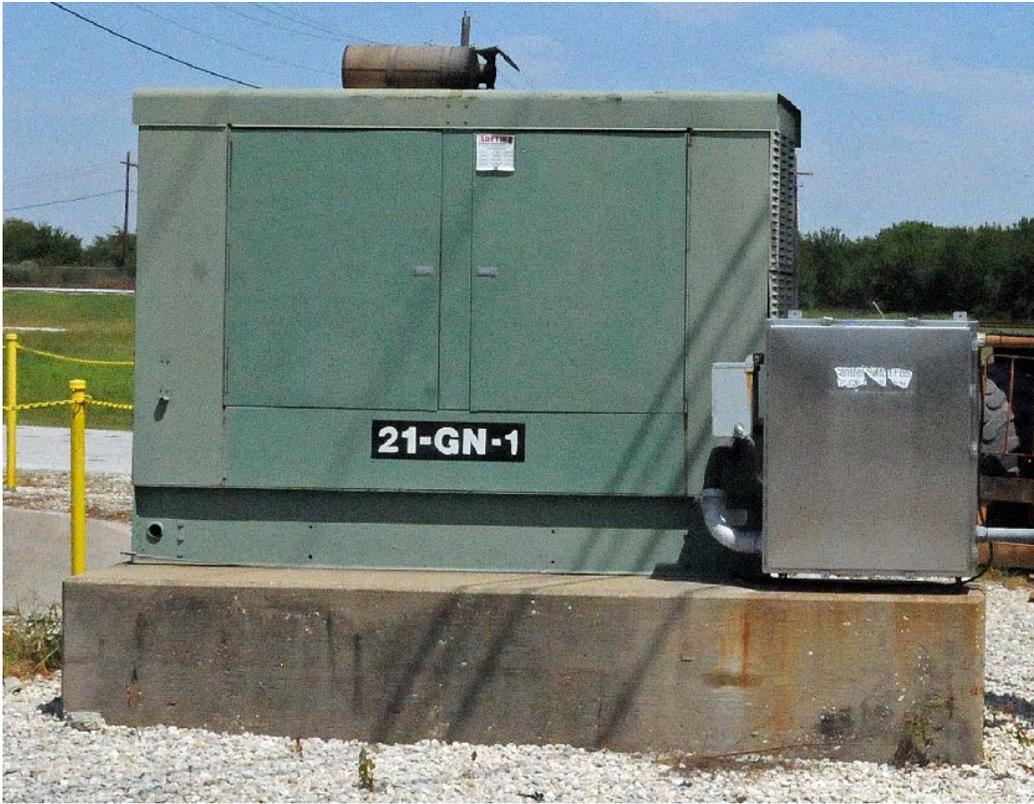
Figure 5. One of Seven Emergency Generators at the Arkema Crosby Facility. Generator 21-GN-1 is one of the two generators providing emergency electrical power to Arkema's seven Low Temperature Warehouses. The bottom of the generator (top of the concrete foundation) is about two feet above the ground. (Source: CSB Photo)

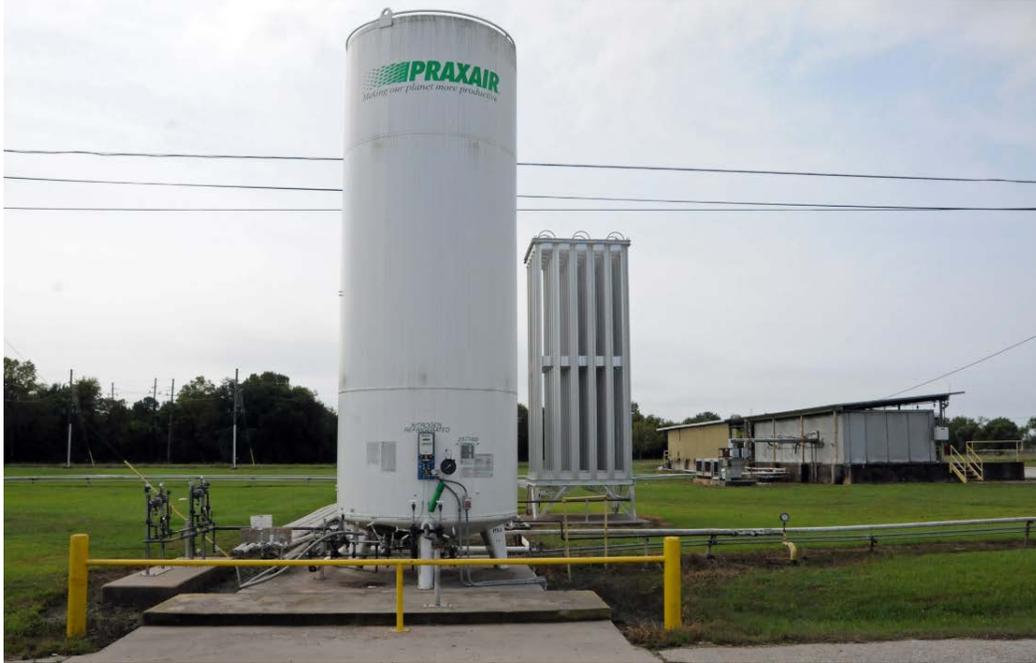
Figure 6. Liquid Nitrogen Tank at the Arkema Crosby Facility. Among other uses, this tank holds up to 40,000 pounds of liquid nitrogen that can be injected into each of the organic peroxide Low Temperature Warehouses to provide a backup refrigeration source. (Source: CSB Photo)

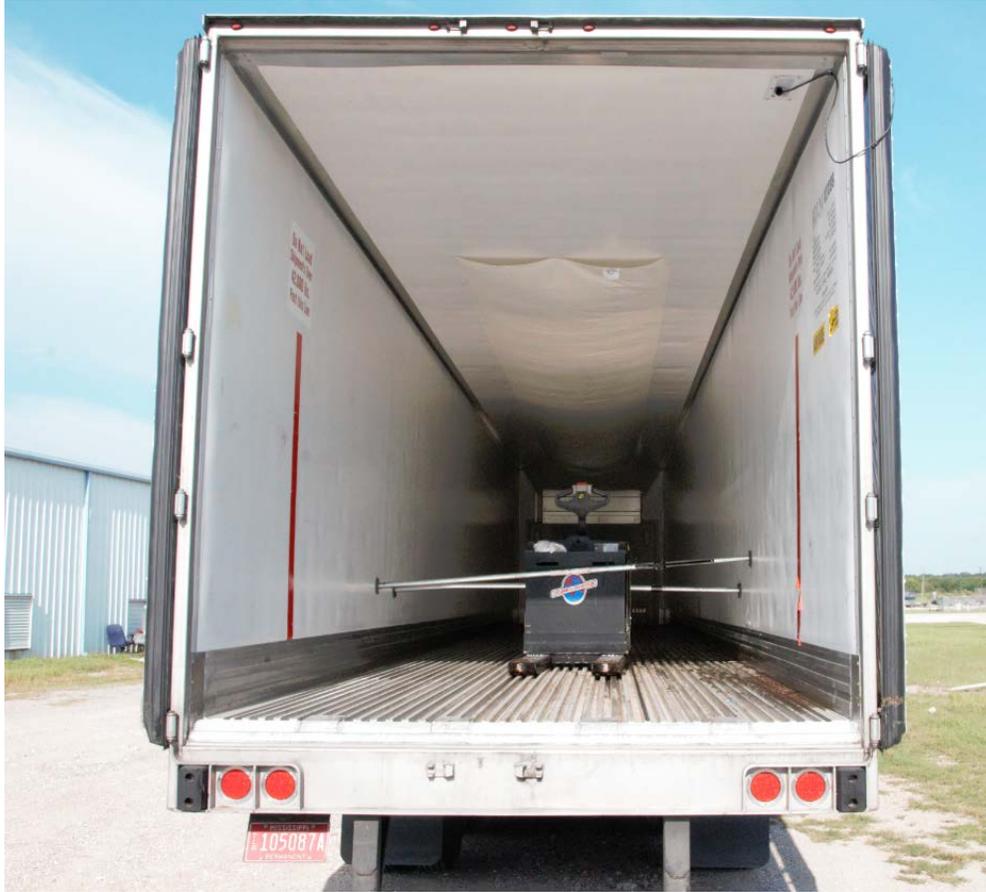
Figure 7. Refrigerated Truck Trailer. Arkema used about a dozen refrigerated truck trailers like this one used to ship organic peroxide products to customers and to provide a temporary storage location if the refrigeration at one or more of the Low Temperature Warehouses could not be maintained. (Source: CSB Photo)

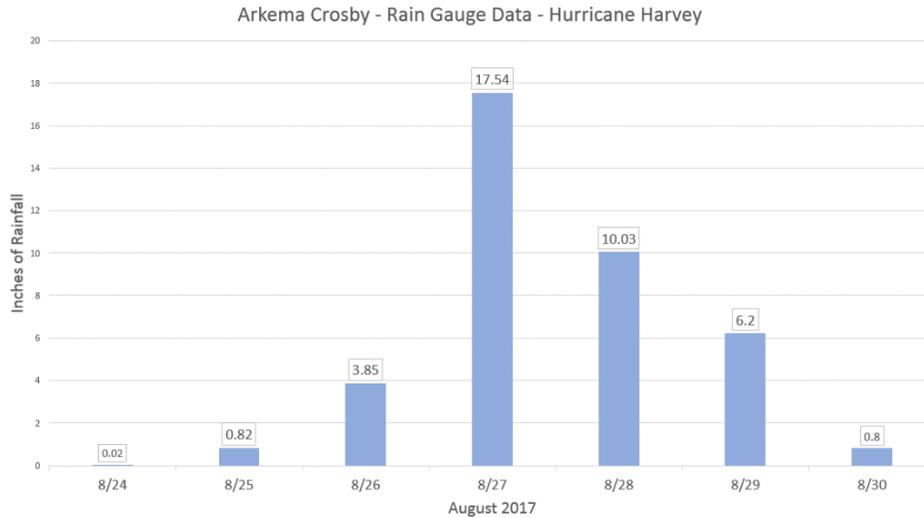
Figure 12. Arkema Crosby Facility Rain Gauge Data. The Arkema site recorded more than 39 inches of rainfall during the days when Hurricane Harvey affected the area.

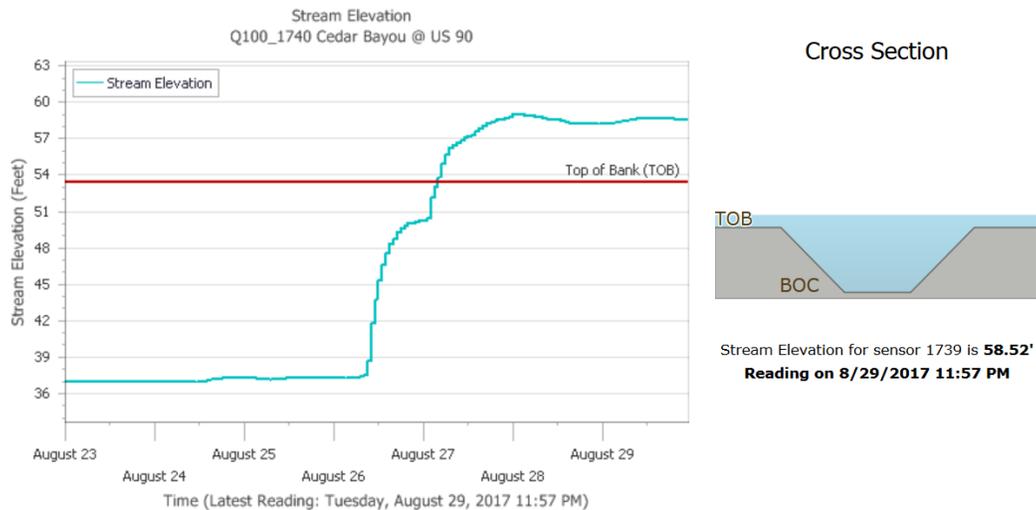
Figure 14. Gauge Station 1740 Graphic Showing Cedar Bayou Stream Elevation During Hurricane Harvey. The water level steadily rose for most of the day on Saturday, August 26, 2017 [29].^{a, b}

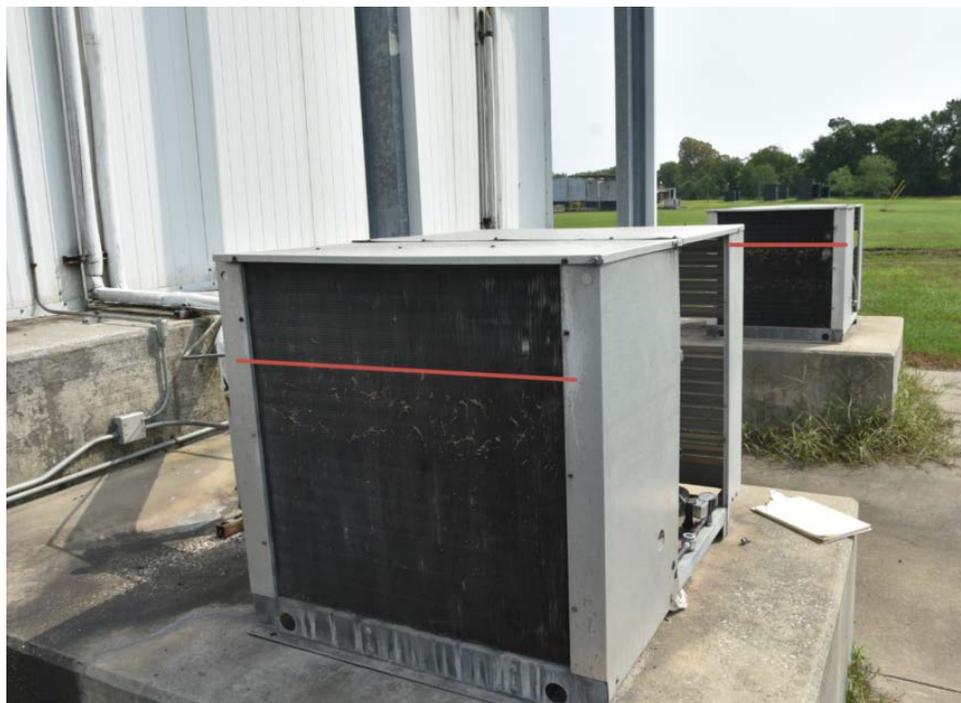
Figure 17. Air Conditioning Units Behind One of the Low Temperature Warehouses. The final floodwater level is approximated by the red lines on the air conditioning equipment at the Arkema Crosby facility. (Source: CSB Photo)

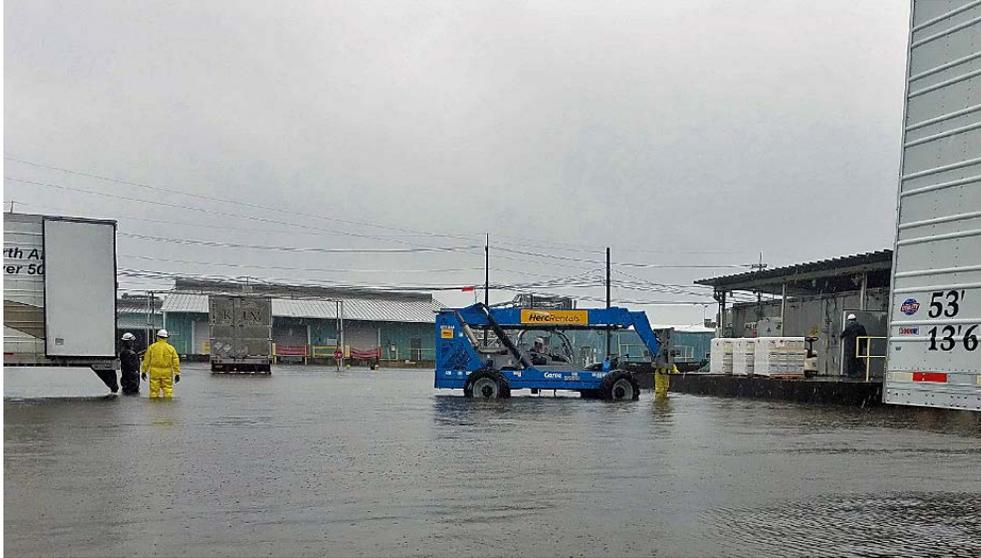
Figure 18. Forklift Used by the Ride-out Crew. Ride-out crew members used the forklift shown in this image to move organic peroxide pallets from the storage buildings after they turned off power to the buildings because of the rising floodwater. (Source: Arkema Photo)

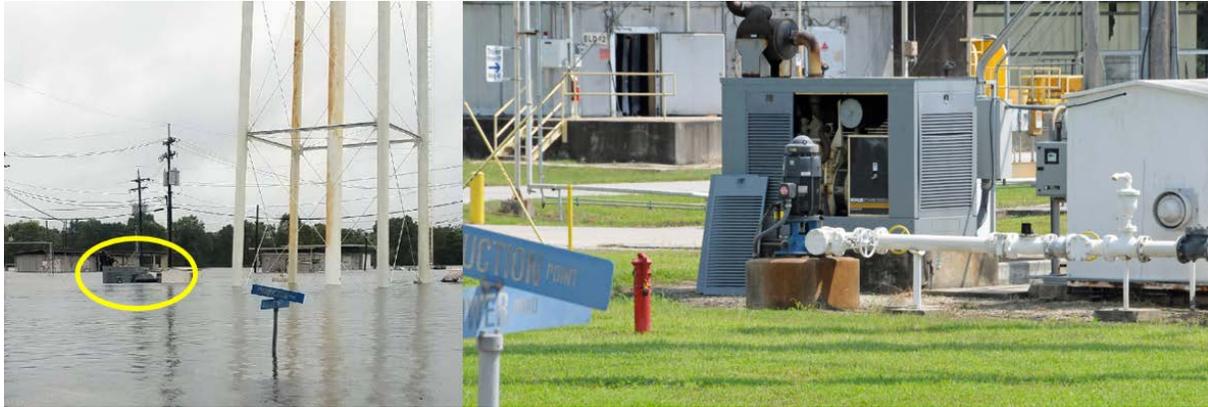
Figure 19. One of the Emergency Generators Providing Backup Electricity to the Low Temperature Warehouses. The photo on the left shows floodwater covering the bottom half of the generator (yellow oval) on Tuesday August 29, 2017. The post-incident photo on the right shows the same generator. (Source: Arkema Photo (left) Modified by CSB, CSB Photo (right))

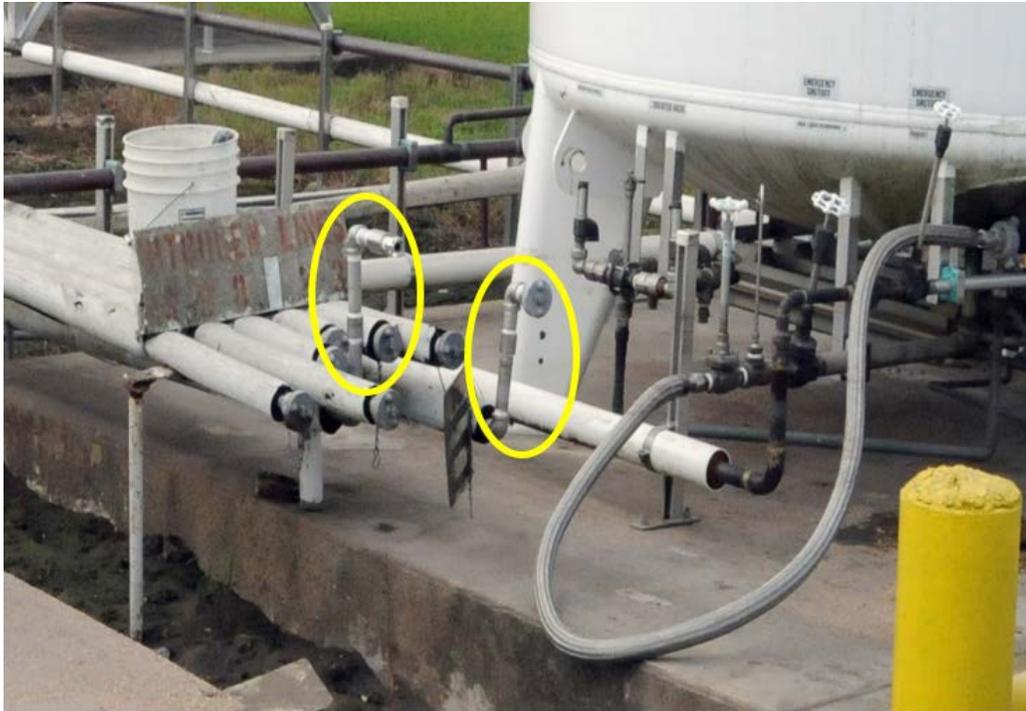
Figure 20. Liquid Nitrogen Piping Extensions. A supervisor modified the liquid nitrogen piping, extending it to ensure that the connection point would be above the floodwater if the ride-out crew needed to inject liquid nitrogen into one of the Low Temperature Warehouses that still contained organic peroxide products. These elevated (extended) connections, however, were not high enough; the rising floodwater eventually submerged them. (Source: CSB Photo)

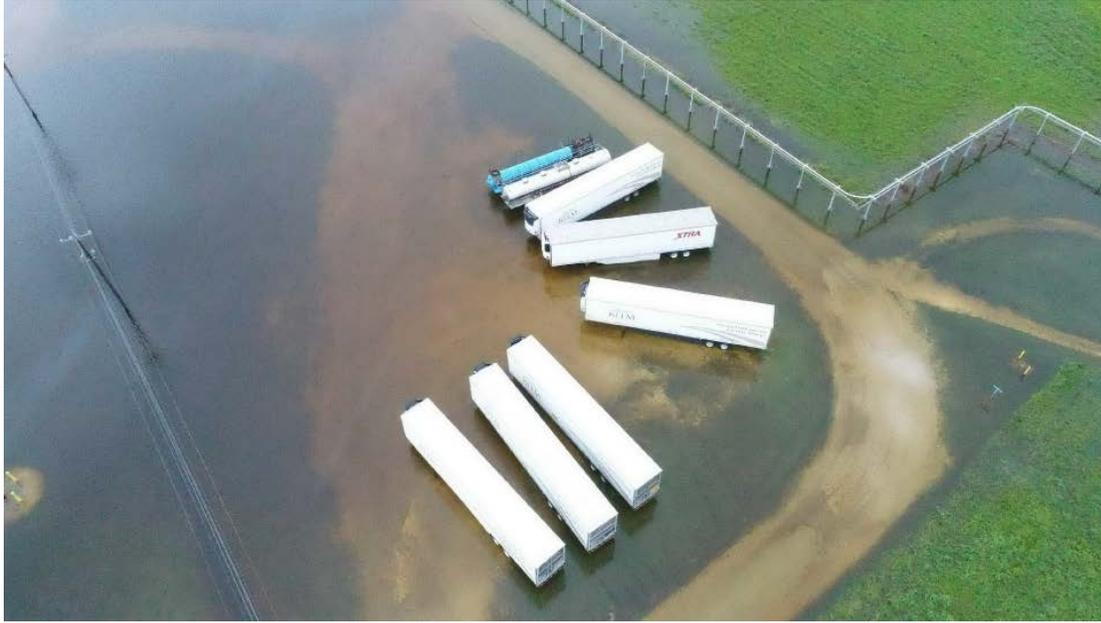
Figure 21. Refrigerated Trailers in the Laydown Area. Six refrigerated trailers loaded with organic peroxide products are shown at the Arkema Crosby facility. Two empty tanker trailers are also shown at the top of the photo. (Source: Photo provided by Arkema)

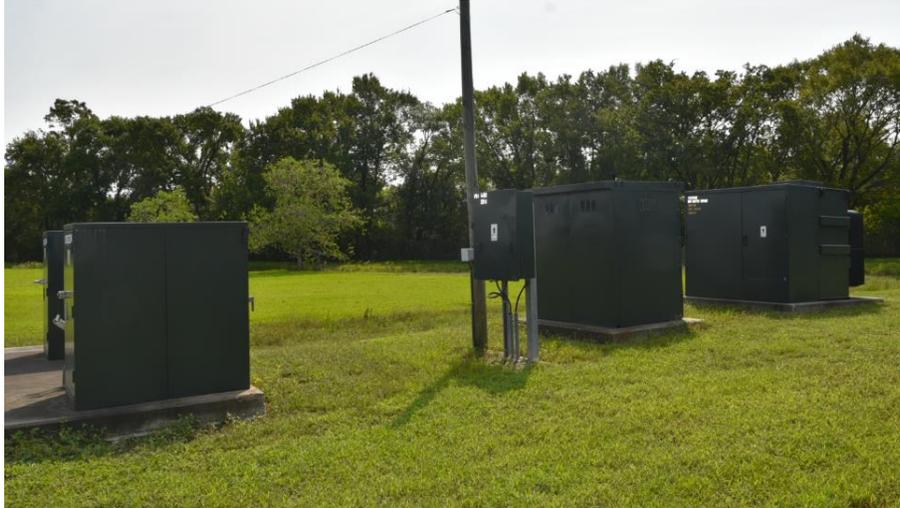
Figure 24. CenterPoint Transformers at the Arkema Crosby Facility. These are the main CenterPoint power transformers onsite at the Arkema Crosby facility. (Source: CSB Photo)

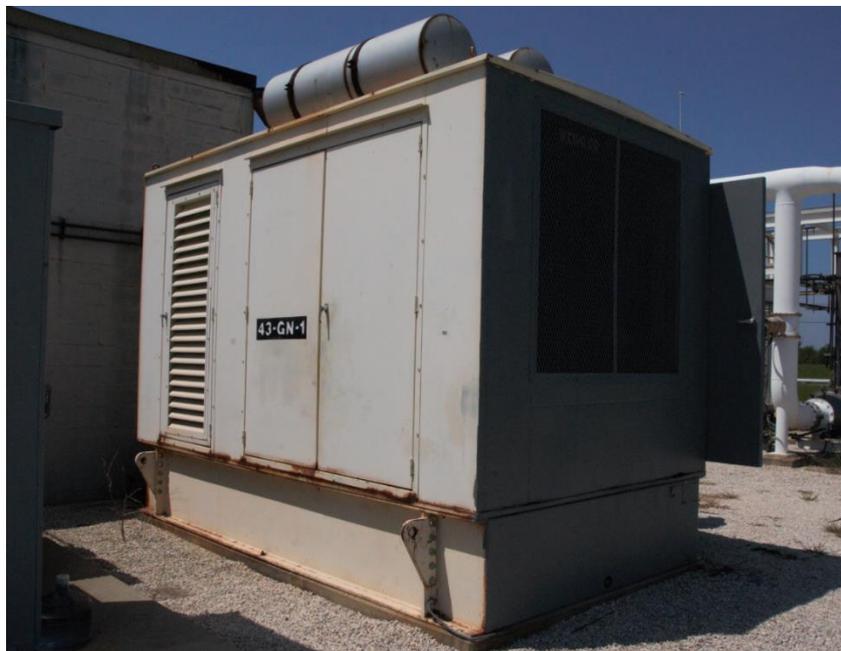
Figure 25. Emergency Generator. This is one of the emergency generators that automatically turned on when the power failed at the Arkema Crosby facility. (Source: CSB Photo)

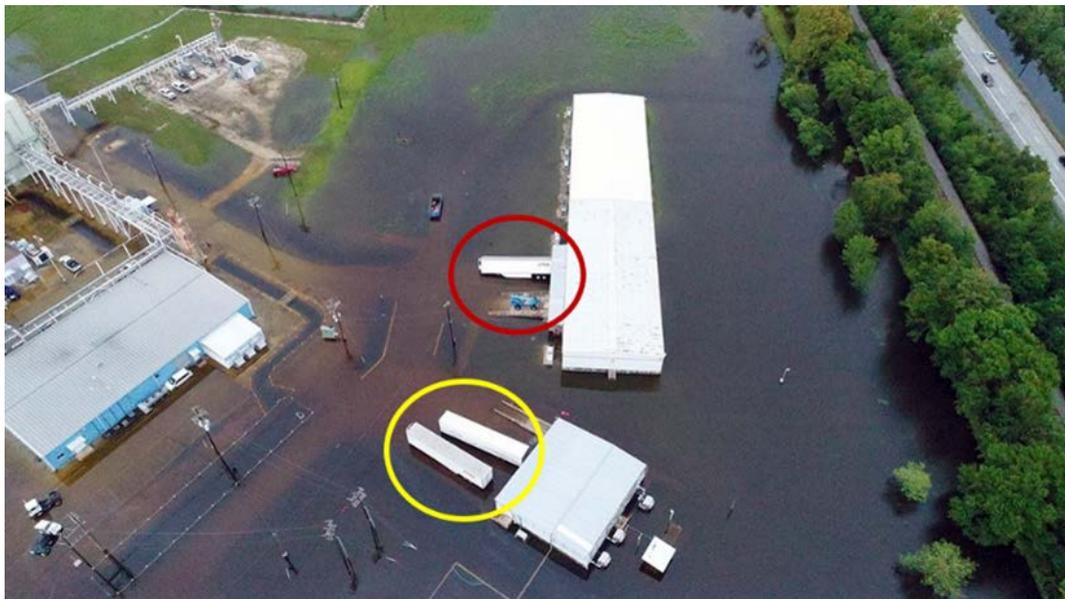
Figure 26. Three Refrigerated Trailers Not Moved to Higher Ground [33]. This aerial view shows three refrigerated trailers (yellow and red circles) filled with organic peroxide containers near two of the organic peroxide product warehouses after the Arkema ride-out crew evacuated the site. (Photo Modified by CSB)

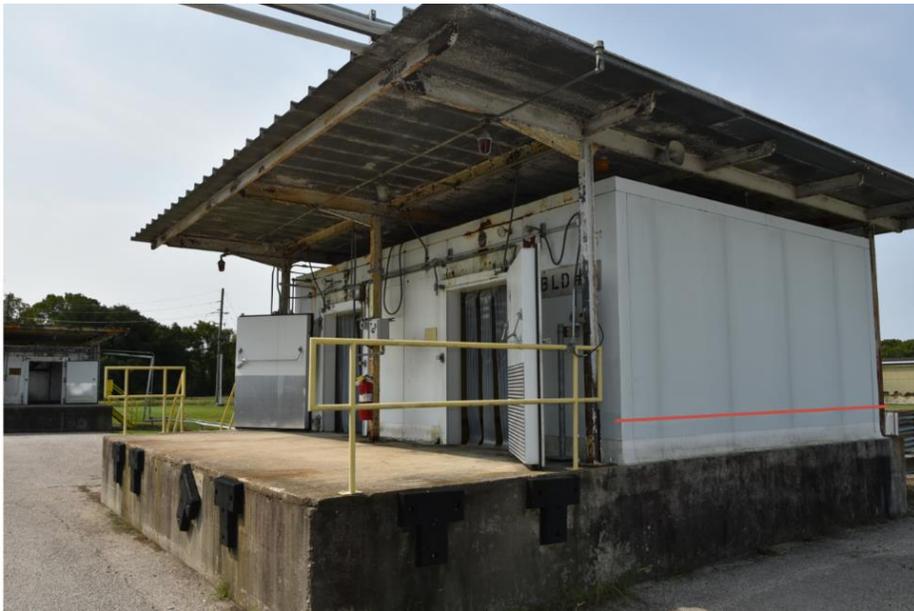
Figure 29. Low Temperature Warehouse at the Crosby facility. The red line shows the high-water mark, just over five feet above the ground. (Source: CSB Photo)

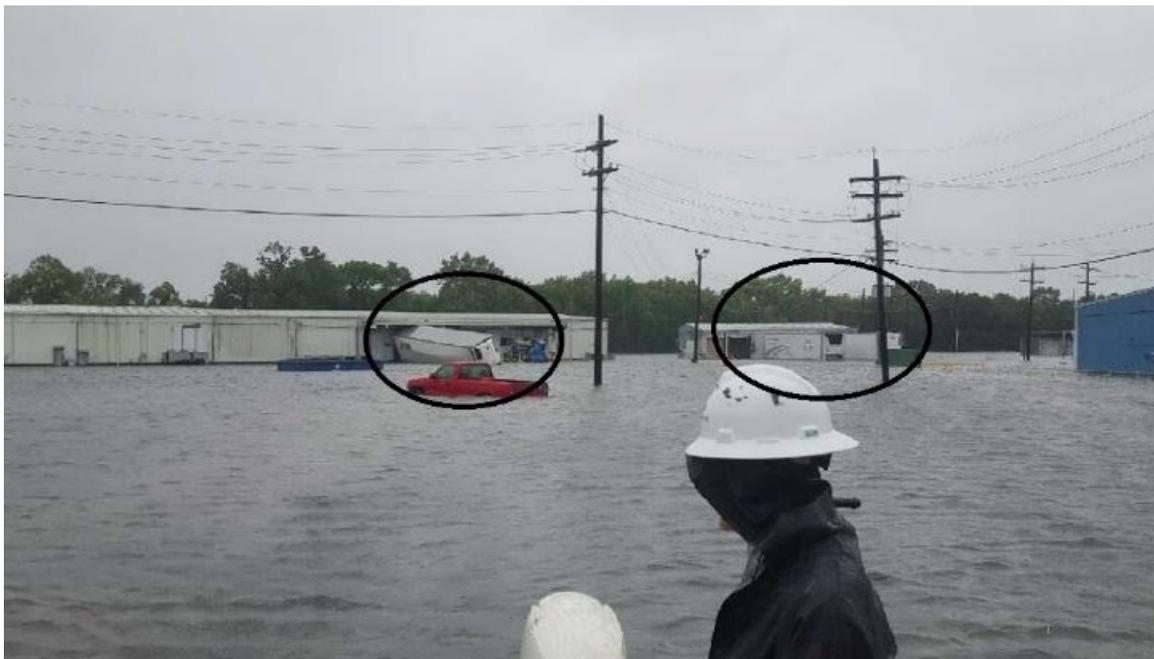
Figure 31. Condition of the Crosby Facility on the Morning of Tuesday, August 29, 2017. The ride-out crew sent this photograph to the corporate crisis team showing the trailer on the left had tilted. (Source: Arkema Photo Modified by CSB)

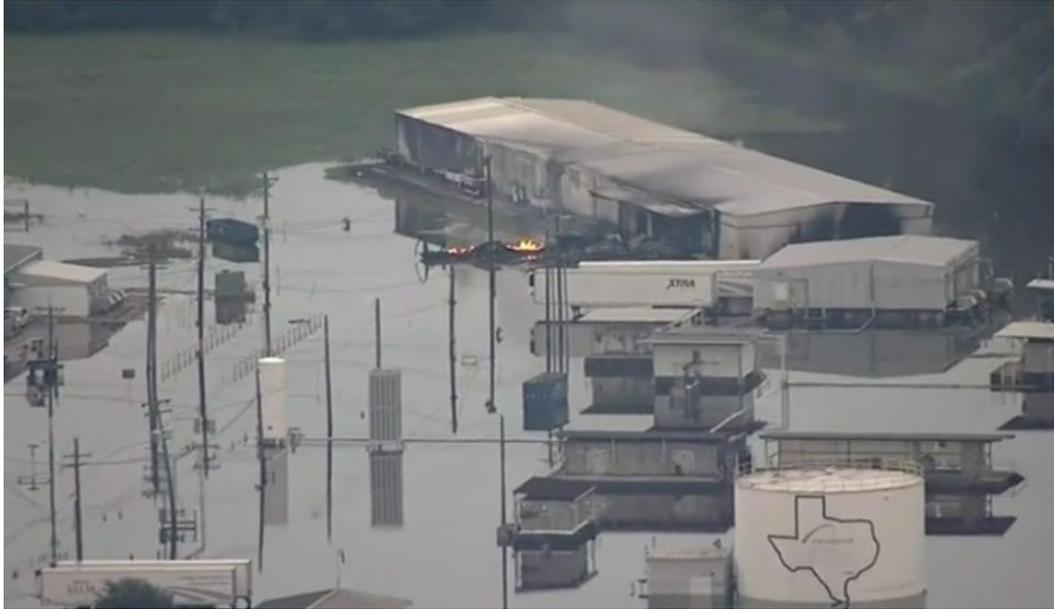
Figure 39. First Refrigerated Trailer to Burn at the Arkema Crosby Facility. The first refrigerated trailer to burn is shown smoldering outside of Building 21 [37].

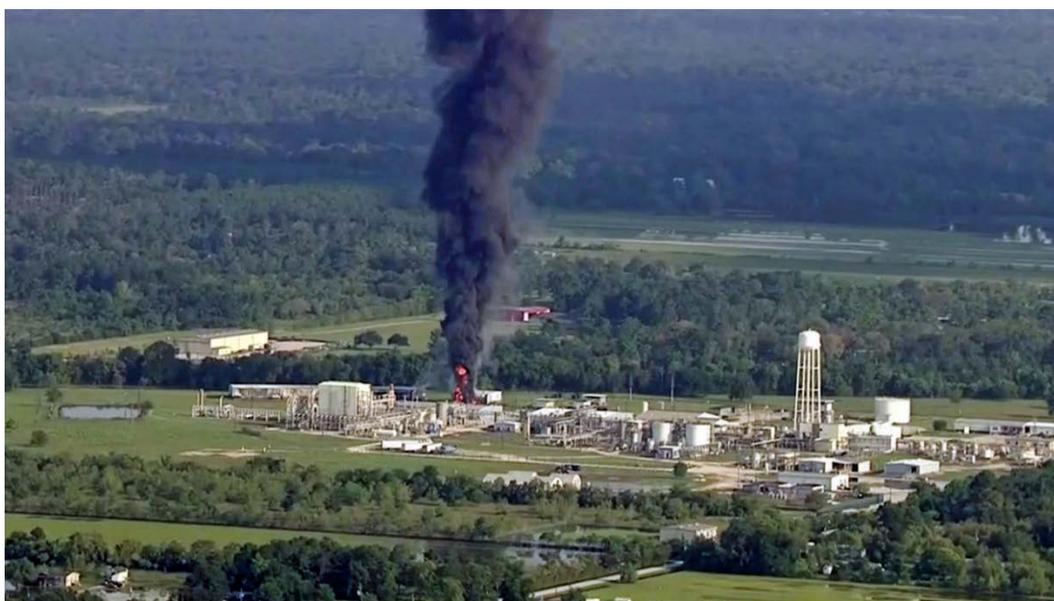
Figure 40. The Second and Third Refrigerated Trailers Burning. Fire and smoke are visible from two refrigerated trailers burning at the Arkema Crosby facility on September 1, 2017 [40].

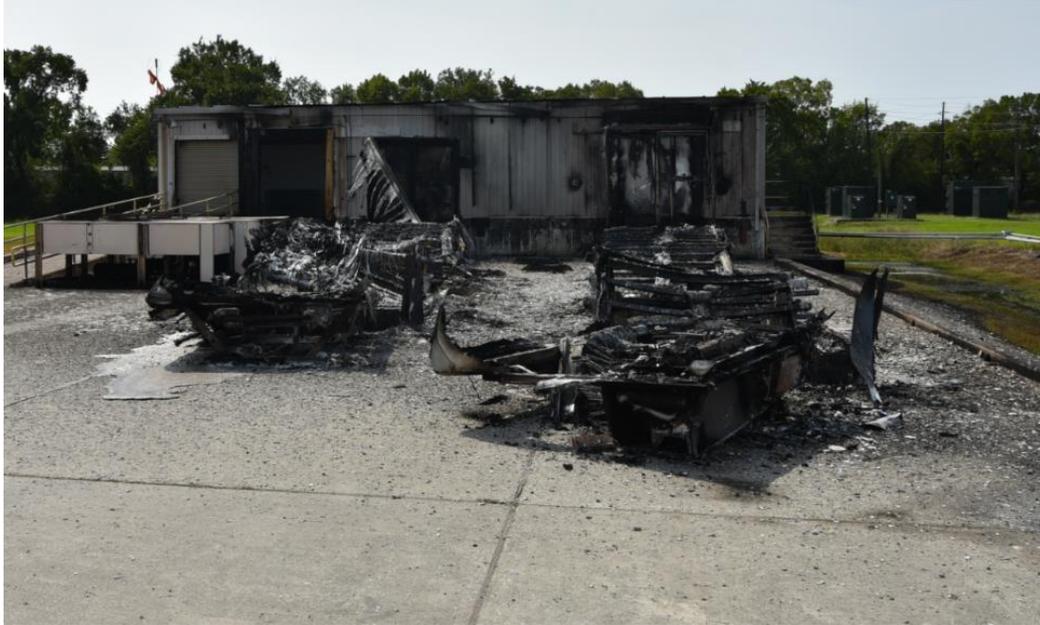
Figure 41. Remains of the Second Fire that Consumed Two Trailers Storing Organic Peroxide Products. The second fire consumed two refrigerated trailers storing organic peroxide products; the remains of those trailers are shown in this image. (Source: CSB Photo)

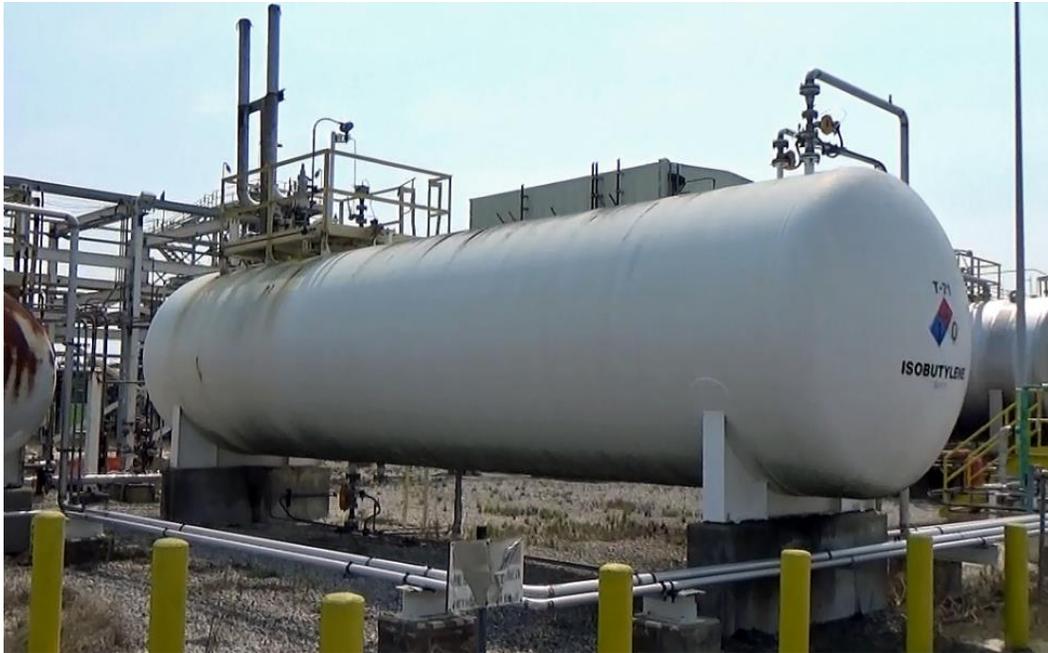
Figure 43. Isobutylene Storage Tank at the Arkema Crosby Facility. The isobutylene tank posed a concern because the controlled burn of the six refrigerated trailers in the laydown area would occur within about 40 yards of this storage tank. (Source: CSB Photo)

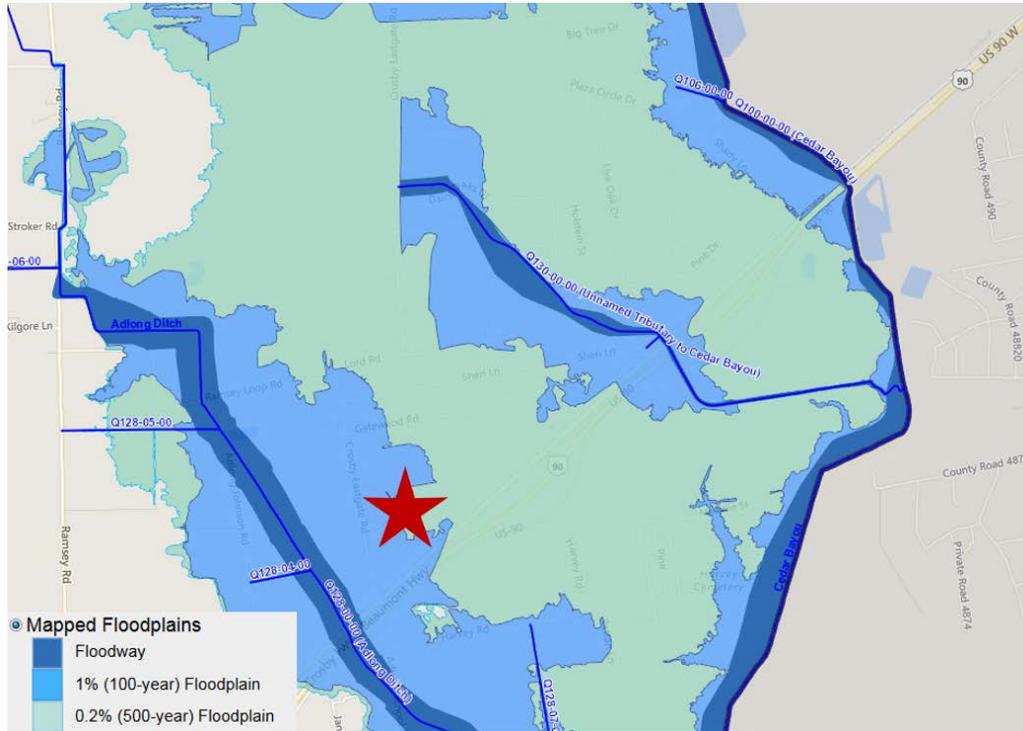
Figure 46. Approximate Floodplain Map of the Area Near the Arkema Crosby Facility. The Arkema Crosby facility (red star) is located between the Adlong Ditch and the unnamed tributary to Cedar Bayou floodways^a and is within both the 100-year^b and 500-year^c floodplain [53]. (Image Modified by CSB)

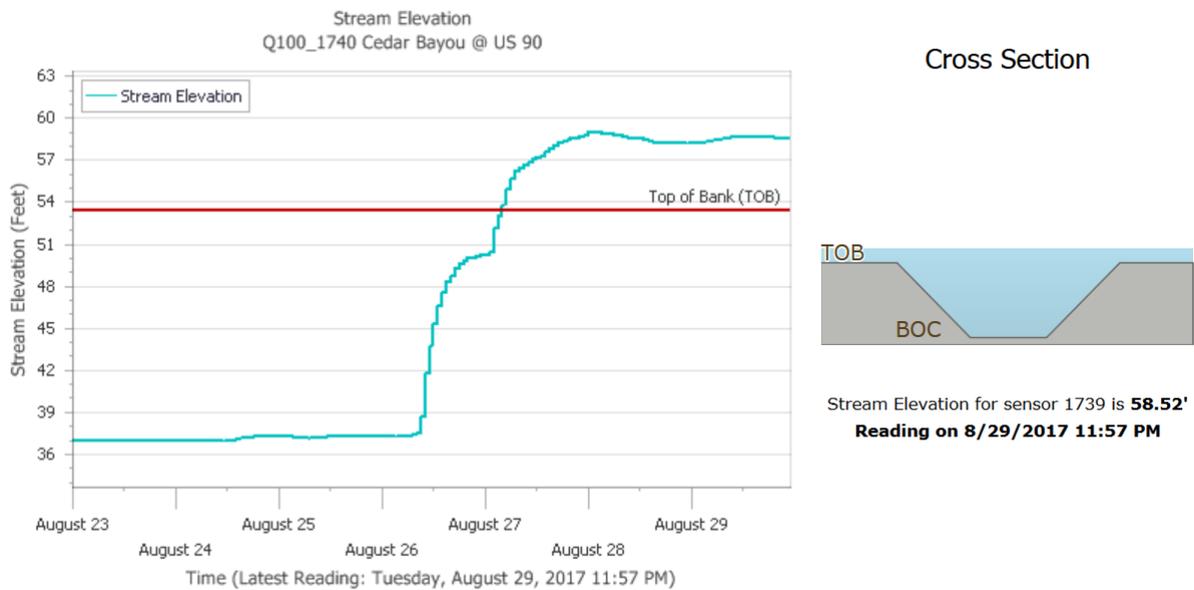
Figure 50. Gauge Station 1740 Stream Elevation Data. The graphs show Cedar Bayou stream elevation during Hurricane Harvey [29]. About 59 feet was the largest stream elevation recorded at about 1:33 am on August 28, 2017 [29].^a

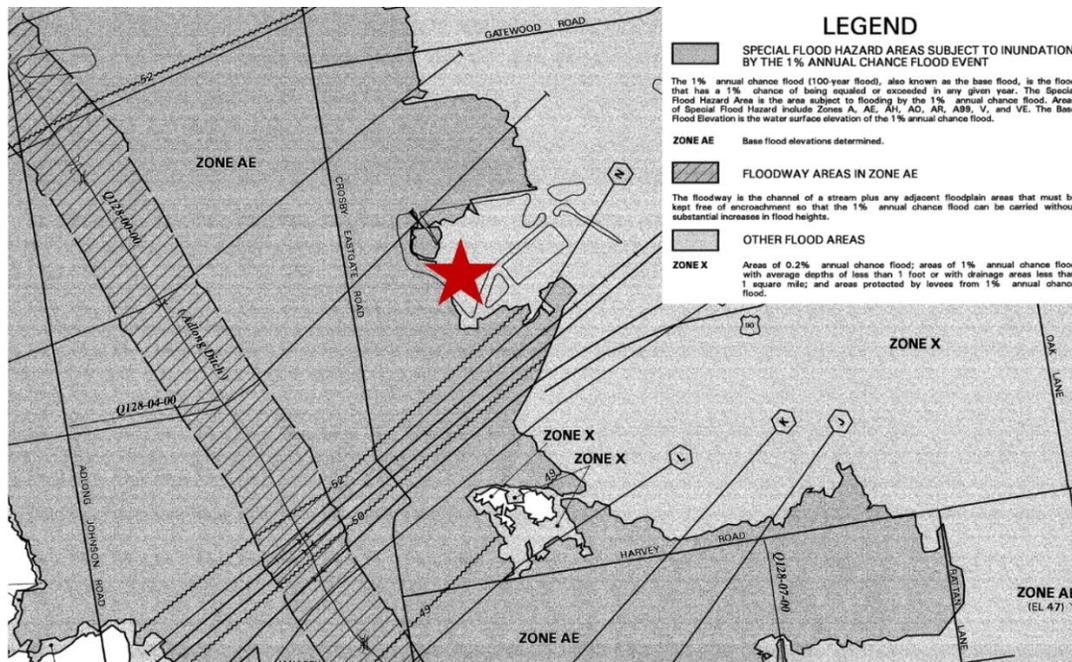
Figure 51. Excerpt from the June 2007 Flood Insurance Rate Map (FIRM). This part of the FIRM shows that the Arkema Crosby facility is located in the 100-year and 500-year floodplains [58]. (Image Modified by CSB)

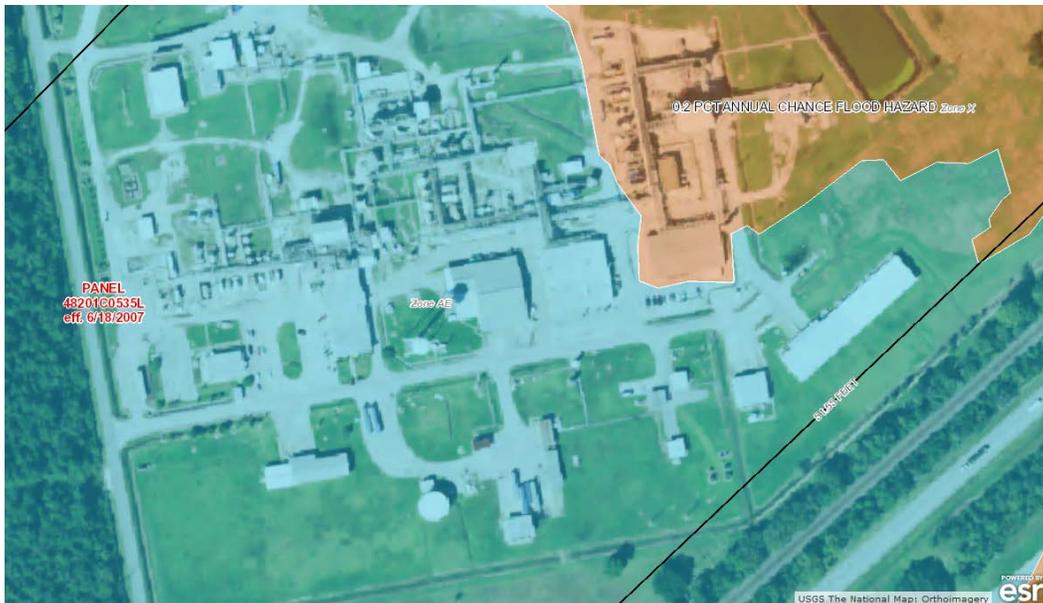
Figure 52. Southern Part of the Arkema Crosby Facility in the 100-Year Floodplain. This digital image shows that the southern part of the facility, where Arkema’s electric utility equipment and refrigerated organic peroxide product storage facilities are located, sits in the 100-year floodplain. The blue portion of the map is Zone AE – the 100-year floodplain [58].^a

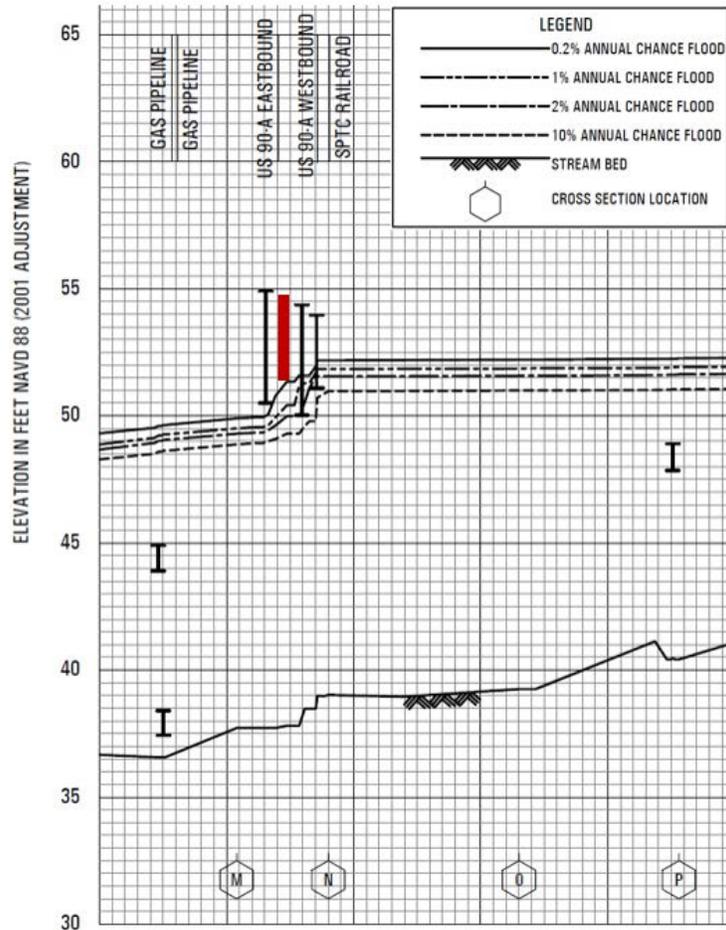
Figure 53. Excerpt from the Adlong Ditch Flood Profile. This excerpt from the Adlong Ditch flood profile shows the estimated water elevation for various flood chance scenarios adjacent to the Arkema Crosby facility [60, p. 35]. The red rectangle was placed by the CSB to show that the approximate floodwater height from Hurricane Harvey was more than two feet above the 500-year flood elevation. Exceeding the 500-year flood elevation by more than two feet is significant because the flood elevation difference between the 100-year and 500-year events is less than one foot. (Graphic Modified by CSB)

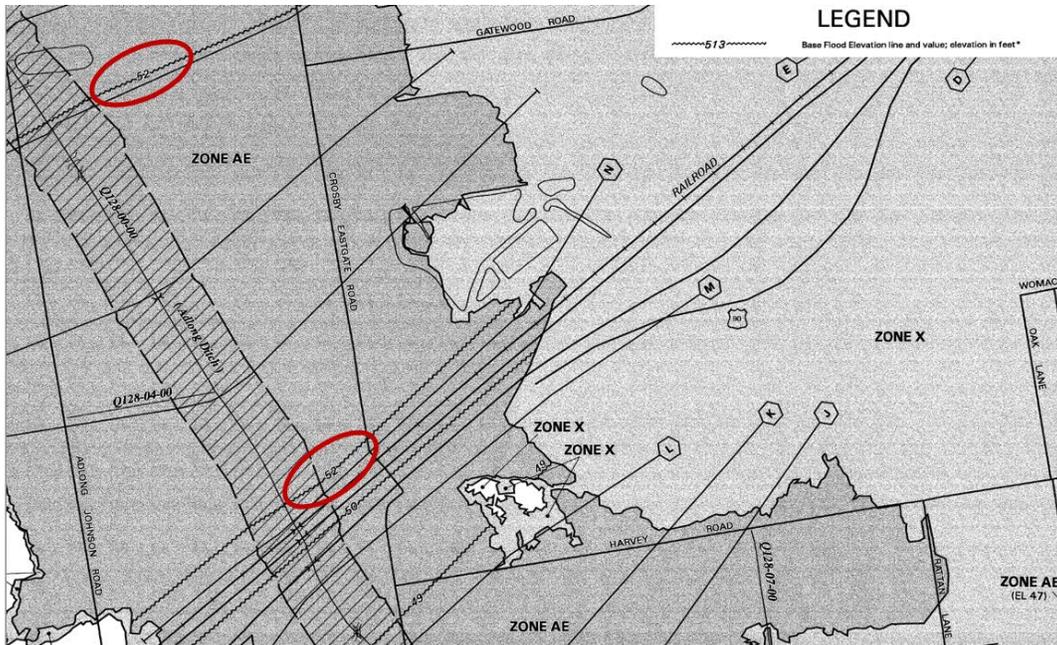
Figure 54. Base Flood Elevation for the Arkema Crosby Facility. The Flood Insurance Rate Map shows that the base flood elevation for the Crosby facility is 52 feet [58]. (Map Modified by CSB)
