# Kaltech Industries Building Explosion

New York, New York April 25, 2002

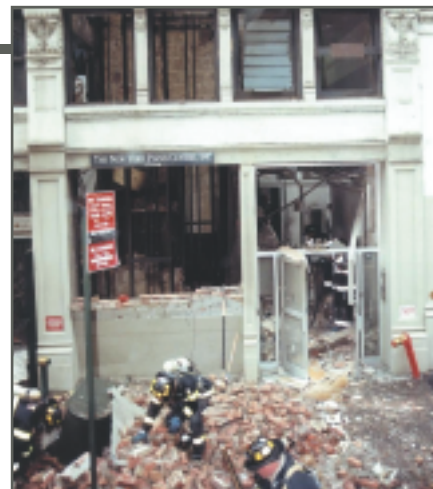
The explosion blew out windows up to the fifth floor and showered the street below with building debris.
