# Hazardous Nitrogen Oxides (NO<sub>x</sub>) Releases at Austin Powder Facilities

Midway, Tennessee |  
McArthur, Ohio |

| No. 2025-OH-I-01

## Investigation Update

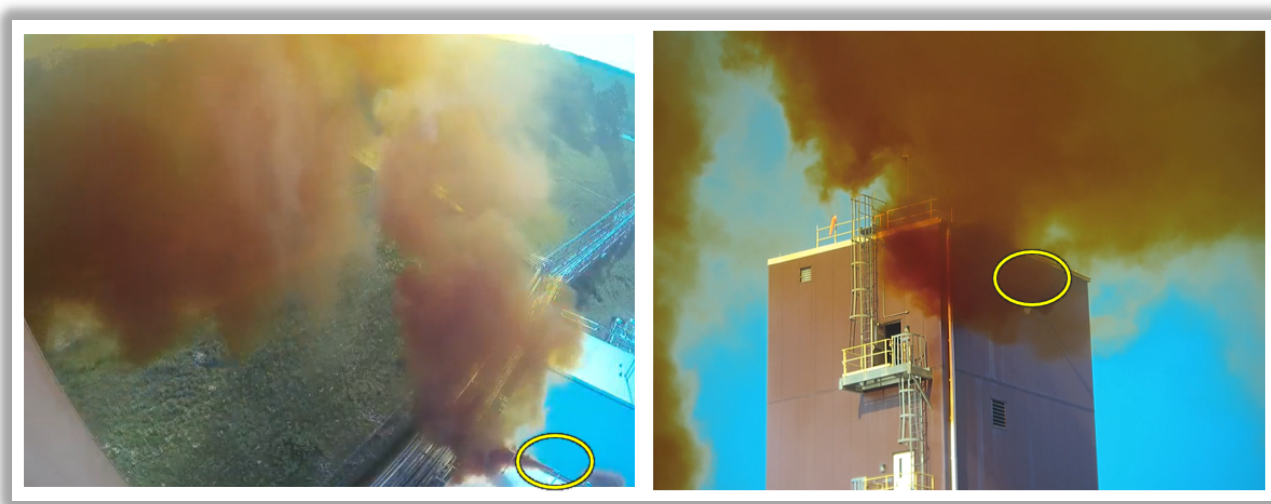
- The visible NO<sub>x</sub> release continued through the morning (**Figure 5**), until approximately 11:25 a.m., when employees were able to get the absorber column back in service. The absorber column then began treating the acid vapors, which stopped the visible emissions to the atmosphere.

**Figure 5.** NO<sub>x</sub> release approximately one hour into the event (9:15 a.m.). The emergency pressure relief valve discharge (left) and absorber column vent (right) are circled. (Credit: Austin Powder, annotated by CSB)

- On the day of the incident, because the floor in the PETN control room was being resurfaced, the control room operators moved to a different room nearby, where they were unable to continuously monitor the acid tank farm and the video provided by security cameras, such as the images shown above in **Figure 4** and **Figure 5**. This contributed to the delayed discovery of the release.

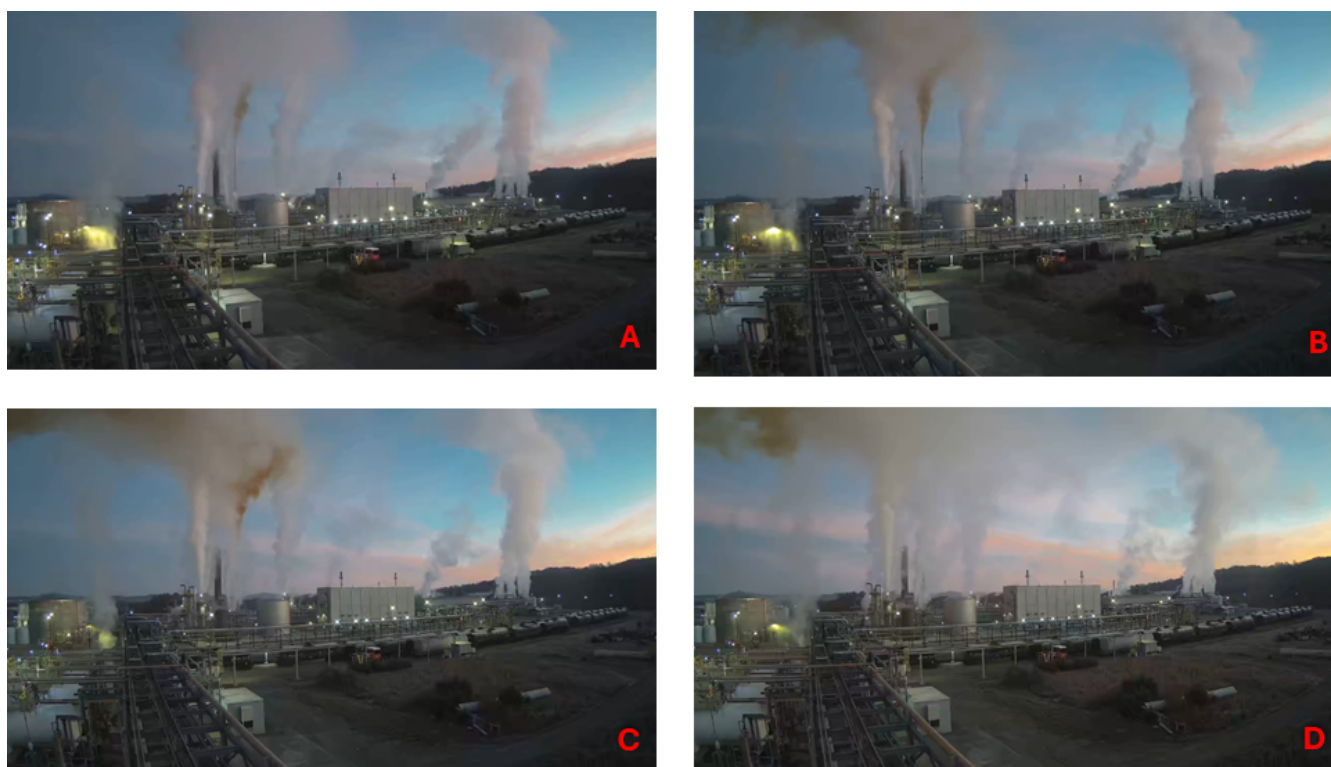
- Approximately five minutes later, at 6:47 a.m., visible  $\text{NO}_x$  emissions began to exit the stack in the nitric acid unit (**Figure 7.A**). Operators shut down the process shortly thereafter. Visible emissions continued for approximately seven minutes (**Figure 7.D**).

**Figure 7.** Progression of the NO<sub>x</sub> release during the first restart attempt. (Credit: U.S. Nitrogen, Annotated: CSB)

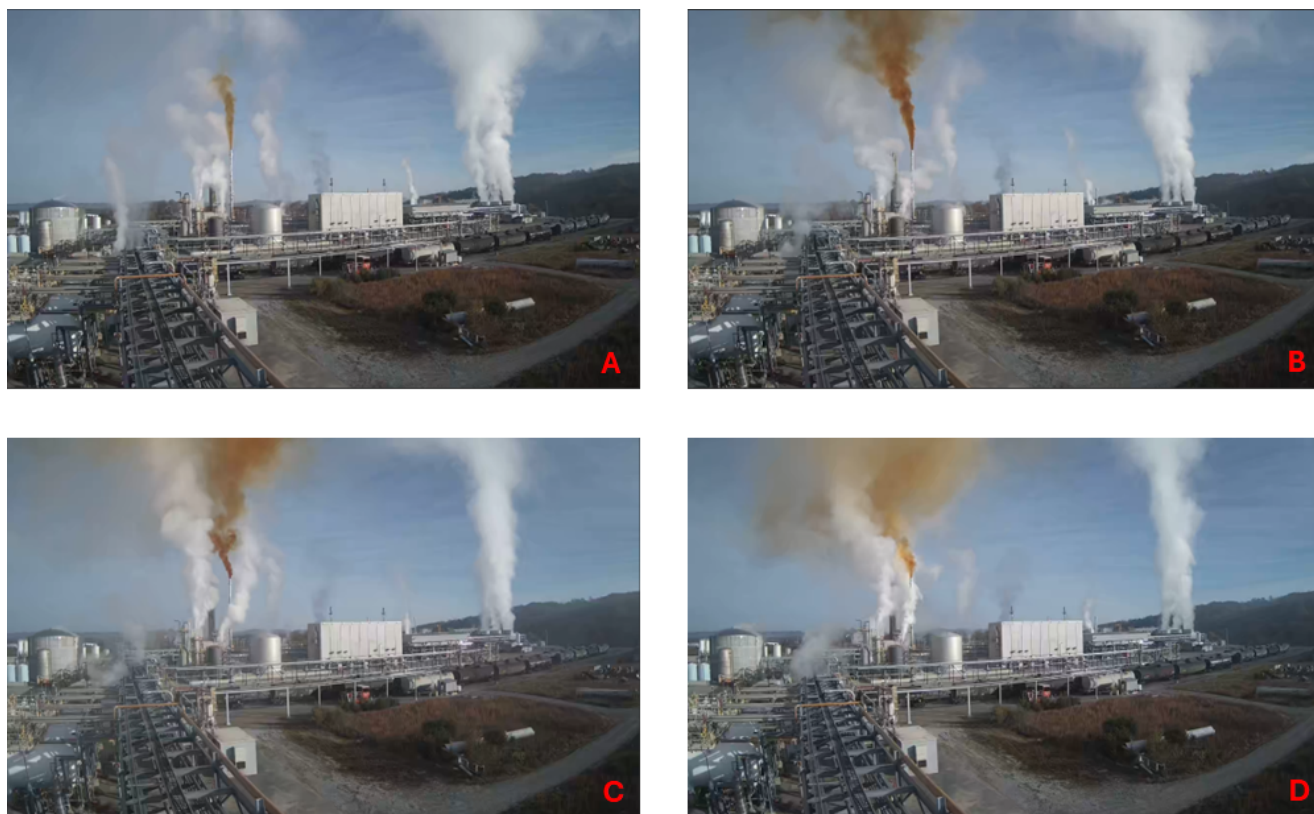
- At approximately 8:42 a.m., visible emissions began to exit the stack in the nitric acid plant a second time (**Figure 8.A**). Operators immediately shut down the process again. Visible emissions continued for approximately ten minutes (**Figure 8.D**).

**Figure 8.** Progression of the NO<sub>x</sub> release during the second restart attempt. (Credit: U.S. Nitrogen, Annotated: CSB)
