# Fatal Combustible Wood Dust Explosion And Fire at Horizon Biofuels Facility

Fremont, NE | Incident Date: July 29, 2025 | No. 2025-NE-I-02

## Investigation Update

September 17, 2025

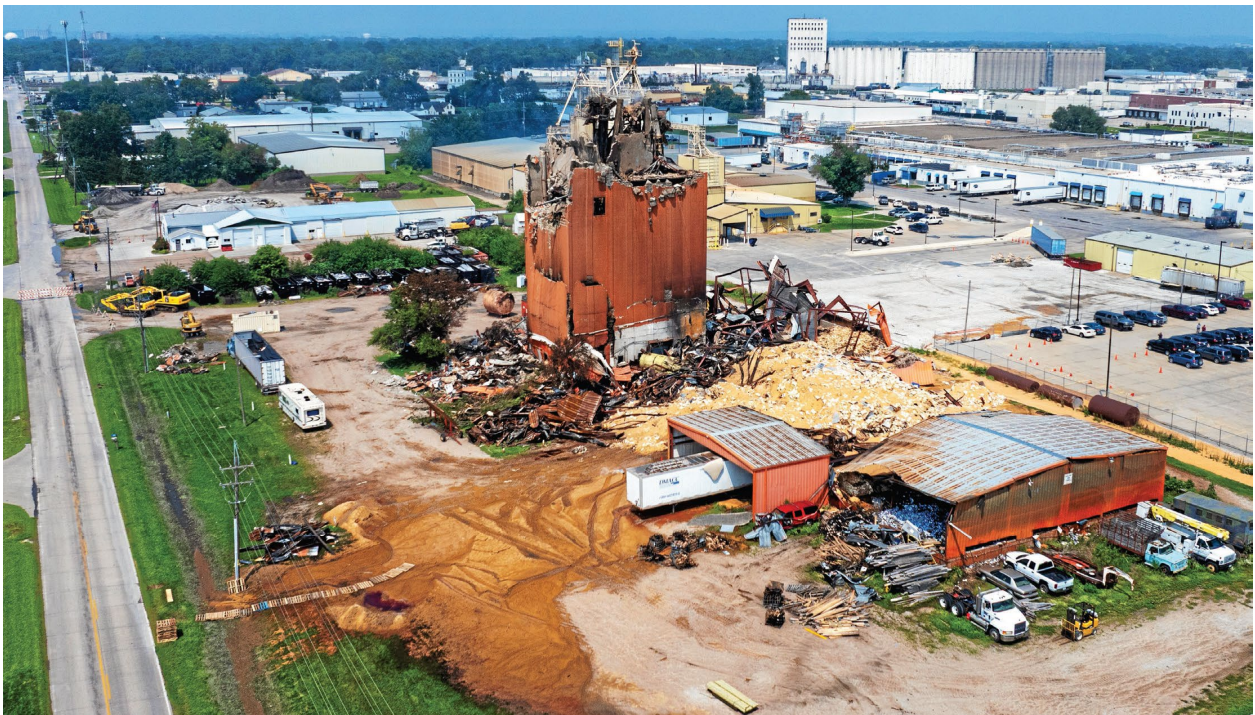
**Figure 1.** Post-incident image of the Horizon Biofuels facility on July 31, 2025. (Credit: Chris Machian Photos, Omaha World-Herald [1])

- There was significant building and vehicle damage within the Horizon Biofuels property as a result of the explosion. There was no apparent physical damage reported to nearby businesses, but explosion debris struck some vehicles in neighboring parking lots [4]. Portions of roads around Horizon Biofuels were closed for traffic after the explosions and fires, affecting neighboring businesses [5] until the emergency responders reduced their presence two days after the explosion, on Thursday, July 31, 2025 [6].

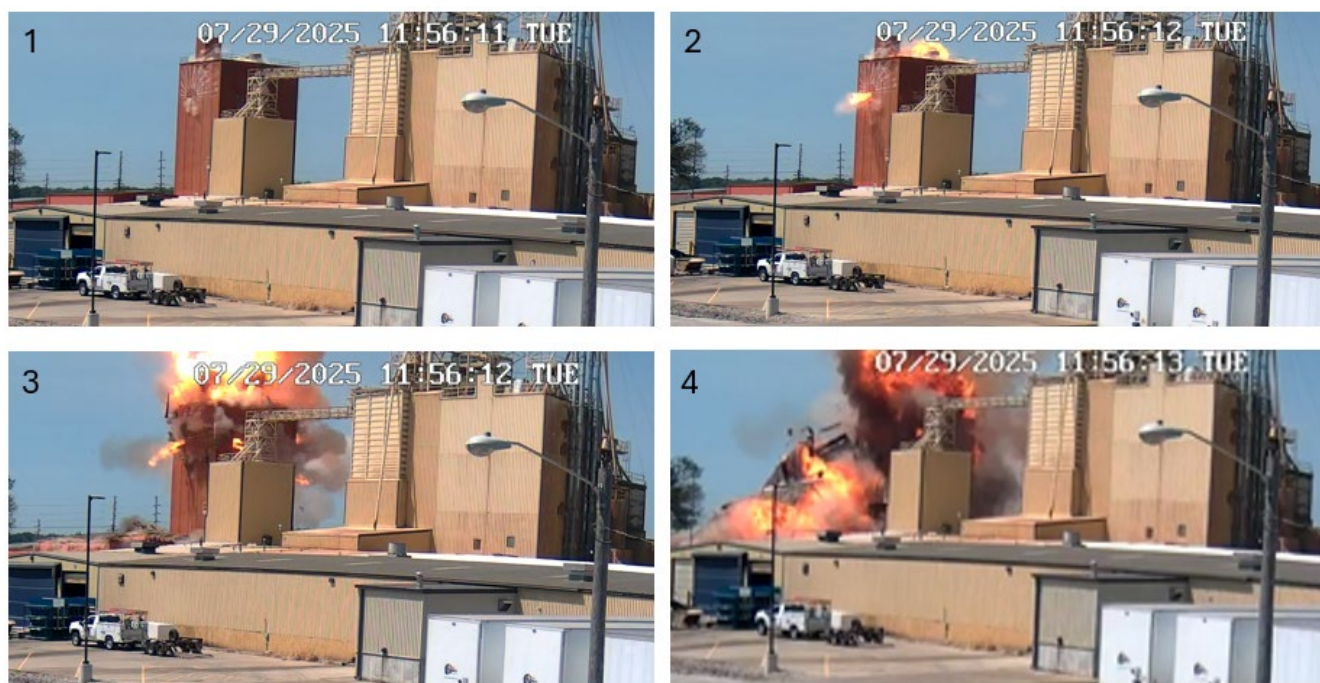
- At approximately 11:56 a.m., a large puff of dust or smoke started billowing from windows near the top of the tower (**Figure 2, panel 1**) and openings from the ground floor of the tower. Within seconds, flames started jetting out of the windows (**Figure 2, panel 2**), followed by a large explosion at the top of the tower (**Figure 2, panel 3**). The explosion and fire propagated through the facility, which severely damaged the structures (**Figure 2, panel 4**). During the explosion, portions of the tower and its adjacent structures collapsed, including the break room immediately north of the tower where the two girls were located.

**Figure 2.** Video screen captures of the explosion on July 29, 2025 (Credit: Americold)
