U.S. CHEMICAL SAFETY AND HAZARD INVESTIGATION BOARD

## THE EXPLOSION AT CONCEPT SCIENCES: HAZARDS OF HYDROXYLAMINE

No. 1999-13-C-PA  
March 2002

### CONCEPT SCIENCES, INC.

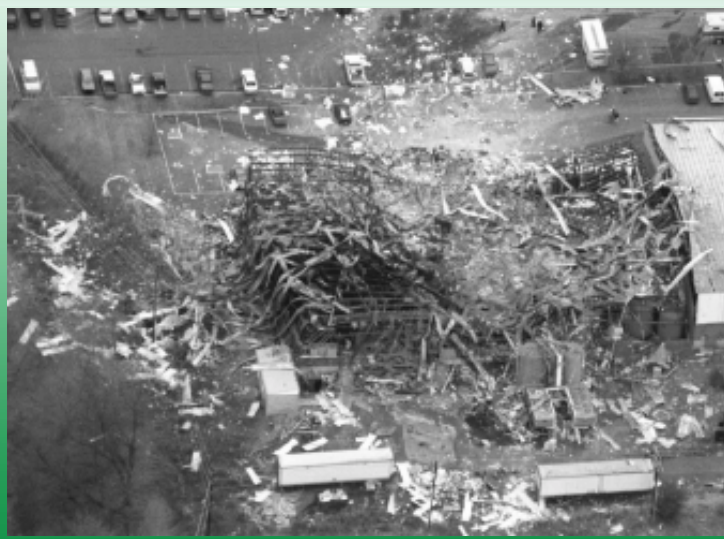
Figure 1

Damage to Concept Sciences, Inc., HA production facility

The production facility was extensively damaged (Figure 1). The explosion also caused significant damage to other buildings in the Lehigh Valley Industrial Park and shattered windows in several nearby homes.

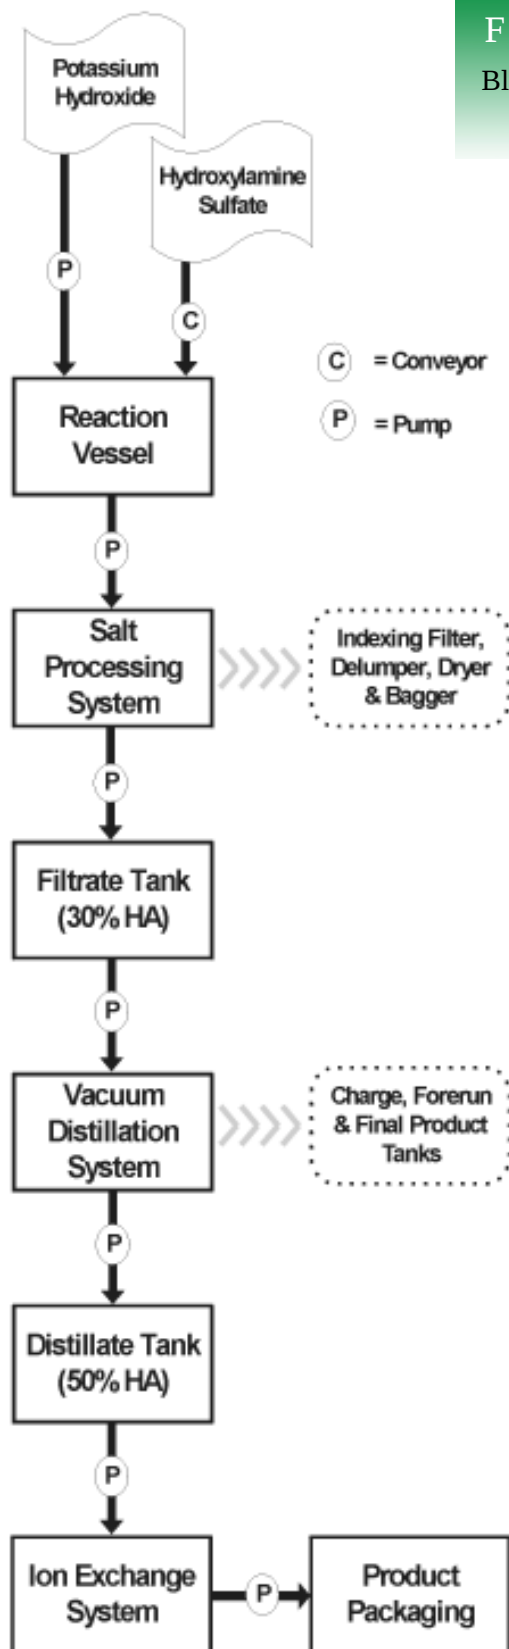
Figure 2

Block flow diagram of the CSI HA production process

1. Reaction of HA sulfate and potassium hydroxide to produce a 30 wt-percent HA and potassium sulfate aqueous slurry:

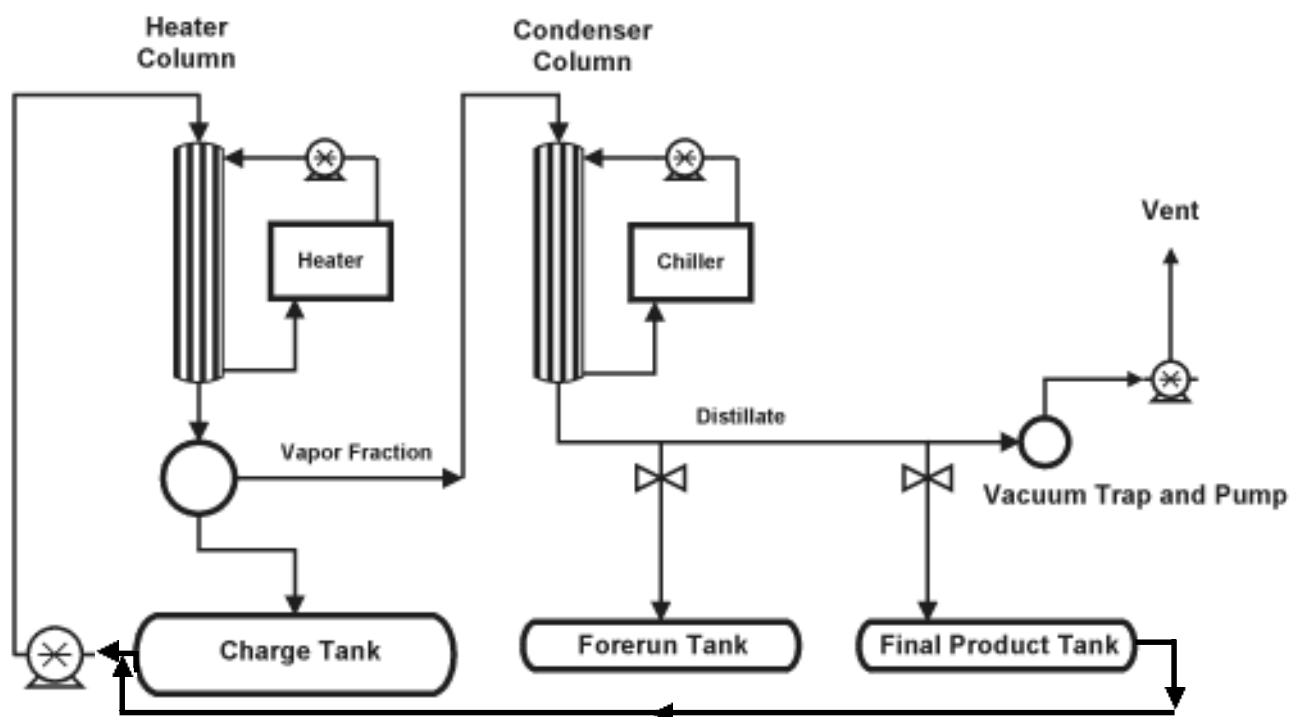
Figure 3

Simplified process flow diagram of the CSI HA vacuum distillation process

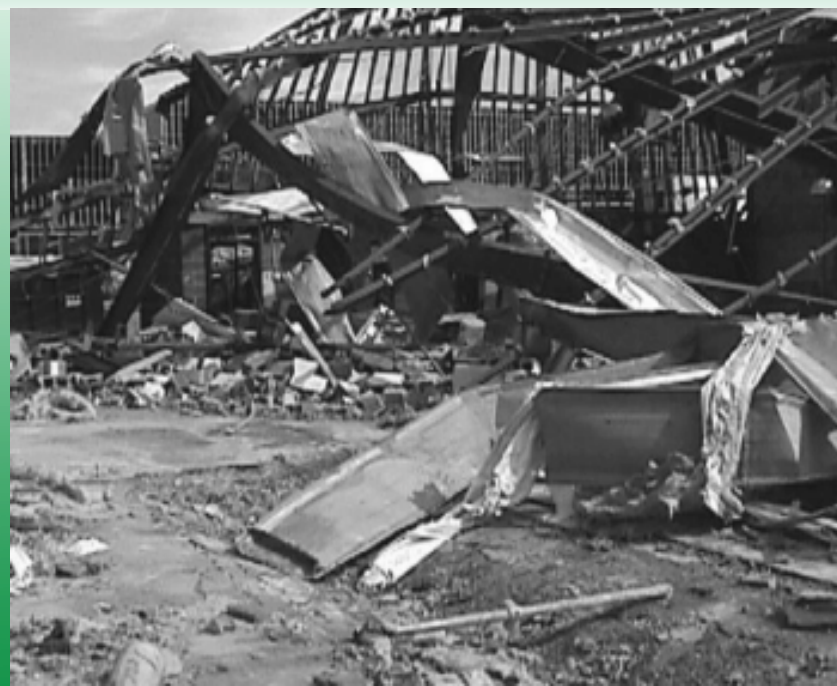
Figure 4

A crater approximately 6 feet wide, 26 feet long, and 16 inches deep was found in the concrete floor directly below where the charge tank had been located (Figure 4). Based on observed crater dimensions, Hazards Research Corporation estimated an explosive force equivalent to 800 pounds of trinitrotoluene (TNT; HRC, 1999).

Building damage and charge tank crater (foreground)

Because of the lack of batch records, it was not possible to determine the exact amount of HA in the charge tank at the time of the explosion. The explosive energy of HA is essentially equivalent to TNT on a weight basis. Hazards Research Corporation estimated that the HA in the tank was equivalent to 667 pounds of TNT (HRC, 1999).
