U.S. Chemical Safety and Hazard Investigation Board

# Organic Peroxide Decomposition, Release, and Fire at Arkema Crosby Following Hurricane Harvey Flooding

Crosby, Texas

Report Number: 2017-08-I-TX  
May 2018

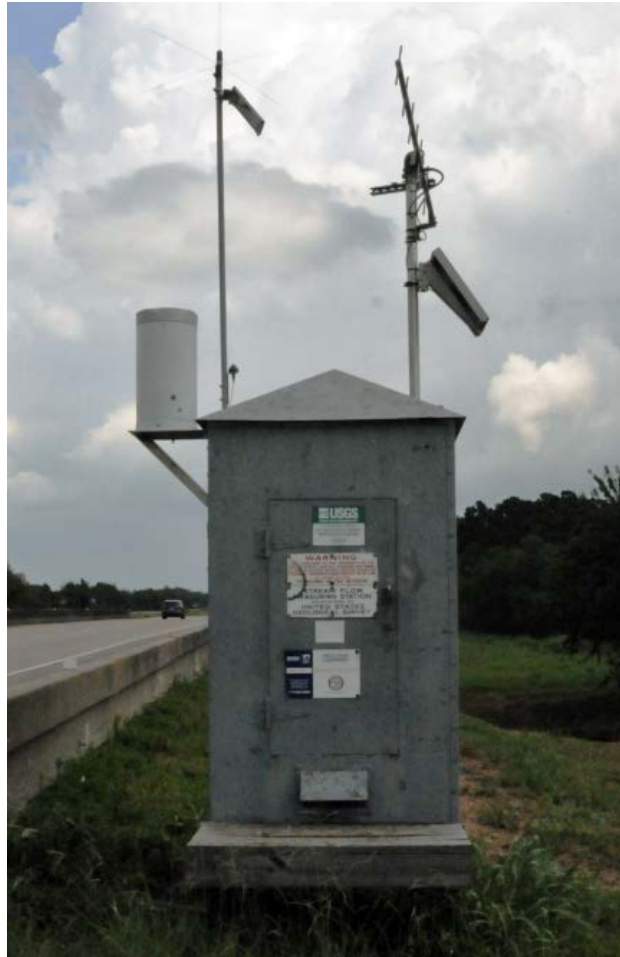
Figure 47. Gauge Station 1740. This gauge station uses a bubbler system to measure the Cedar Bayou water elevation at Highway 90, about three miles northeast of the Arkema Crosby facility.<sup>a</sup> (Source: CSB Photo)
