BETA LAB NO.M10198, REV. 1 - Tesoro E6600 HEAT EXCHANGER "E". SUMMARY OF THE RESULTS  PART: 6600-E HEAT EXCHANGER "E", ALL PARTS DAMAGE DEPTH, AND PART 17 MOUNTS	TESORO REFINING AND MARKETING COMPANY ANACORTES REFINERY 10200 W. MARCH POINT ROAD T91WA4428 ANACORTES, WA 98221	CUSTOMER P.O. No.: 4501667904
		DATE: 3/7/2011
		PAGE 1 OF 70

**LABORATORY REPORT**

This report contains the summary of the results obtained in ten previous reports, measurements of the damage penetration on all mounts, as well as evaluation of the Part 17, mounts from weld LS1 labeled LS-1 and 17-LS1 (see layout of the mounts on Figure 1).

This report is the eleventh in a series of the reports on the failed parts ("E") of the 6600E heat exchanger "E". The LS# and CS# refer to longitudinal and circumferential weld seams respectively, while the part number refers to the chain of custody number.

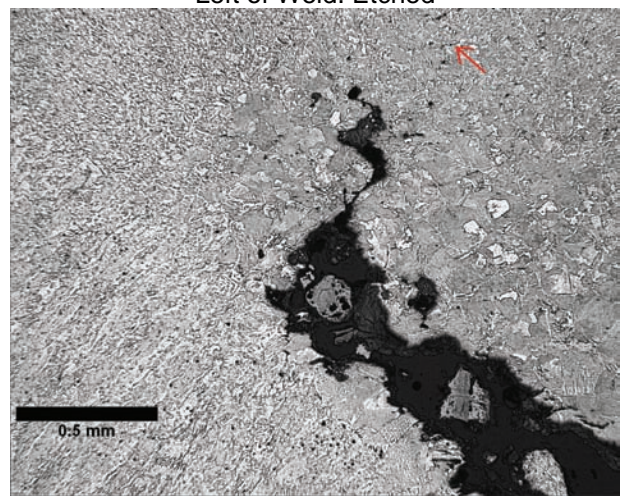
**CS3 WELD, SAMPLE 14-M2**

Left of Weld. Un-etched

Left of Weld. Etched

Right of Weld

Right of Weld. Etched

Damage Depth	
Left of Weld	Right of Weld
2.54	1.23
