**API 653
Inspection Report**

Report Prepared For
**U.S. CHEMICAL SAFETY AND HAZARD INVESTIGATION BOARD
FREEDOM INDUSTRIES**

4-METHYLCYCLOHEXANEMETHANOL (MCHM)

Tank Number
397

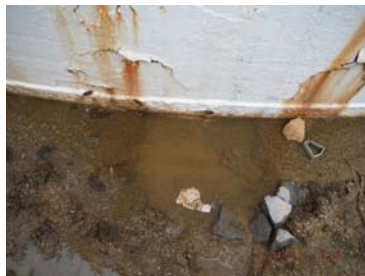
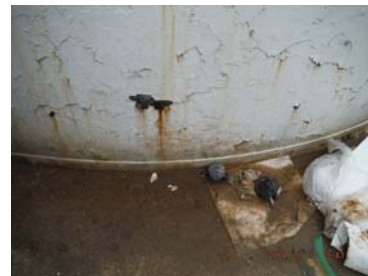
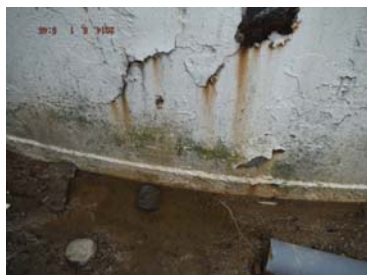
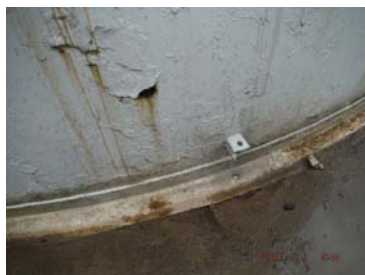
WATER IN CONTACT WITH BOTTOM PLATES

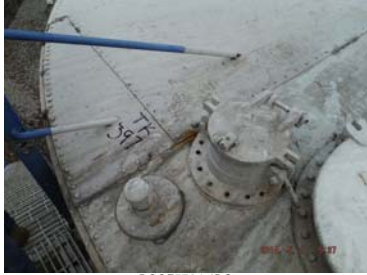
DSCF5724.JPG

COATING FAILURE AND CORROSION ALONG ROOF DECK

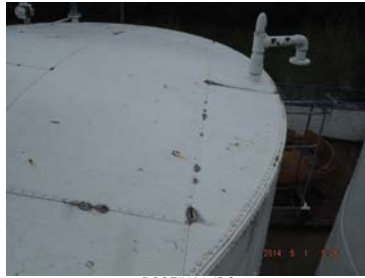
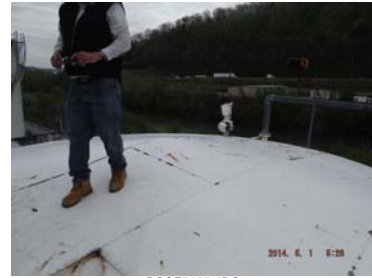
CORROSION ALONG THE ROOF DECK

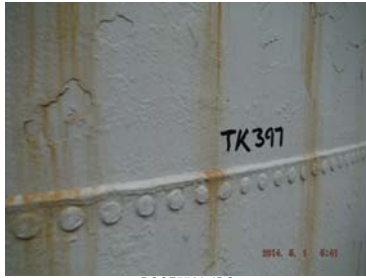
DSCF5728.JPG

COATING FAILURE AND CORROSION ALONG SHELL PLATES

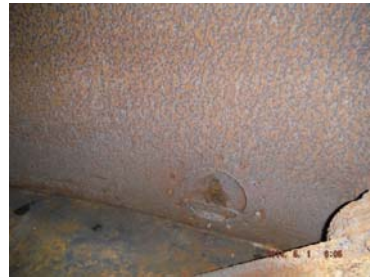
DSCF5781.JPG

COATING FAILURE ALONG THE SHELL

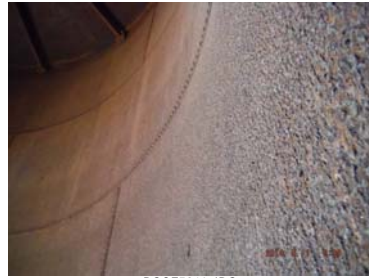
DSCF5810.JPG

CORROSION ALONG THE INTERIOR SHELL PLATES

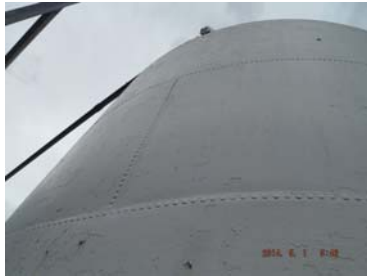
DSCF5755.JPG

COATING FAILURE ALONG EXTERIOR SHELL

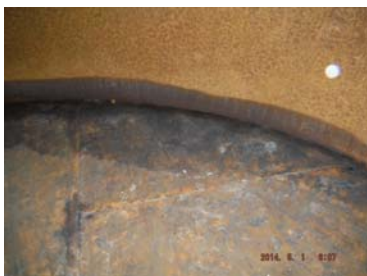
DSCF5800.JPG

WATER AND DIRT PREVENTED ACCURATE UT PROVE-UP OF MFL INDICATIONS

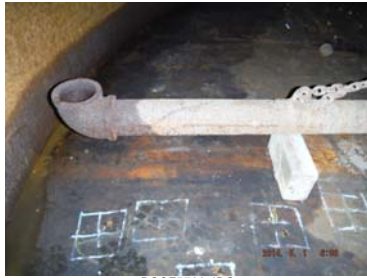
DSCF5792.JPG

0.200-IN PITTING AND THROUGH HOLE CORROSION
ON THE BOTTOM PLATES

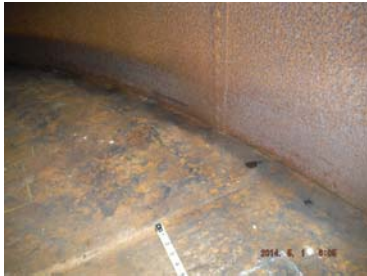
DSCF5782.JPG

PITTING ALONG BOTTOM PLATES

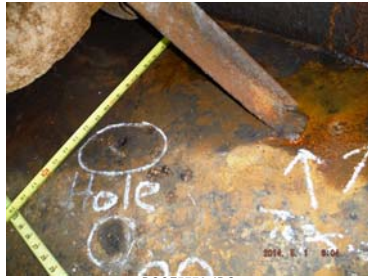
DSCF5778.JPG

THROUGH-HOLE CORROSION AND 0.200-IN DEEP PITTING ALONG BOTTOM PLATES
