BETA LAB NO. M10198, TESORO LS2 AND LS2/CS2 TEE FINDINGS PART: 6600-E HEAT EXCHANGER, LS2 22 IN, 36.5 IN MOUNTS, LS2 T2L SEM FRACTOGRAPHY AND PART 22 LS2-CS2 TEE FINDINGS PARTS 16-1 AND 22	TESORO REFINING AND MARKETING COMPANY ANACORTES REFINERY 10200 W. MARCH POINT ROAD T91WA4428 ANACORTES, WA 98221	CUSTOMER P.O. No.: 4501667904
		DATE: OCTOBER 13, 2010
		PAGE 1 OF 56

LABORATORY REPORT

This report is the tenth of a series of the reports on the failed parts of the 6600E heat exchanger. The LS# and CS# refer to longitudinal and circumferential weld seams respectively, while the part number refers to the chain of custody number. Below is the list of the previously issued reports:

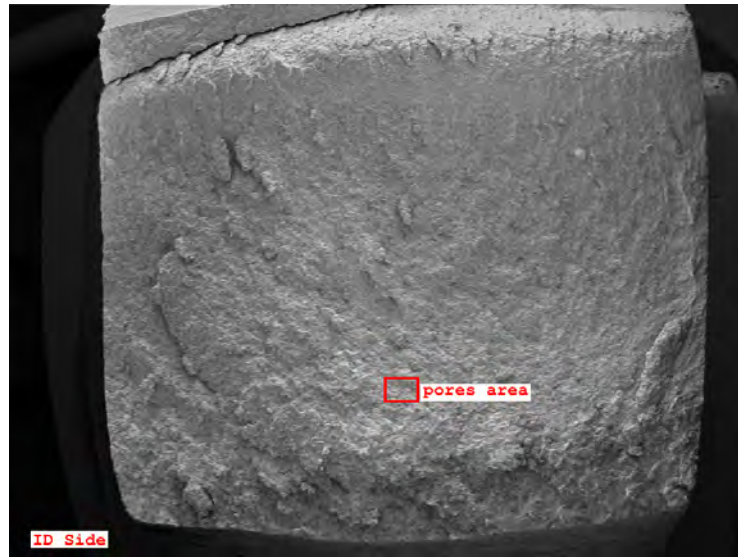
A. Area evaluated
