BETA LAB No.M10198- LS3 TOP	TESORO REFINING AND MARKETING COMPANY ANACORTES REFINERY 10200 W. MARCH POINT ROAD T91WA4428 ANACORTES, WA 98221	CUSTOMER P.O. No.: 4501667904
PART: 6600-E HEAT EXCHANGER LS 3 TOP PART 15		DATE: SEPTEMBER 20, 2010
PAGE 1 OF 53

LABORATORY REPORT-LS3 TOP

This report is the seventh of a series on the failed parts of the 6600E heat exchanger. The LS# and CS# refer to longitudinal and circumferential weld seams while the part number refers to the chain of custody number.

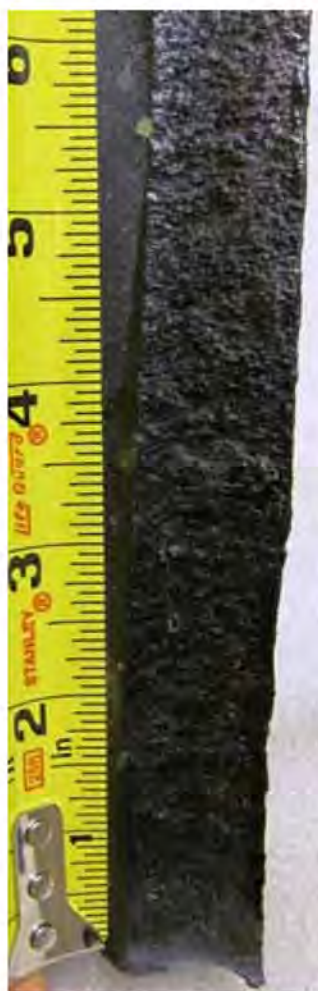
Location V1

Figure 4. Fracture surfaces along the CS4 weld. ID is on the right.

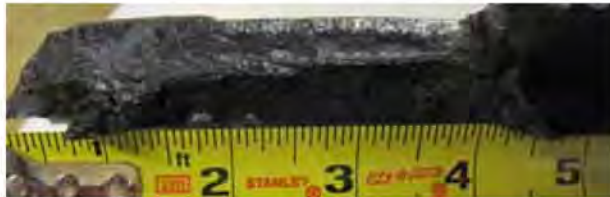
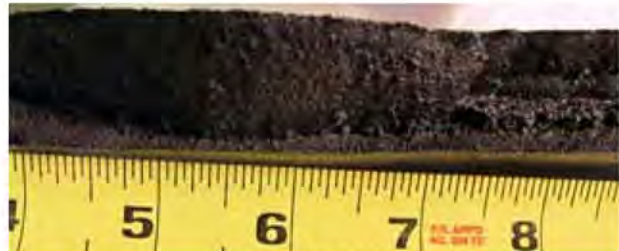
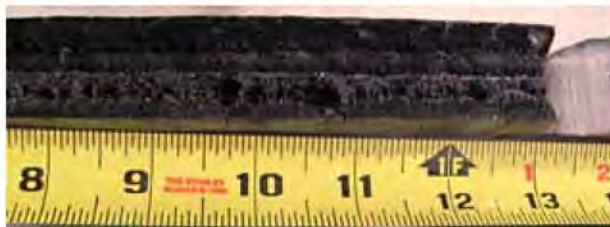
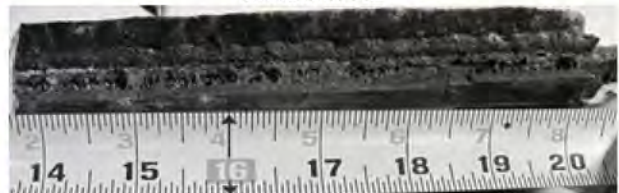
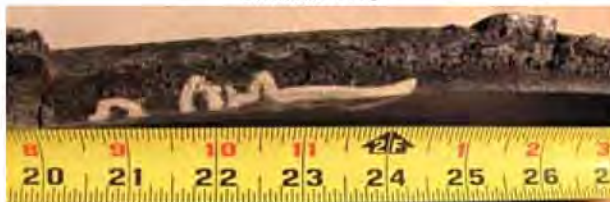
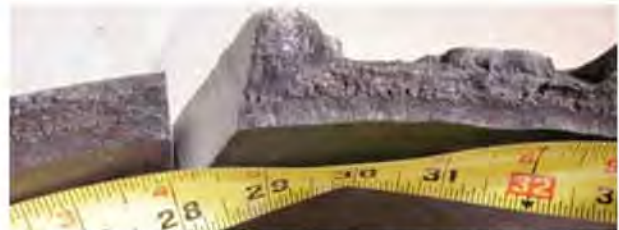
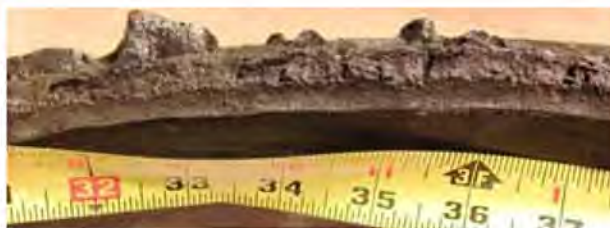
Figure 5. Fracture surfaces along the LS3 weld. ID is on the bottom, where the measure tape is located.

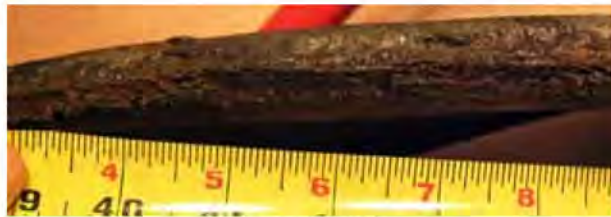
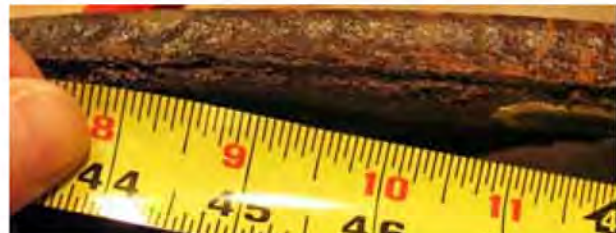
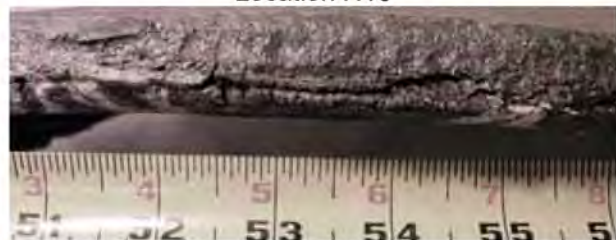
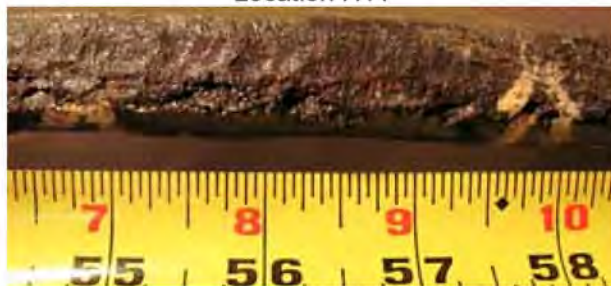
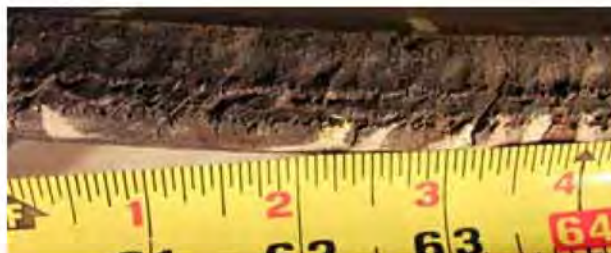
Figure 6. Fracture surfaces along the LS3 weld. ID is on the bottom, where the measure tape is located.

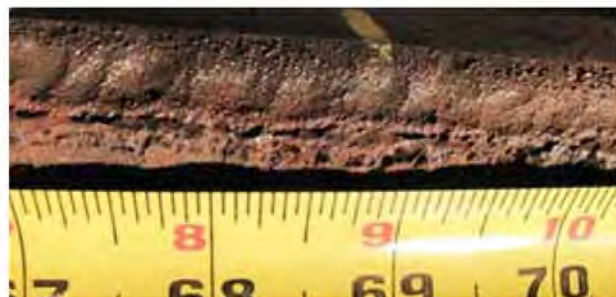
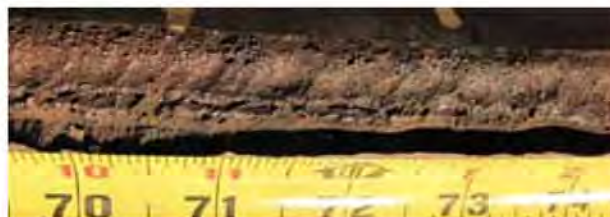
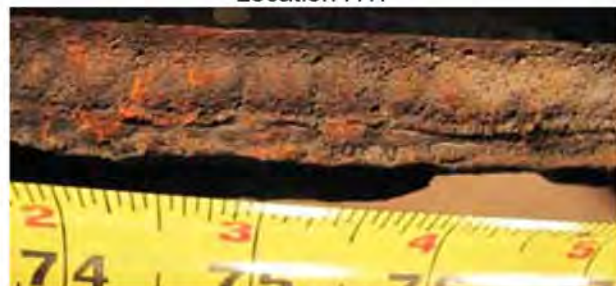
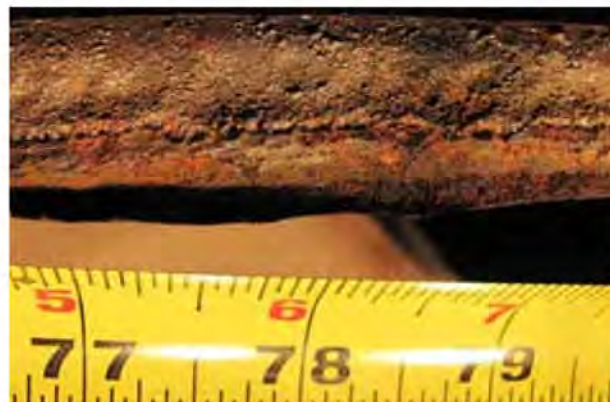
Figure 7. Fracture surfaces along the LS3 weld. ID is on the bottom, where the measure tape is located.

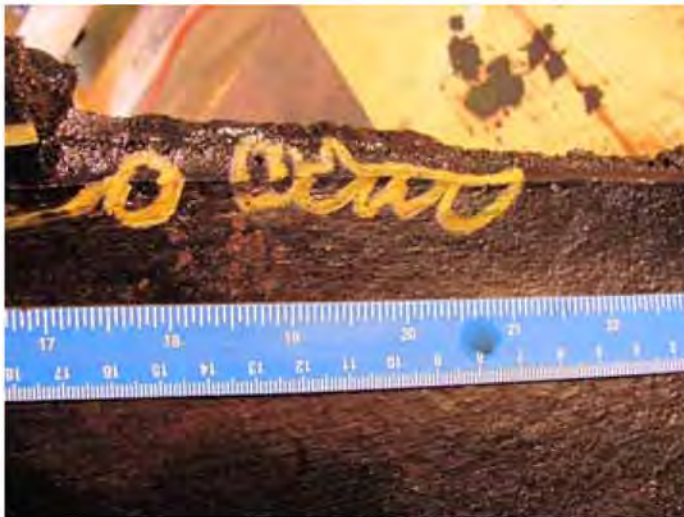
Figure 10. Magnetic Particle inspection. Indications circled (fracture on top and looking at ID surface)

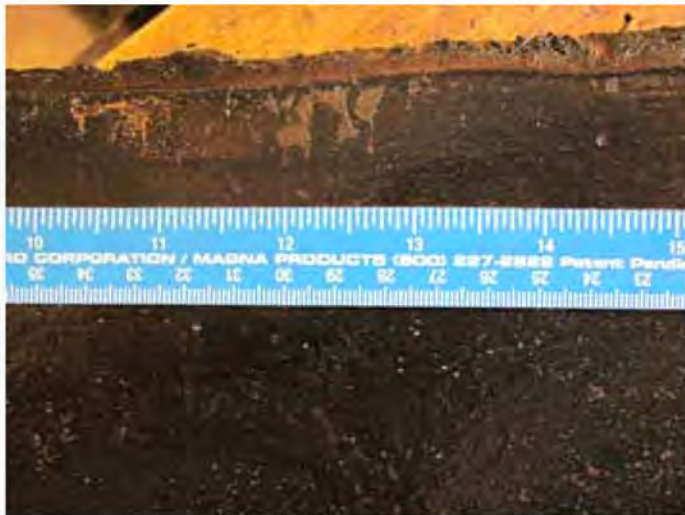
Location 9

Figure 11. Magnetic Particle inspection. Indications circled (fracture on top and looking at ID surface)

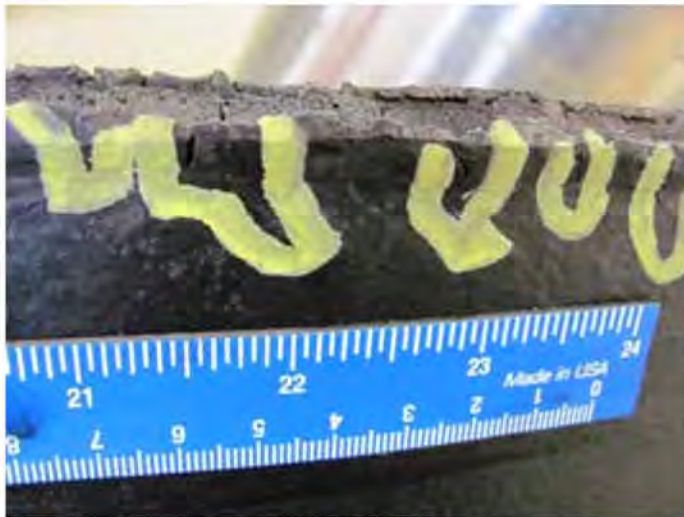
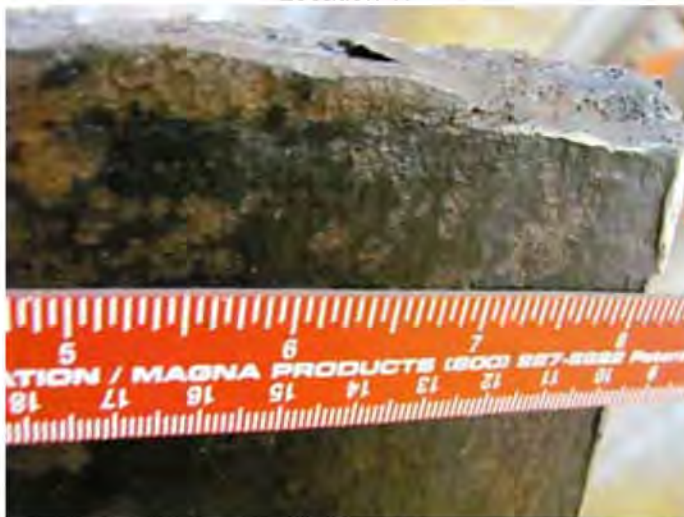
Figure 13. Magnetic Particle inspection. Indications circled (fracture on top and looking at ID surface)

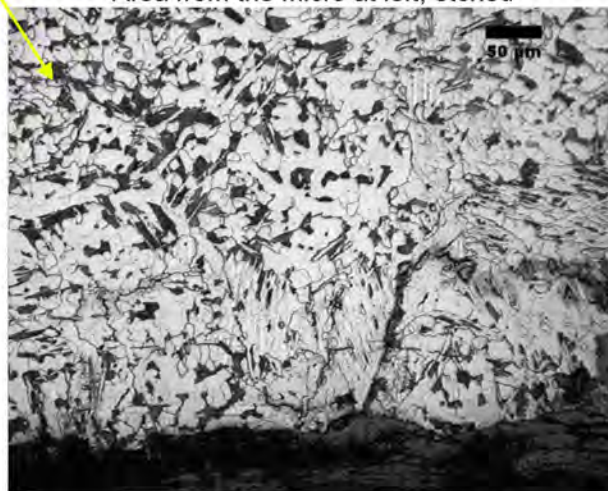
Figure 21

Area near the crack, un-etched

Area from the micro at left, etched

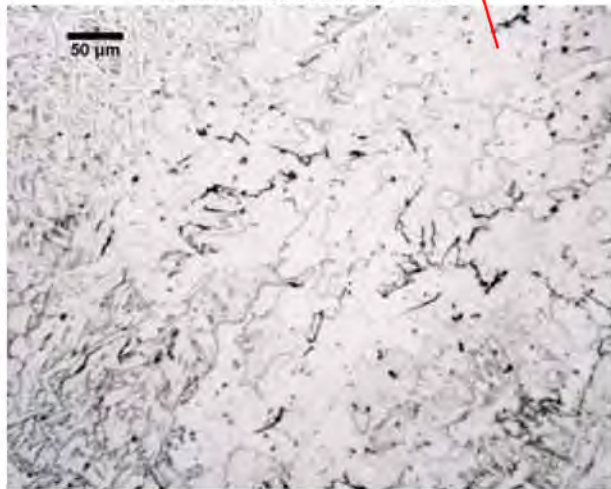
Weld metal near ID. Etched
