**API 653
Inspection Report**

**Internal Inspection and
Out-of-Service
or
Internal Inspection
w/ External Checklist**

4-METHYLCYCLOHEXANEMETHANOL (MCHM)

Tank Number
396

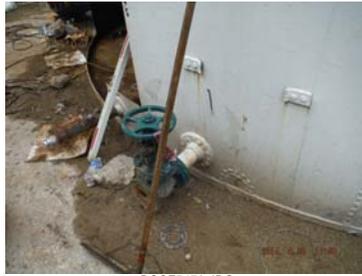
DSCF5479.JPG

PORTIONS OF BOTTOM EXTENSION COVERED BY SOIL

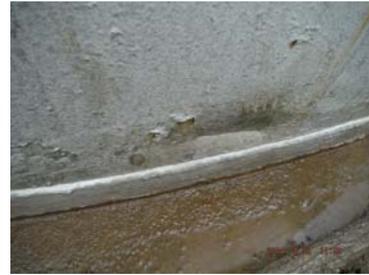
DSCF5484.JPG

RAINWATER IN CONTACT WITH BOTTOM PLATES

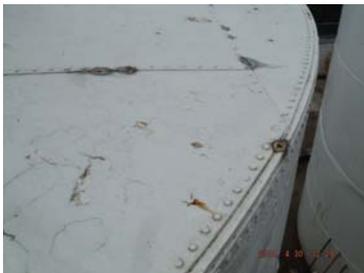
DSCF5522.JPG

D. ROOF
COATING FAILURE AND CORROSION ALONG CONE ROOF

DSCF5519.JPG
COATING FAILURE AND CORROSION ALONG CONE ROOF

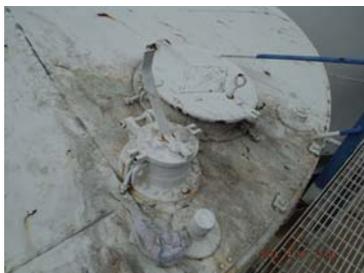
DSCF5527.JPG

D. ROOF
CORROSION ALONG UPPER ANGLE

DSCF5523.JPG
CORROSION ALONG UPPER ANGLE

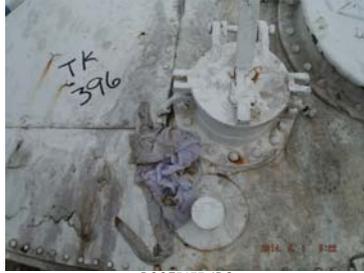
DSCF5529.JPG

D. ROOF
CORROSION ALONG ROOF LAP WELDS

CORROSION ALONG ROOF LAP WELDS

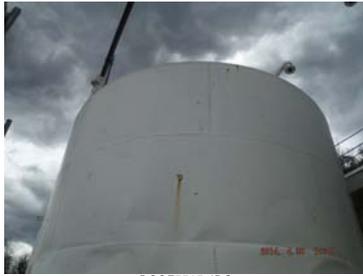
DSCF5505.JPG

DSCF5506.JPG
CREASES IN SHELL

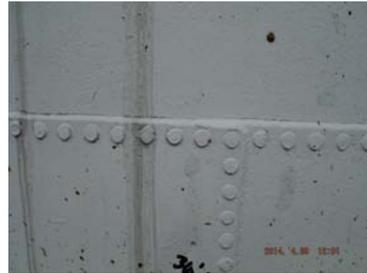
DSCF5501.JPG

DSCF5502.JPG
CREASE IN SHELL PLATES

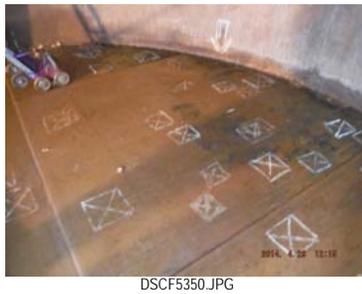
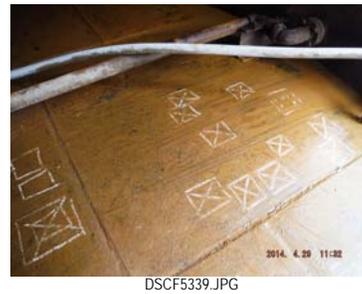
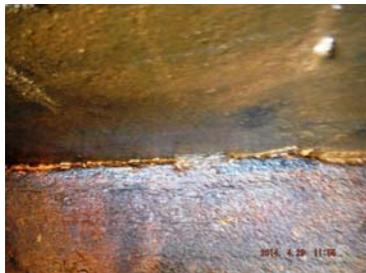
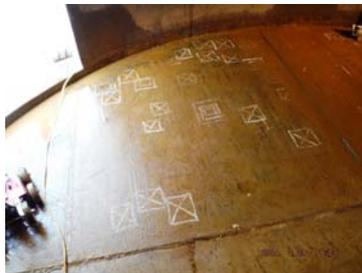
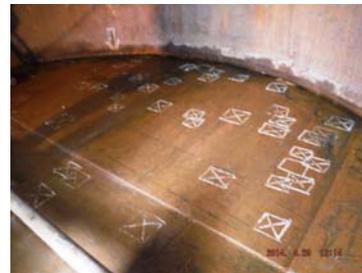
F. BOTTOM

WIDESPREAD MFL INDICATIONS OF SOIL-SIDE CORROSION ON BOTTOM PLATES

WIDESPREAD MFL INDICATIONS OF SOIL-SIDE CORROSION

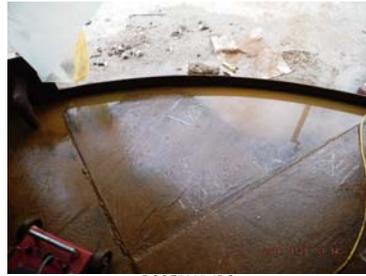
DSCF5335.JPG
WATER AND DIRT PREVENTED ACCURATE UT PROVE-UP OF MFL INDICATIONS

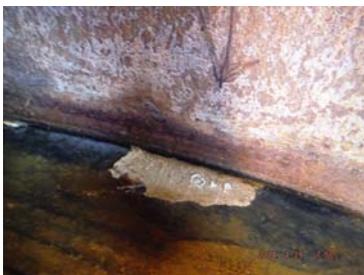
DSCF5315.JPG

F. BOTTOM
**THROUGH-HOLE SOIL-SIDE CORROSION ALONG THE
BOTTOM PLATES**

THROUGH-HOLE SOIL-SIDE CORROSION ALONG THE
BOTTOM PLATES

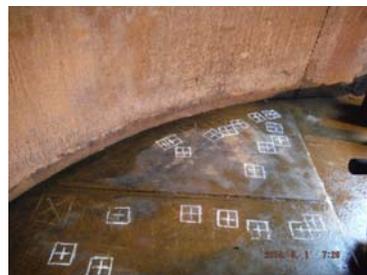
DSCF5891.JPG

F. BOTTOM
**POSSIBLE INDICATIONS OF MIC (MICROBIOLOGICALLY
INDUCED CORROSION)**

POSSIBLE INDICATIONS OF MIC (MICROBIOLOGICALLY INDUCED CORROSION)
